# COUNTY OF LOS ANGELES

### **CONSOLIDATED SEWER MAINTENANCE DISTRICT CONDITION ASSESSMENT PROGRAM REPORTS PROJECT NOS. Y0TV0708C AND Y0TV0809B**

**CONDITION ASSESSMENT REPORT  
COUNTY OF LOS ANGELES DEPARTMENT OF PUBLIC WORKS  
CONSOLIDATED SEWER MAINTENANCE DISTRICT**

**100 PERCENT SUMMARY**

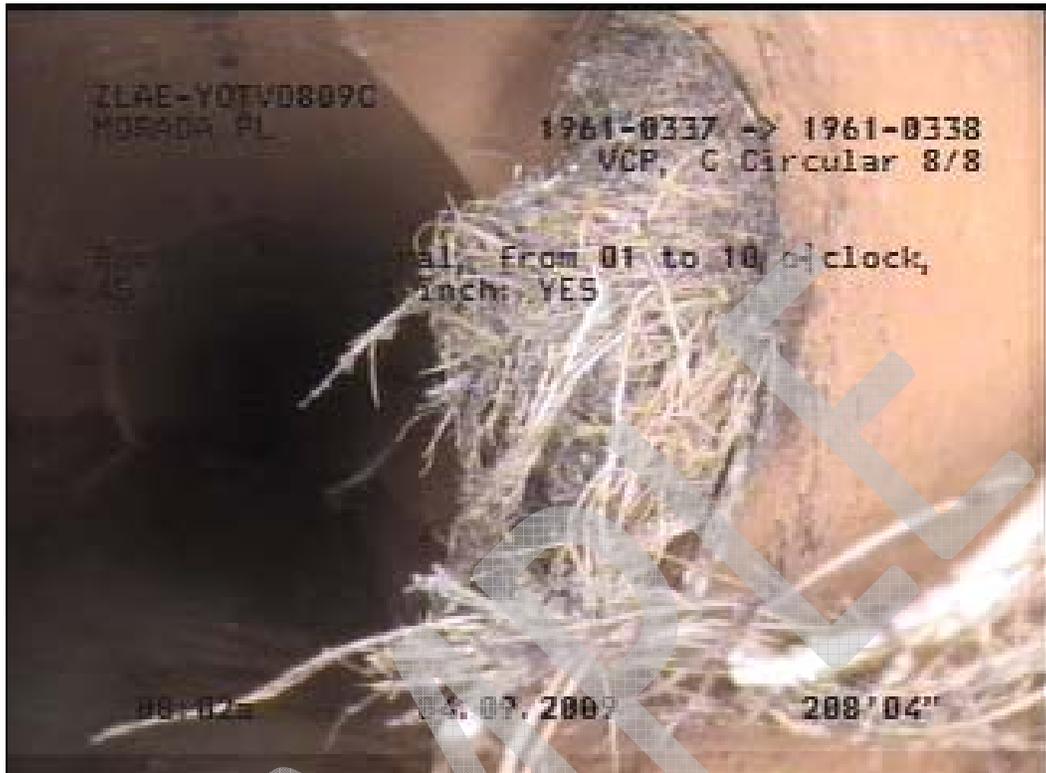
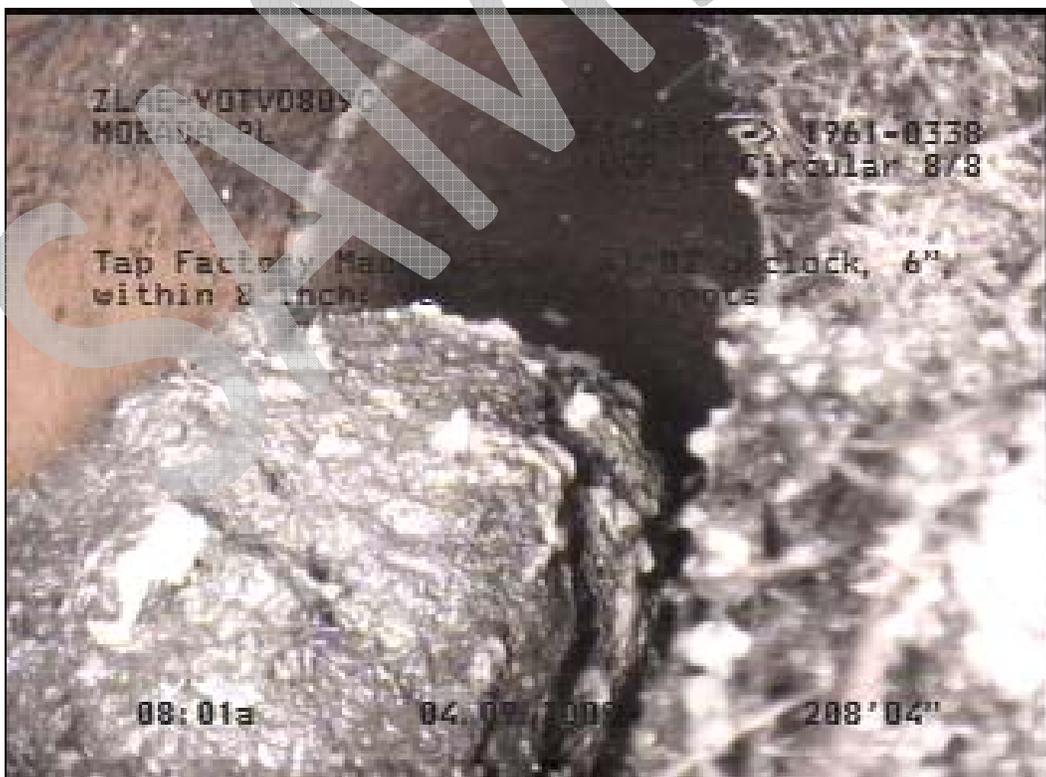
For your reference, we have enclosed photos of your lateral connection showing the presence of the root blockage. Also enclosed are some literature on ways of minimizing sewer overflows and damage to your home.

XXXX  
Roots at Lateral Connection

your sewer lateral within 90 days to remove roots and any other obstructions that may cause a sewage backup.
