CONSOLIDATED SEWER MAINTENANCE DISTRICT CONDITION ASSESSMENT PROGRAM REPORTS PROJECTS Y0TV0506D AND Y0TV0708F

**CONDITION ASSESSMENT REPORT
COUNTY OF LOS ANGELES DEPARTMENT OF PUBLIC WORKS
CONSOLIDATED SEWER MAINTENANCE DISTRICT**

PROJECT NAME:	Y0TV0708F	PROJECT MGR:	Kari Eskridge
PROJECT DATE:	10/22/07-12/24/07	CONTACT NO:	(626) 300-3390
SUP DISTRICT(s):	5	MAP PAGE(S):	2342,2341,2299
Report By:	Hanna Kebede	Report Date:	05/05/2009

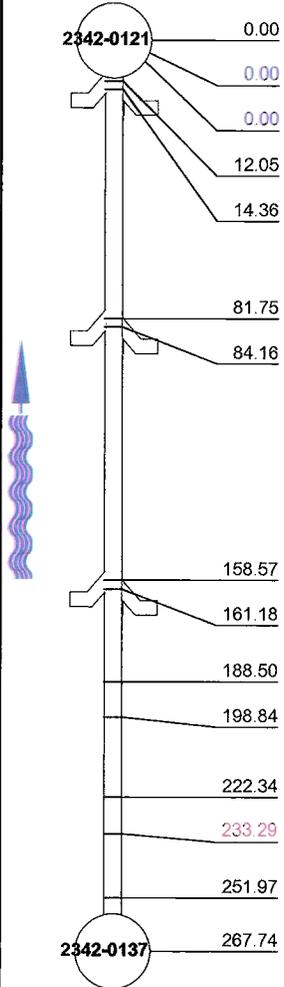
Street: DODSWORTH AV	Flow Control: N Not Controlled	Start MH: 2342-0121
City: GLR	Year Renewed:	End MH: 2342-0137
Location Code: C Light Highway	Tape/Media #: 1	pipe length: 267.74 ft
Reason for inspection: F Routine Assessment		Dia/Height: C 8/8
Use of Sewer: SS Sanitary		Material: VCP Pipe Length: 261
Drain. Area: 2342		Lining Method:
		Category:

158.57	Tap Factory Made Active, at 03 o'clock, 6", within 8 inch: YES, Remark:	00:04:27	457	
	161.18	Roots	00:04:43	458	
	188.50	Roots Fine Joint, from 08 to 11 o'clock, within 8 inch: YES	00:05:26	459

198.84	Roots Fine Joint, from 02 to 05 o'clock, within 8 inch: YES	00:05:50	460, b	
	222.34	Roots Fine Joint, from 12 to 12 o'clock, within 8 inch: YES	00:06:33	462, b

233.29	Fracture Multiple, from 10 to 02 o'clock, within 8 inch: YES	00:07:03	464, b	S 4
	251.97	Roots Fine Joint, from 09 to 03 o'clock, within 8 inch: YES	00:07:42	466, b

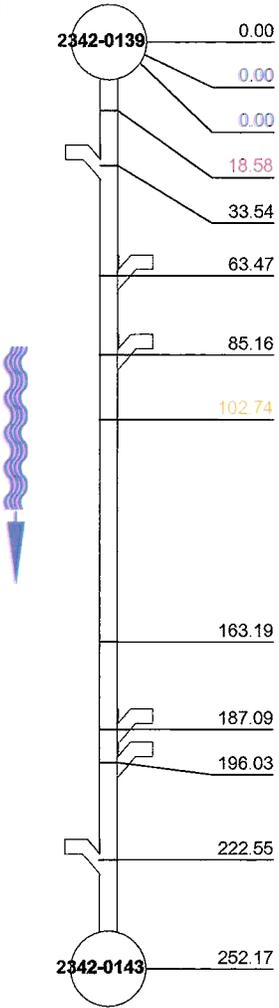
Street:	Flow Control: N Not Controlled	Start MH: 2342-0139
City: GLR	Year Renewed:	End MH: 2342-0143
Location Code: D Easement/Right of Way	Tape/Media #: 1	pipe length: 252.17 ft

0.00	Water Mark, 10 % of cross sectional area			M 2
	18.58	Fracture Multiple, from 02 to 05 o'clock, within 8 inch: YES	00:01:08	590, b	S 4
	33.54	Tap Factory Made Active, at 02 o'clock, 4" within 8 inch: YES, Remark: Roots	00:01:43	592

102.74	Crack Multiple, from 06 to 12 o'clock, within 8 inch: YES	00:04:06	595, b	S 3
	163.19	Roots Fine Joint, from 08 to 03 o'clock, within 8 inch: YES	00:05:31	597 b
