DEPARTMENT OF PUBLIC WORKS

**CONSOLIDATED SEWER MAINTENANCE DISTRICT
CONDITION ASSESSMENT PROGRAM REPORT
PROJECT NO. Y0TV0809C**

**CONDITION ASSESSMENT REPORT
COUNTY OF LOS ANGELES DEPARTMENT OF PUBLIC WORKS
CONSOLIDATED SEWER MAINTENANCE DISTRICT**

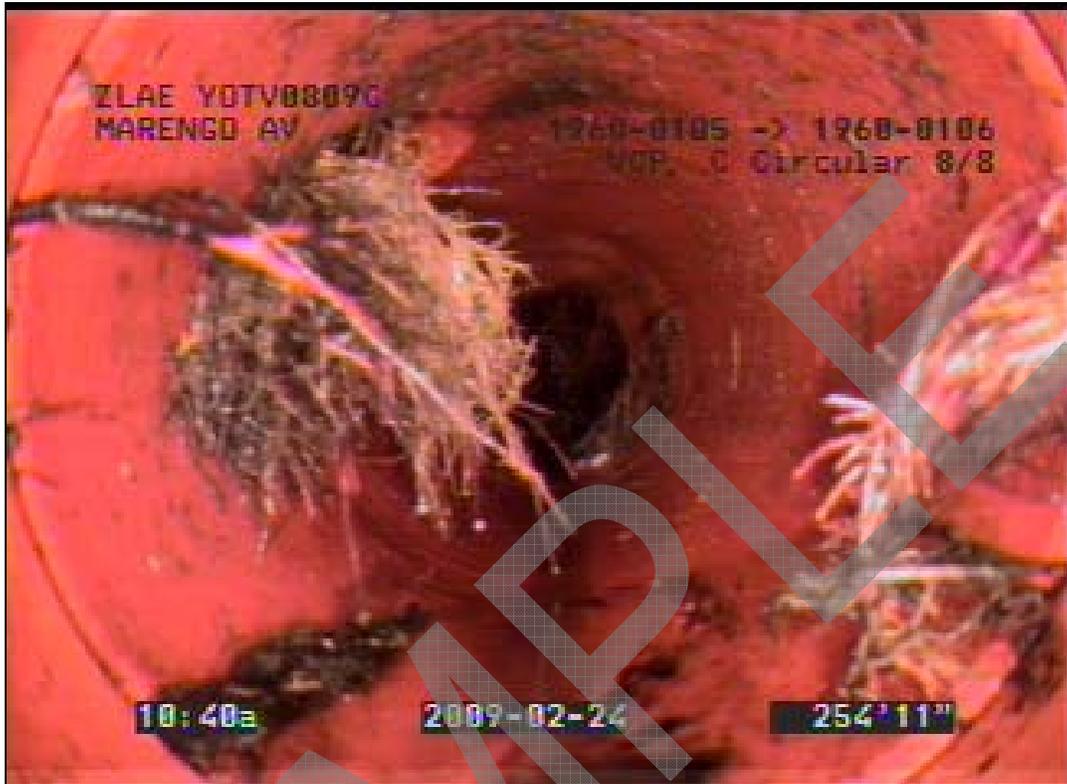
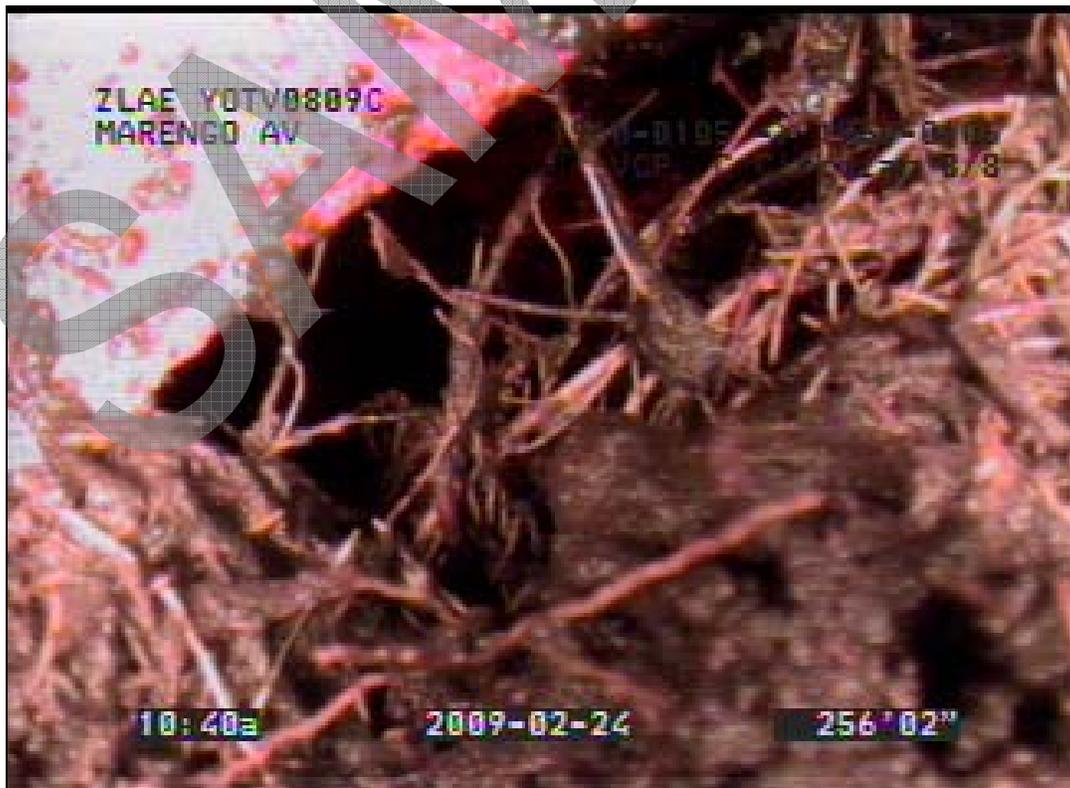
For your reference, we have enclosed photos of your lateral connection showing the presence of the root blockage. Also enclosed are some literature on ways of minimizing sewer overflows and damage to your home.

3476 MARENGO AVE
ALTADENA
Roots at Lateral Connection

your sewer lateral within 90 days to remove roots and any other obstructions that may cause a sewage backup. Failure to do so may result in future overflows and subject you to civil prosecution, reimbursement costs, and fines up to \$1,000. Reference 20.24.160 Violation - Penalty; 20.24.170 Continued violations; 20.32.690 Reimbursement for repairs and maintenance following violations.
