**CONSOLIDATED SEWER MAINTENANCE DISTRICT
CONDITION ASSESSMENT PROGRAM REPORT
PROJECT NO. Y0TV1011A**

**CONDITION ASSESSMENT REPORT
COUNTY OF LOS ANGELES DEPARTMENT OF PUBLIC WORKS
CONSOLIDATED SEWER MAINTENANCE DISTRICT**

PROJECT NAME:	Y0TV1011A	PROJECT MGR:	Eric Liu
PROJECT DATE:	08/31/11	CONTACT NO:	(626) 300-3380
SUP. DISTRICT(s):	4	MAP PAGE(S):	2175, 2221
Report By:	May Hong	Report Date:	04/10/2013

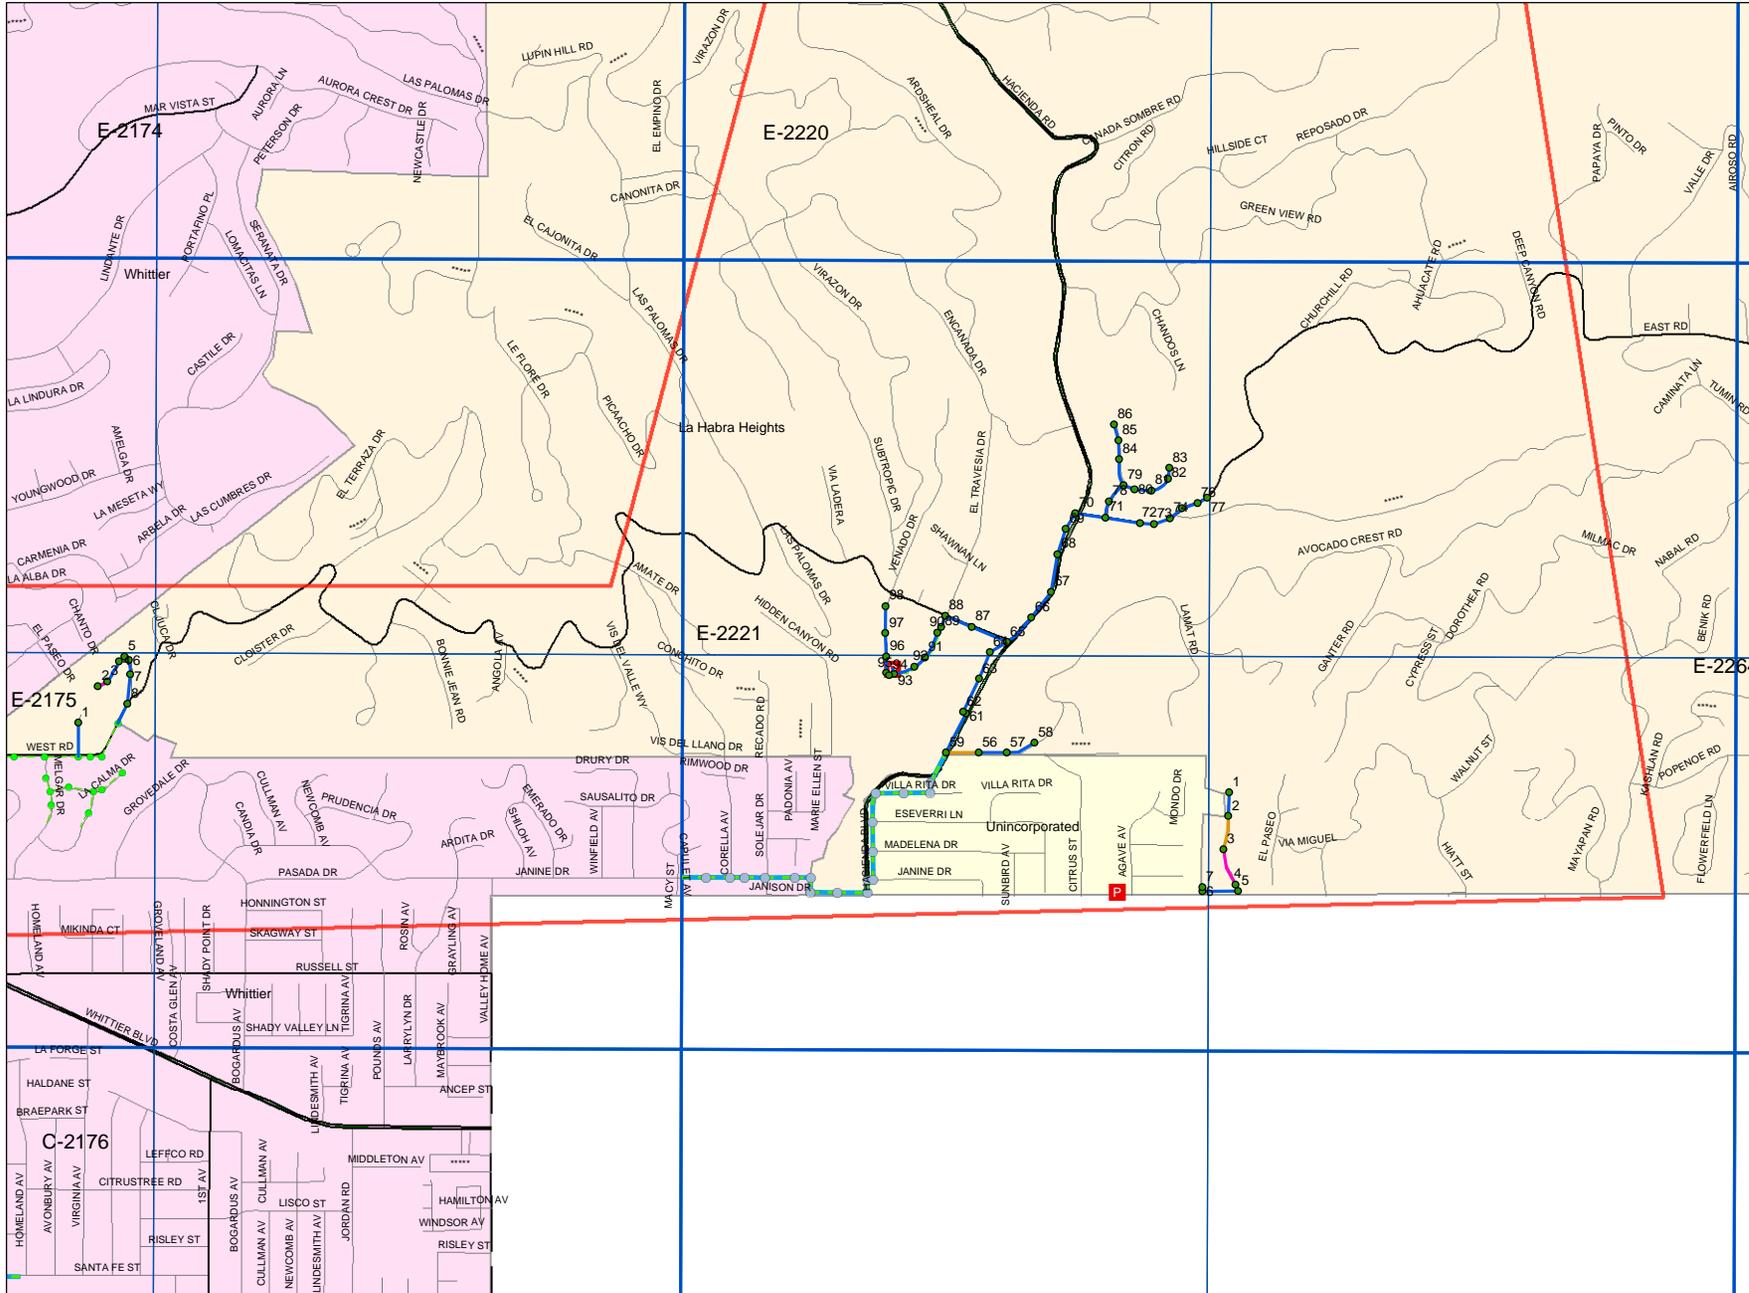
QUICK MAINTENANCE RATING (QMR)

Our inspection revealed that approximately 89.9 percent of the system televised was free of blockages or restrictions that would impede sewer flows. However, the remaining 10.1 percent of the inspected pipe segments within the City area had a PACP maintenance grade of 3, 4, or 5 as indicated in the Quick Maintenance Rating Table shown below. These segments have been incorporated into an enhanced cleaning schedule with corrective action taken as noted on the Quick Maintenance Rating Report Priority List (Enclosure 2).

ITEM NO.	QMR	START MH	END MH	STREET	OBSERVATION	CORRECTIVE ACTION TAKEN	DATE COMPLETED
1	3121	2221-0056	2221-0059	AVOCADO CREST RD	Roots	Hydrojet	03/28/13
2	4221	2175-0002	2175-0003	CANCHO DR	Root ball	Hydrojet	03/28/13
3	3121	2221-0002	2221-0003	SIERRA VISTA DR	Grease; roots	Hydrojet	03/28/13
4	4121	2221-0003	2221-0004	SIERRA VISTA DR	Root ball	Hydrojet	03/28/13
5	3121	2221-0004	2221-0005	SIERRA VISTA DR	Roots	Hydrojet	03/28/13

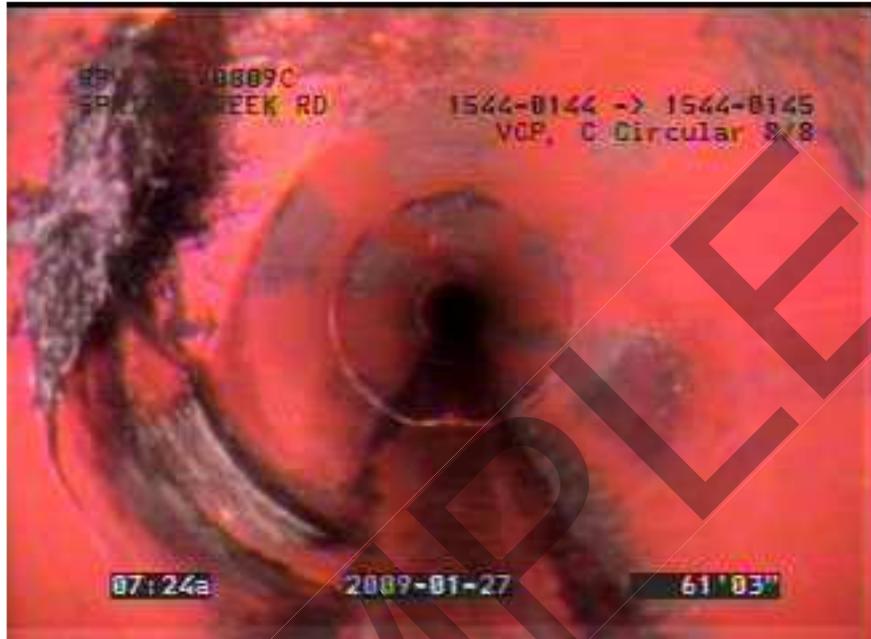
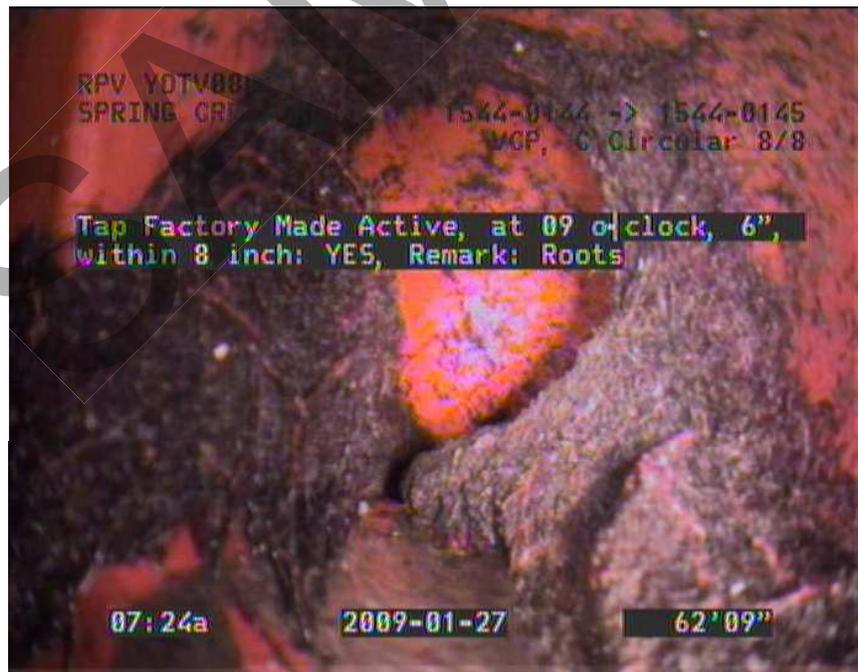
XXXX
Roots at Lateral Connection

Using closed-circuit television (CCTV) camera technology, the District recently televised the sanitary sewer mainline and discovered the presence of roots in your sewer lateral connection. The intrusion of the roots from your lateral may block the flow of sewage in the mainline sewer causing a sanitary sewer overflow upstream of your property.

For your reference, we have enclosed photos of your lateral connection showing the presence of the root blockage. Also enclosed are some literature on ways of minimizing sewer overflows and damage to your home.

Since the CCTV inspection, the sewer mainline has been cleaned and blockages from root growth have been removed; however, the root blockage in your sewer lateral is still present. As the property owner, you are responsible for the entire length of the sewer lateral, which includes the portion that extends beyond the property line into the public right of way. We request that you contact a qualified plumbing contractor to service your sewer lateral within 90 days to remove roots and any other obstructions that may cause a sewage backup.

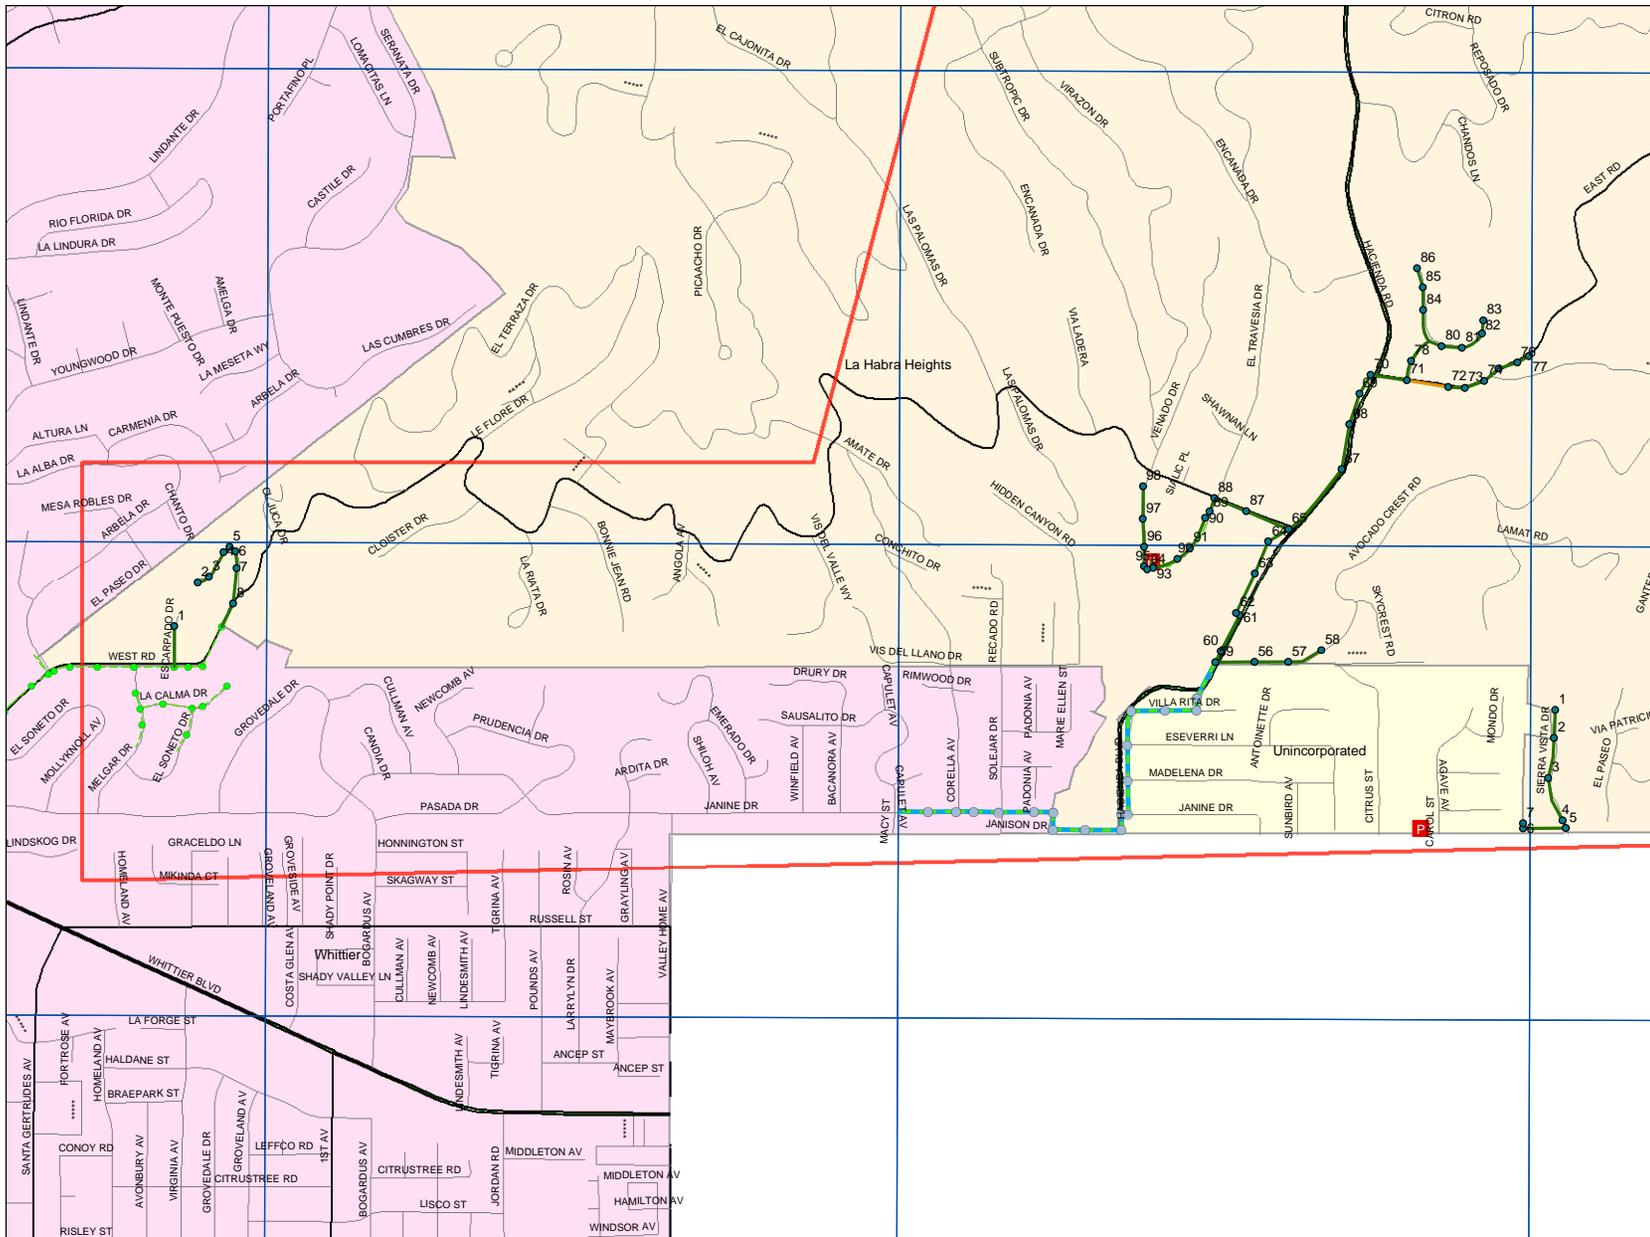
**QUICK
STRUCTURAL
RATING
(QSR)**

Our inspection revealed that 100 percent of the inspected pipe segments within the City were free of severe structural defects. Severe structural defects are identified when pipe segments had a PACP structural grade of 4 and 5. As indicated in the Quick Structural Rating Table shown below, our inspection revealed there are no severe structural defects in your system.
