**CONSOLIDATED SEWER MAINTENANCE DISTRICT
CONDITION ASSESSMENT PROGRAM REPORT
PROJECT NO. Y0TV0809C**

**CONDITION ASSESSMENT REPORT
COUNTY OF LOS ANGELES DEPARTMENT OF PUBLIC WORKS
CONSOLIDATED SEWER MAINTENANCE DISTRICT**

PROJECT NAME:	Y0TV0809C	PROJECT MGR:	Kari Eskridge
PROJECT DATE:	08/10/2009	CONTACT NO:	(626) 300-3390
SUP. DISTRICT(s):	5	MAP PAGE(S):	2384 □ 2385
Report By:	Hanna Kebede	Report Date:	07/29/2010

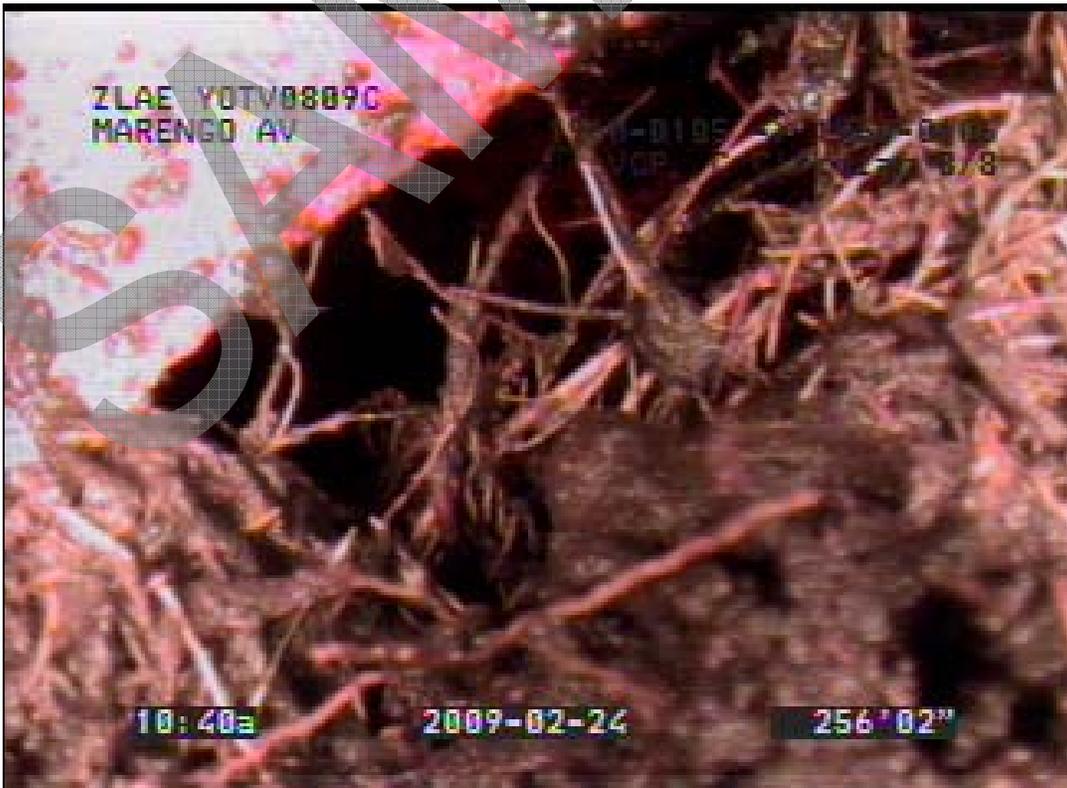
Using closed-circuit television (CCTV) camera technology, the District recently televised the sanitary sewer mainline and discovered the presence of roots in your sewer lateral connection. The intrusion of the roots from your lateral may block the flow of sewage in the mainline sewer causing a sanitary sewer overflow upstream of your property.

Since the CCTV inspection, the sewer mainline has been cleaned and blockages from root growth have been removed; however, the root blockage in your sewer lateral is still present. As the property owner, you are responsible for the entire length of the sewer lateral, which includes the portion that extends beyond the property line into the public right of way. We request that you contact a qualified plumbing contractor to service

3476 MARENGO AVE
ALTADENA
Roots at Lateral Connection

your sewer lateral within 90 days to remove roots and any other obstructions that may cause a sewage backup. Failure to do so may result in future overflows and subject you to civil prosecution, reimbursement costs, and fines up to \$1,000. Reference 20.24.160 Violation - Penalty; 20.24.170 Continued violations; 20.32.690 Reimbursement for repairs and maintenance following violations.
