Title: Panama Moving & Storage Sample Locations
 Project: MRCA Asbestos and LBP Survey of "Glendon", Property
 Project No: L-9985
 Drawn By: L. Kennington / J. Schmitt
 Checked By: *JKM*
 Date: 9/21/2010
 Scale: NTS

Title: "Factory" 2844 Gleneden Street Sample Locations
 Project: MRCA Asbestos and LBP Survey of "Gleneden" Property
 Project No: I-9985
 Drawn By: L. Kennington / J. Schmitt
 Checked By: *JMM*
 Date: 9/21/2010
 Scale: NTS

Photographs – “Panama Moving and Storage” Warehouse

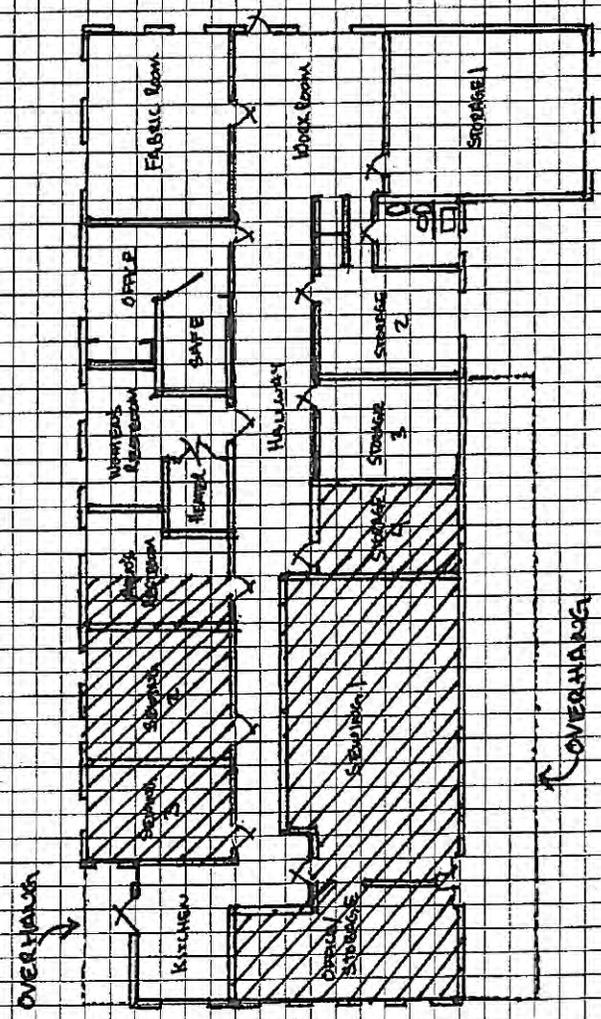
ASBESTOS CONTAINING MATERIALS:
 [Hatched Box] = CUTX-IT: SPRAYED ACoustICAL CEILING PLASTER
 (ACCM)

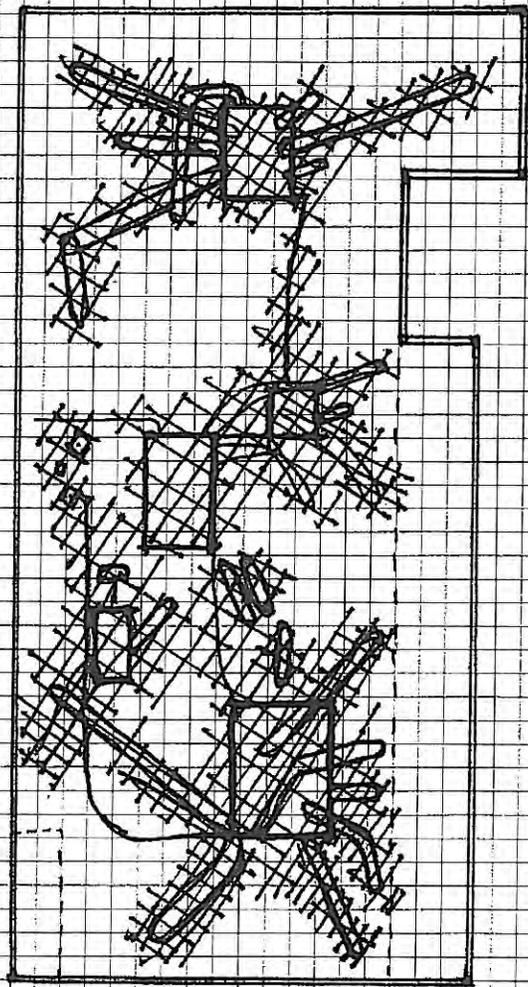
- ACM ROOFING MASTICS ASSOCIATED WITH HVAC DUCTS, JOINTS, SEAMS & PENETRATIONS:
- RFMMS-05: BLACK MASTIC ASSOCIATED WITH ROOF PENETRATIONS
- RFMMS-06: SILVER/GRAY MASTIC ASSOCIATED WITH ROOF PENETRATIONS
- HJMTIP-07: HVAC DUCT TAPE AND MASTIC (CONTAINS TYPE 1014 GRAY CONTAIN.)
- HJMS-09: BLACK MASTIC ON HVAC JOINTS AND SEAMS
- MISC-10: BLACK TARRY MASTIC/CONTAIN ON 1" AND 2" PIPES ON THE ROOF
- MISC-11: SILVER TERTIARY CONTAIN ON "ROUND" HVAC DUCTWORK

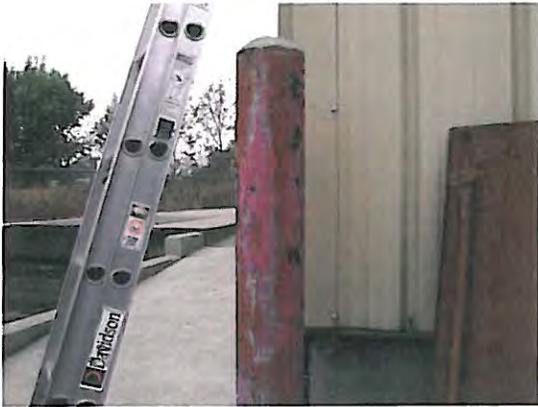
1. Lead-based chipped red paint on the exterior steel bollard at the Warehouse [Bulk Sample I.D. Pb-06-RD, containing 11,000 ppm].

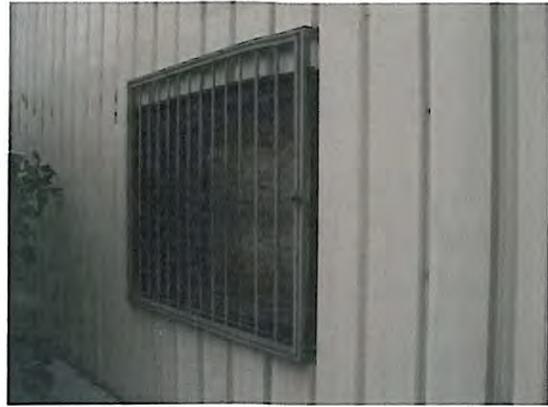
2. Lead-containing chipped gray paint on exterior window frames of the Warehouse [Bulk Sample I.D. Pb-07-GY, containing 1,600 ppm].

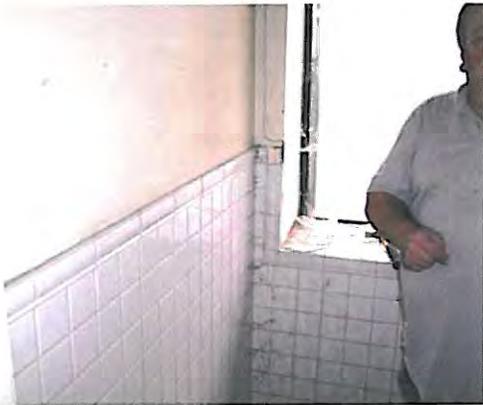
3. Lead-glazed ceramic wall and floor tiles, present in the Men's and Women's Restrooms (Assumed lead-glazed by SCA).

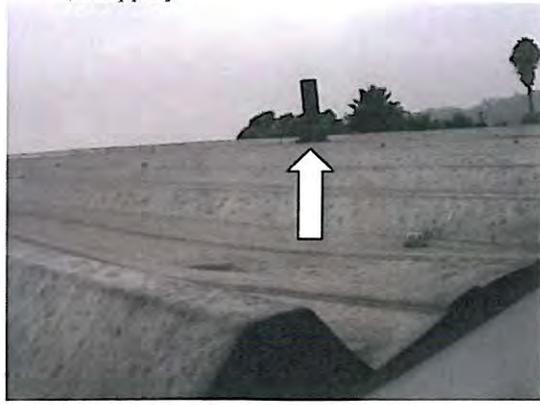
4. ACM roof penetration mastic associated with the restroom vent penetration, totaling about 3 square feet (Assumed asbestos-containing by SCA).

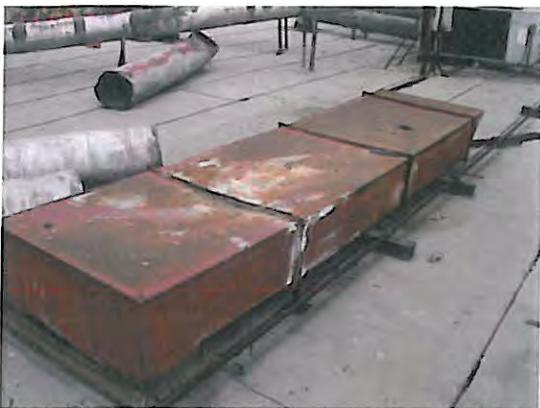
1. Intact lead-based red paint on metal HVAC equipment housing and ductwork on the Roof of the Factory [Bulk Sample I.D. Pb-08-RD, containing 21,000 ppm].

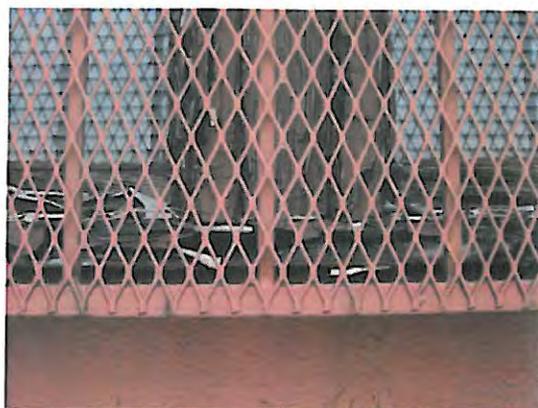
2. Severely chipped and peeling lead-based red paint on the exterior wood window frames of the Factory [Bulk Sample I.D. Pb-11-RD, containing 67,000 ppm].

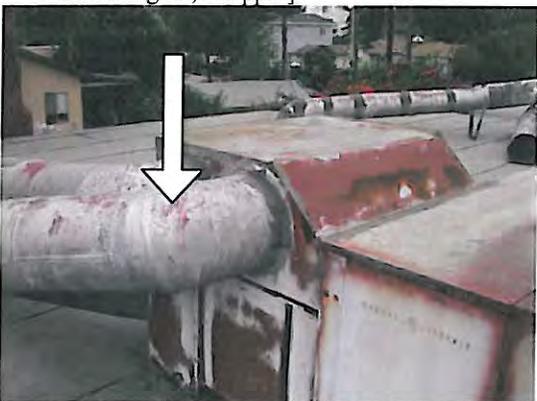
3. Peeling lead-containing silver paint (also ACM) on the roof-mounted HVAC unit housing and ductwork of the Factory [Bulk Sample I.D. Pb-09-SLVR, containing 900 ppm].

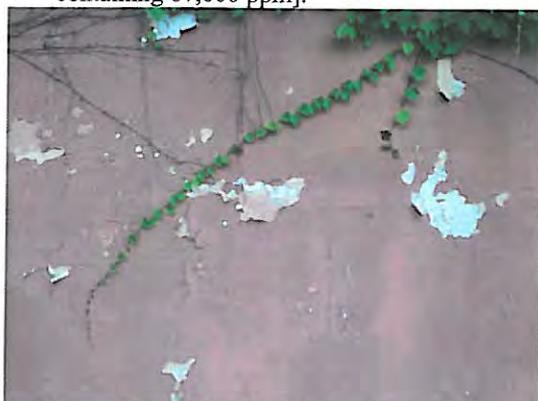
4. Chipped and peeling lead-containing red paint on the exterior stucco walls of the Factory [Bulk Sample I.D. Pb-10-RD, containing 900 ppm].

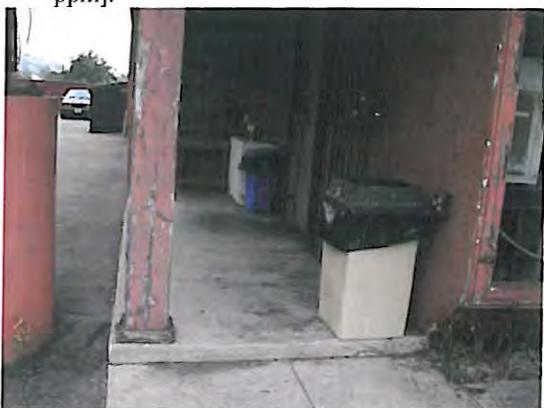
5. Chipped and peeling lead-based brown paint on an exterior wood support column and wood utility housing of the Factory [Bulk Sample I.D. Pb-14-BR, containing 38,000 ppm].

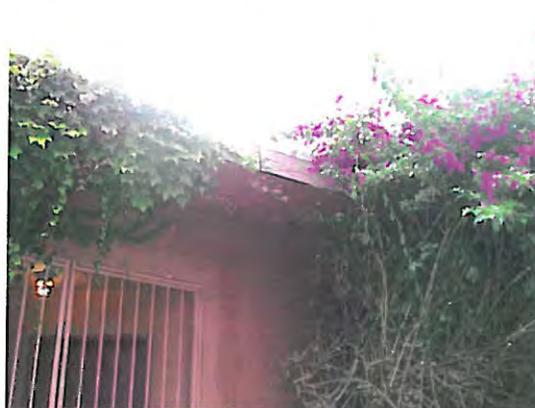
6. Severely chipped and peeling lead-based red paint on the exterior wood fascia of the Factory [Bulk Sample I.D. Pb-19-RD, containing 22,000 ppm].

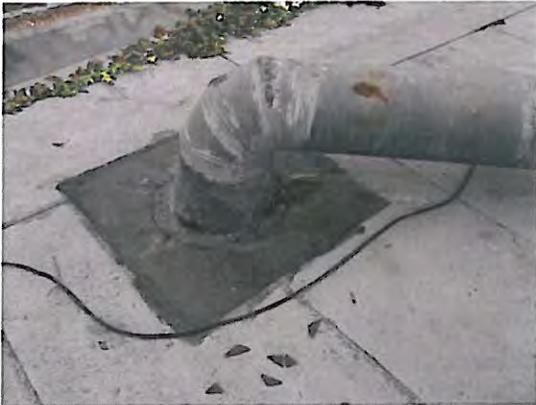
7. ACM black mastic associated with roof penetrations, totaling about 50 ft² [Sample I.D. RFMAS-05-01, -02, -03, containing 4% Chrysotile asbestos (CH)].

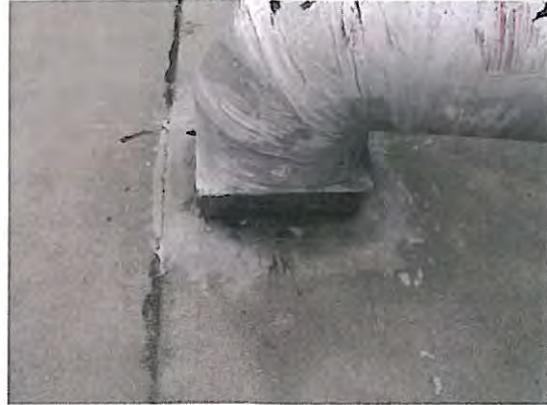
8. ACM silver/gray mastic associated with roof penetrations, totaling about 100 ft² [Sample I.D. RFMAS-06-01, -02, -03, containing 3% CH].

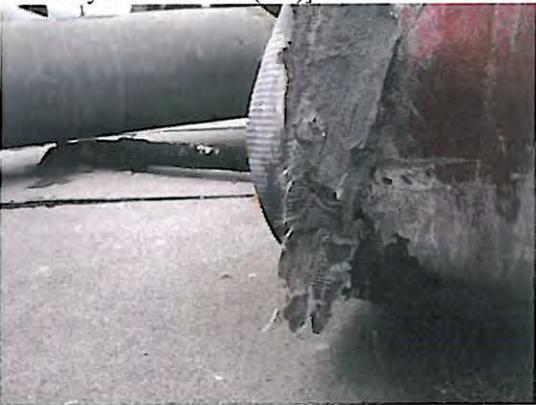
9. ACM HVAC duct tape and mastic (canvas type, with gray coating), totaling about 75 ft² [Sample I.D. HDUTP-07-01, -02, -03, containing 5% CH].

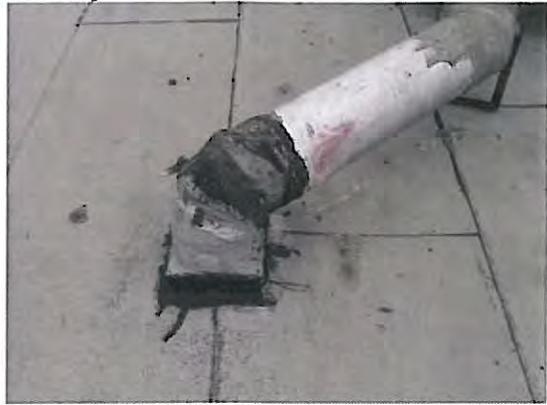
10. ACM black mastic on HVAC joints and seams, totaling about 20 ft² [Sample I.D. HMAS-09-01, -02, -03, containing 2% CH].

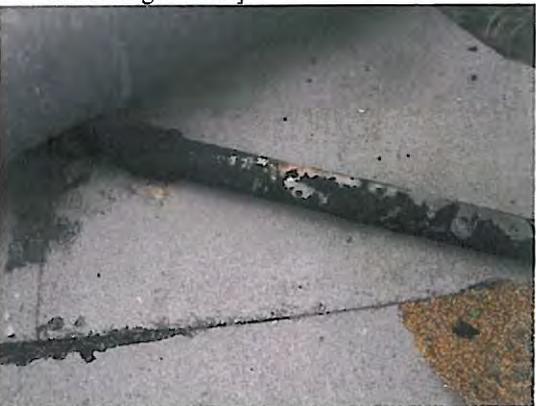
11. ACM black, tarry wrap/coating on 1” and 2” pipes on the roof, totaling about 30 ft² [Sample I.D. MISC-10-01, -02, -03, containing 3% CH].

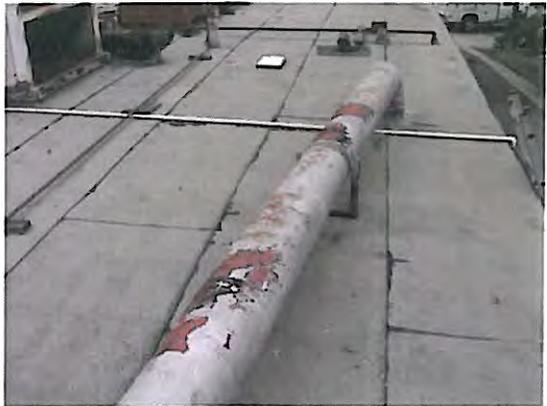
12. ACM and lead-containing silver texture coating on “round” HVAC ductwork, totaling about 400 ft² [Sample I.D. MISC-11-01, -02, -03, containing 3% CH].

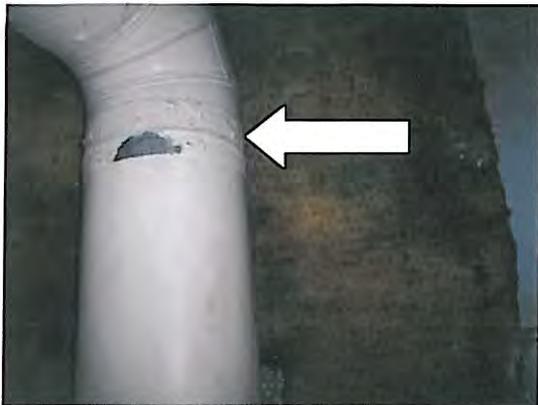
13. ACM white, painted HVAC duct seam tape on a duct associated with the heater in the Women’s Restroom closet, totaling about 3 ft² [Sample I.D. HDUCTP-16-01, containing 70% CH].

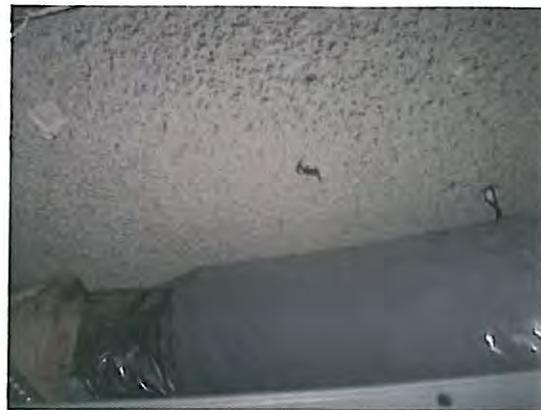
14. ACM sprayed-on acoustical ceiling finish, totaling about 1,000 ft² (occurring above non-ACM laid-in ceiling tiles) [Sample I.D. CLTX-17-01, -02, -03, containing 5% CH].

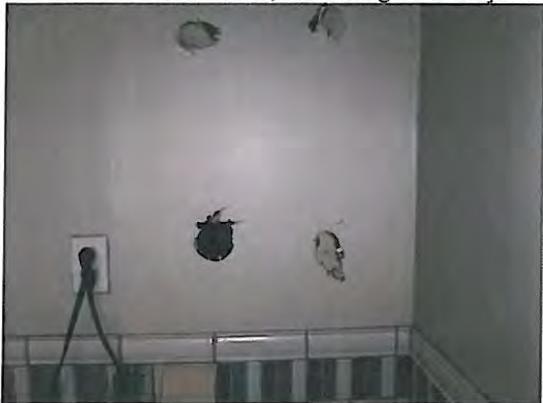
15. ACM black mirror mastic on a wall (mirror absent), totaling about 1 ft² in the Men’s Restroom [Sample I.D. MASTIC-19-01, containing 10% CH].

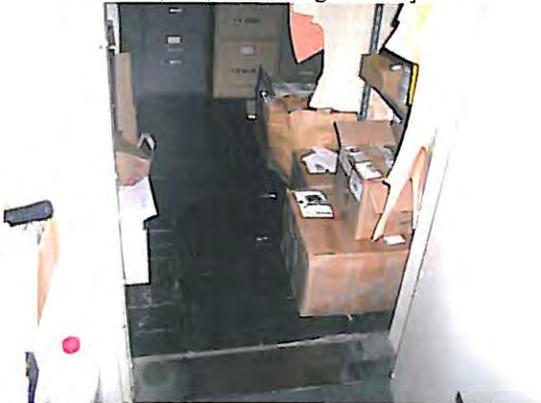
16. ACM 9” x 9” black vinyl floor tiles with tan streaks and associated black mastic (typically concealed beneath carpet), totaling about 2,400 ft² [Sample I.D. FLVCT-23-01, -02, -03, containing >1% CH in the tiles, 3% CH in the mastic].

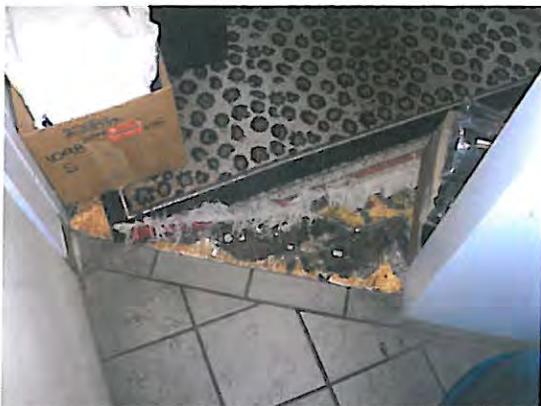
17. ACM black mastic present below non-ACM leveling compound in the Office Storage Room, totaling about 10 ft² [Sample I.D. MISC-24-01, -02, -03, containing 3% CH in the mastic, only].

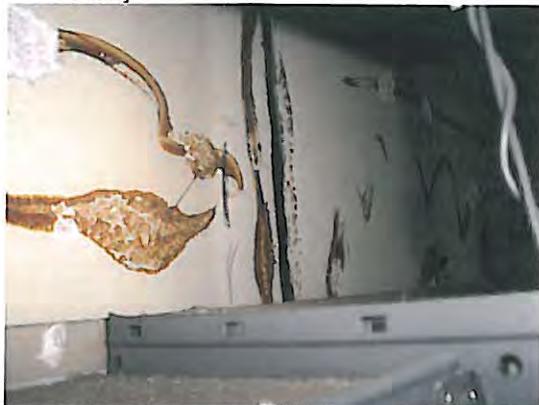
18. ACM brown wall mastic (including concealed material) observed in a Storage Room, Sewing Room and Men’s Restroom, totaling about 25 ft² observed [Sample I.D. MASTIC-27-01, -02, -03, containing 1-2% CH].

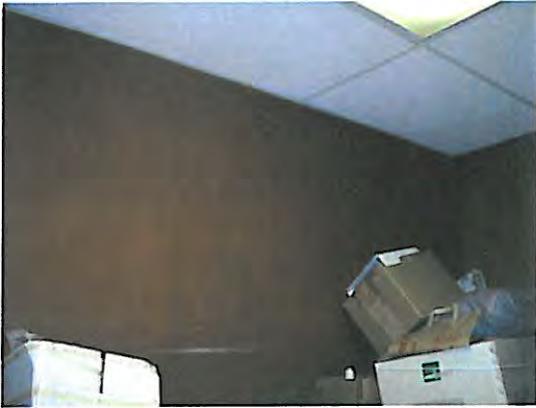
19. ACM concealed wall mastic (assumed present behind wood and cork wall panels), totaling about 500 ft² [I.D. MASTIC-AAA, assumed asbestos containing by SCA].

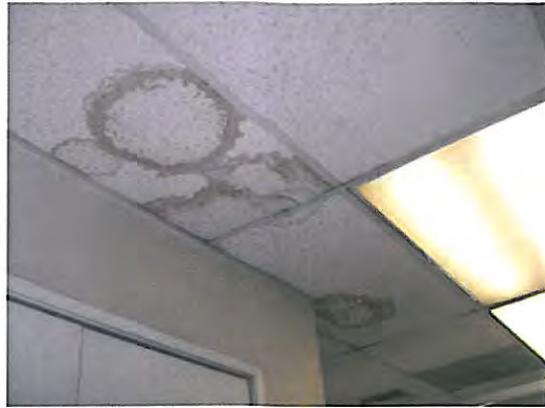
20. Visible water stains on ceiling tiles, attributed to roof leaks.
