# 2010 Annual Report for the Big Tujunga Wash Mitigation Area Los Angeles County, California

**2010 Annual Report for the  
Big Tujunga Wash Mitigation Area,  
Los Angeles County, California**

**Guide to Compliance with the Terms and Conditions in the California  
Department of Fish and Game Streambed Alteration Agreement (SAA) #1600-  
2008-0253-R5 for the Big Tujunga Wash Mitigation Area,  
dated January 29, 2009**

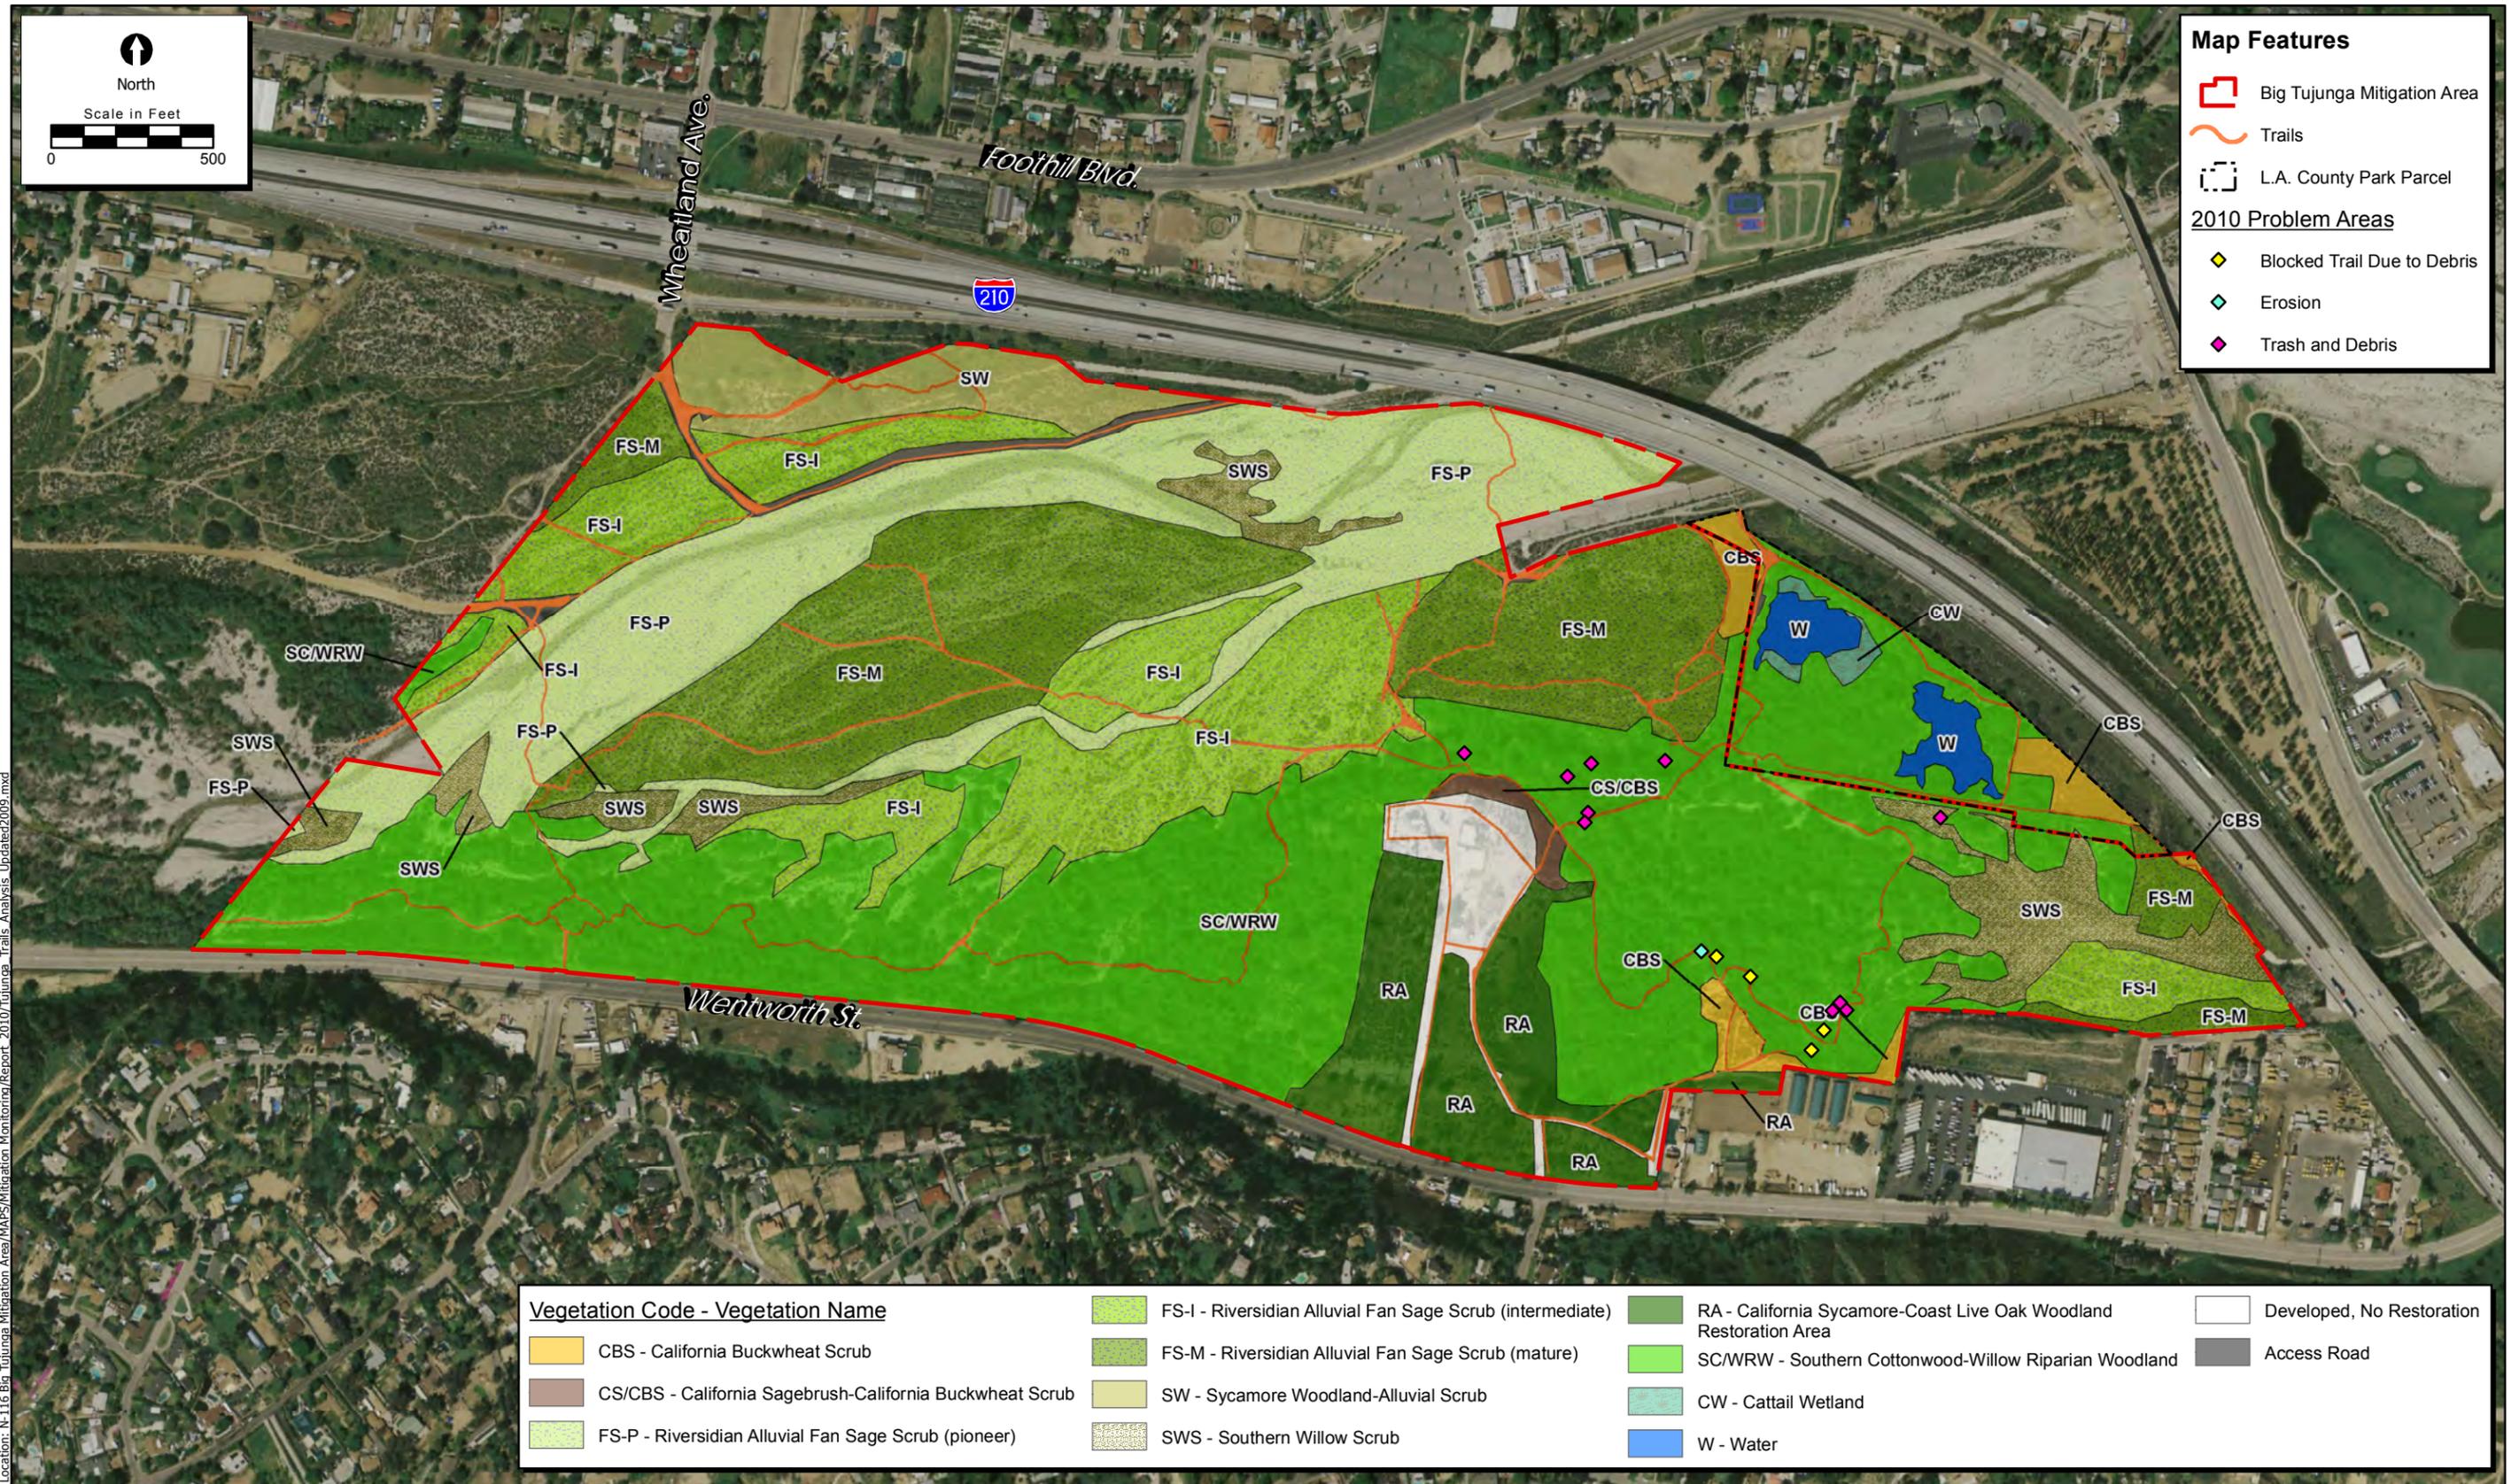
**Figure 6-1. Vegetation Communities and Trails in the Mitigation Area**

Quarterly site visits were conducted by ECORP biologists Gregorio Benavides, Kristen Mobraaten, Alicia Pool, Phillip Wasz, and Terrance Wroblewski between January and December 2010. The biologists walked the trail system, taking site photographs and recording locations of trash, debris, graffiti and vandalism, un-maintained trails, and potential areas for trail closure. These areas were summarized into quarterly trail maintenance reports, which are included as Appendix F. The existing trails that were surveyed and problem areas that were recorded by ECORP in 2010 are shown on Figure 6-1.

ECORP biologists Gregorio Benavides and Kristen Mobraaten conducted site visits on March 5 and 16, 2010 to document and assess the status of the following issues of concern that resulted from the post-fire rains: trail erosion and stability, trash and debris, damage to vegetation, flooding of understory vegetation, and creek condition. The entire length of the Mitigation Area trail system was surveyed on both days, and problem areas were documented with digital photography and locations were recorded using a GPS unit. Problem areas were ranked to prioritize locations that would require immediate attention with highest priority problems consisting of those that posed a danger to recreational visitors and/or those that impeded or obstructed flow in Haines Canyon Creek. Problem areas documented during these visits are presented in Figure 6-1 in Section 6.0.

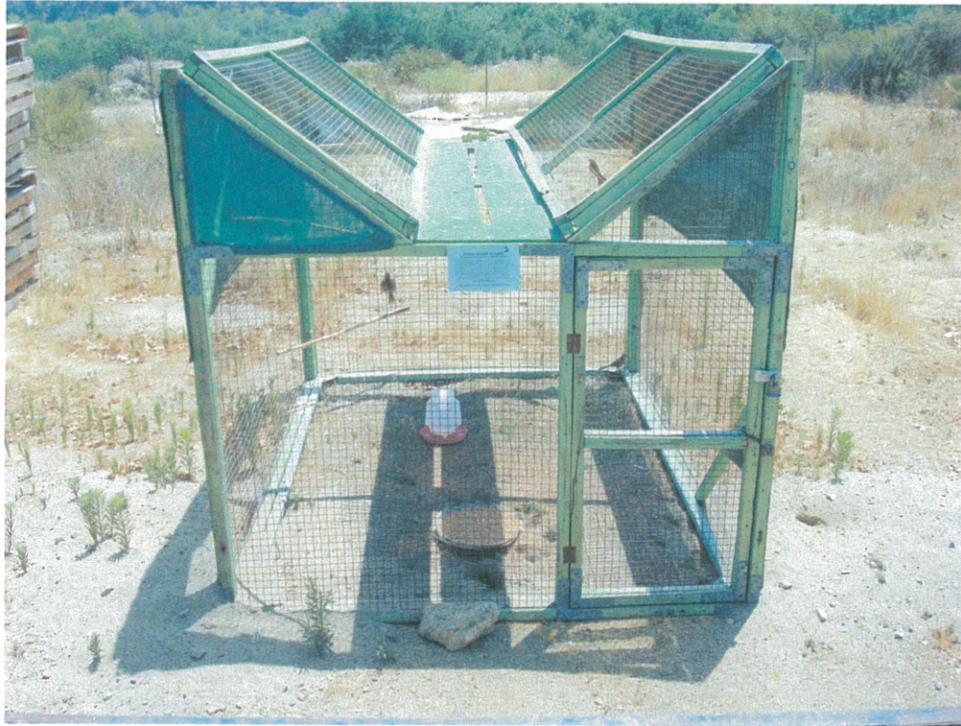
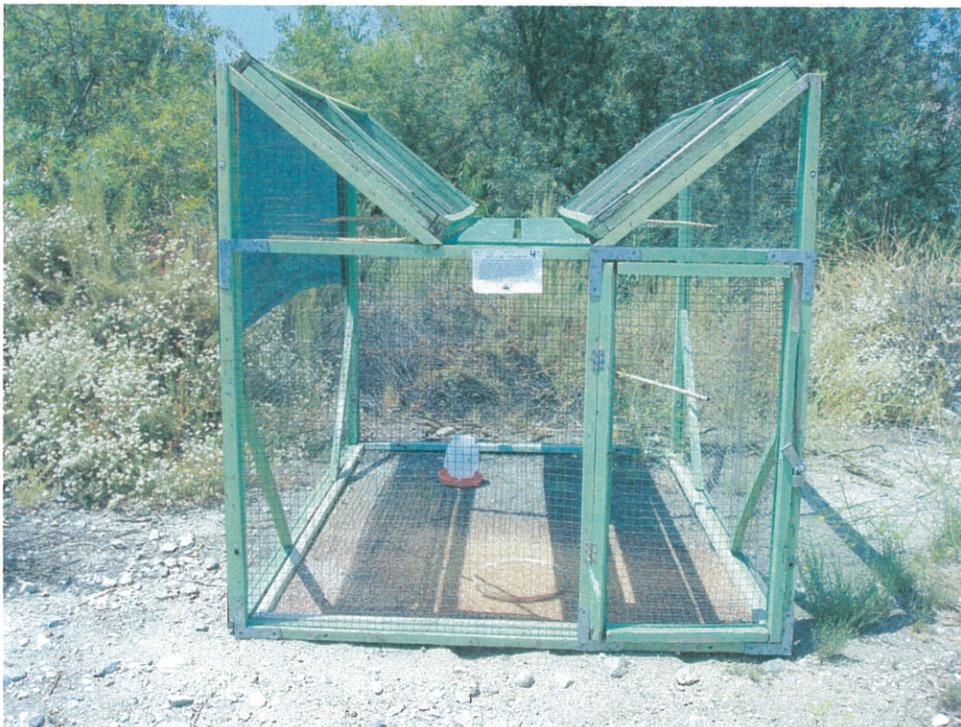
Figure 3. 2010 Big Tujunga brown-headed cowbird Trap 1 (top) and Trap 2 (bottom).

Each trap is 6' wide, 8' long, and 6' tall, with a 1 3/8" wide capture slot on top through which cowbirds can drop down and in but cannot fly up and out. The traps include: 1 floor, 2 side, 2 end (door and back), and 2 top panels, and a plywood slot board.

Four cowbird traps were placed, activated, operated, serviced, disassembled, and stored per the *Brown-headed Cowbird Trapping Protocol* (GWB 1992, updates) and state and federal permit requirements (Figures 2-4). Trap 1 (Hansen Dam Stables) and T3 and T4 (Gibson Ranch) were in foraging areas. Trap 2 was within the Big Tujunga Wash Mitigation Bank adjacent to riparian and coastal sage habitat. The traps were placed and assembled on 28 March, activated 1 April, and operated from 1 April to 30 June 2010 (91 days, 13 weeks).

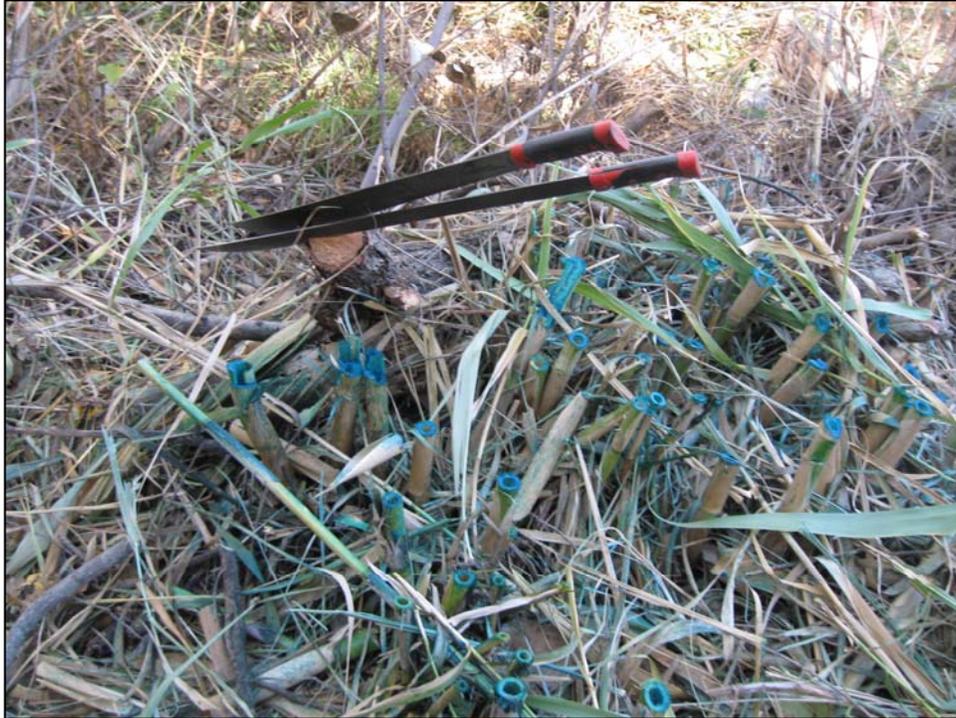
Figure D-3. Giant reed stalks that have been cut and treated with herbicide.

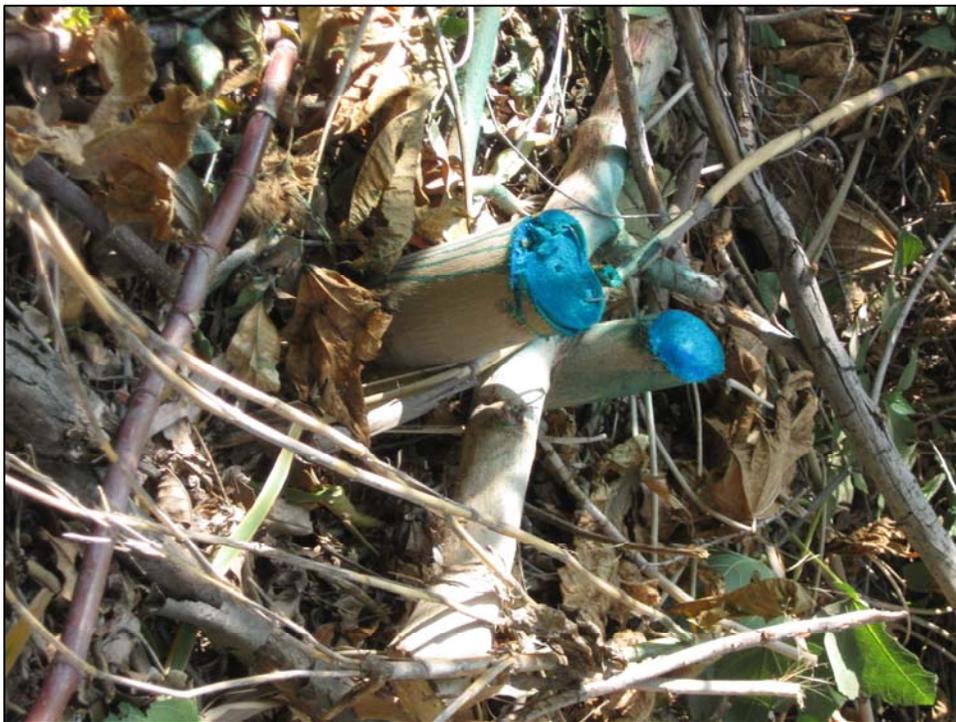
Figure D-4. Exotic tree stumps treated with herbicide.

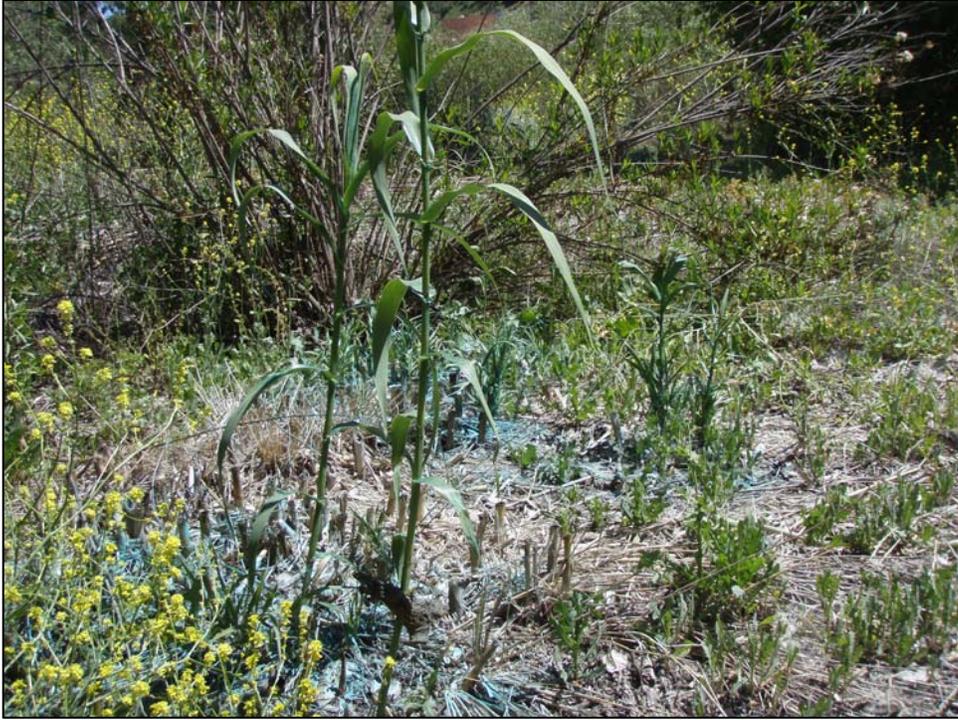
Figure D-5. Giant reed stalks treated with herbicide.

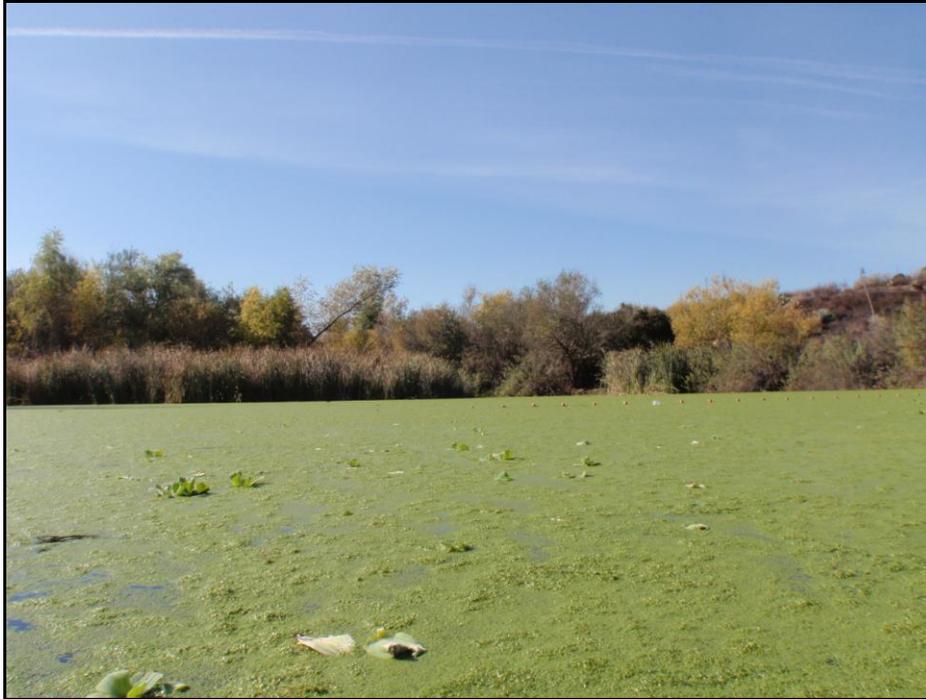
Photo G: Surface of the West Pond covered in macrophytes during the November and December 2010 removal efforts.

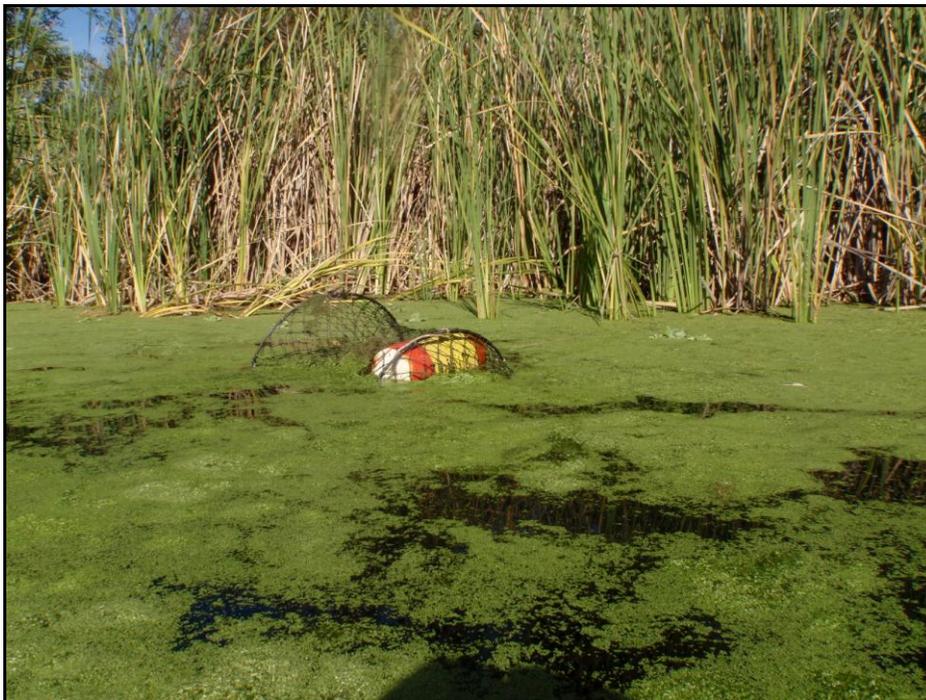
Photo H: Turtle trap set in the West Pond during the November 2010 removal effort.

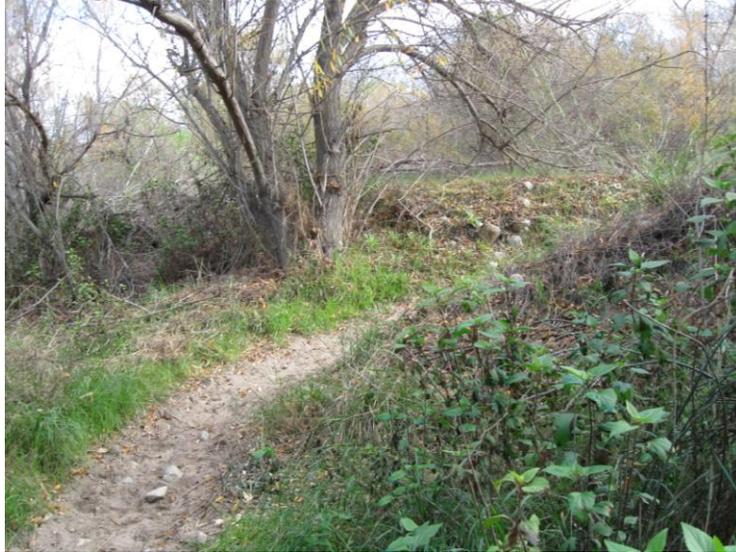
Figure 1. Representative trail conditions in Restoration Section 3. Vegetation and debris along were not obstructing established trails.

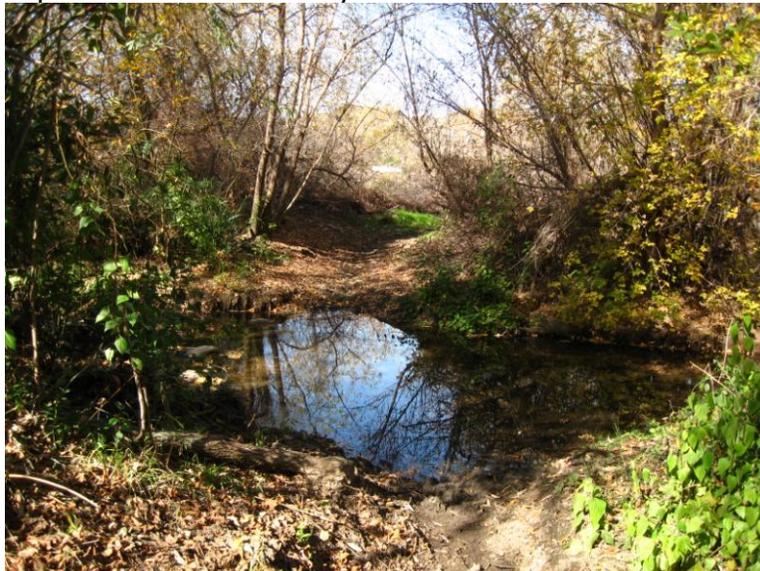
Figure 3. Example of flooded trail following post-Station Fire rains. This location is in Restoration Section 4.

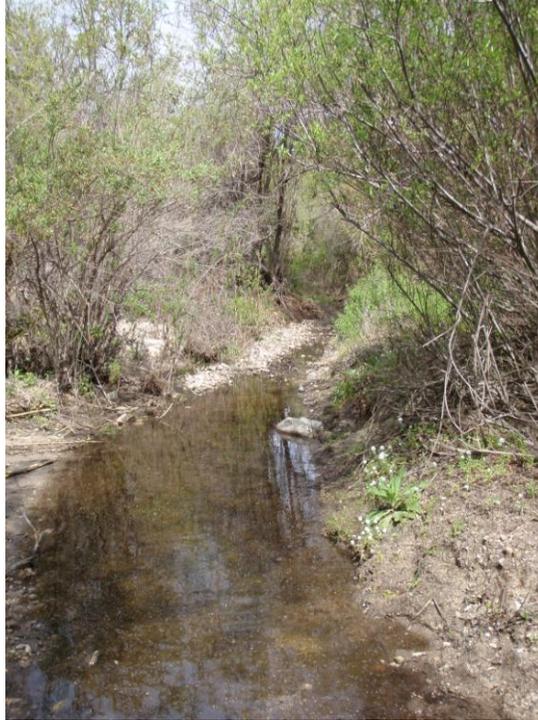
Figure 4. This trailhead (in Restoration Section 2) exhibited severe erosion caused by overland runoff from the post-Station Fire rains. Exposed tree roots and debris have made this part of the trail impassable.

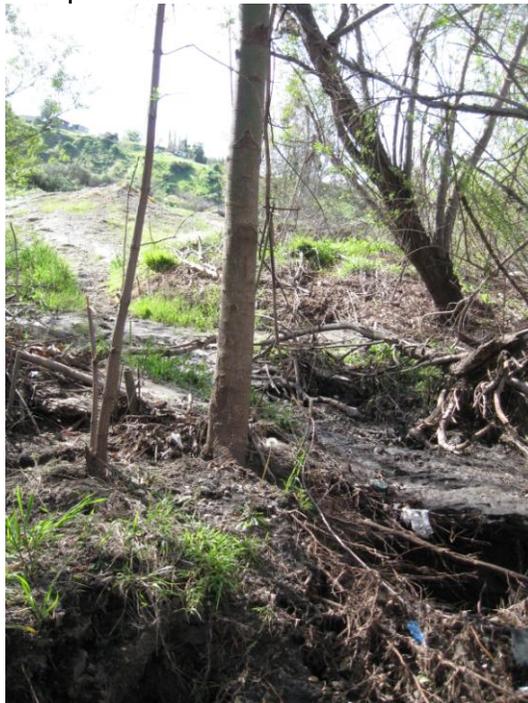
Figure 5. A large dead tree that had been situated about one meter from the trail edge was felled by intense overland water flow following the rains.

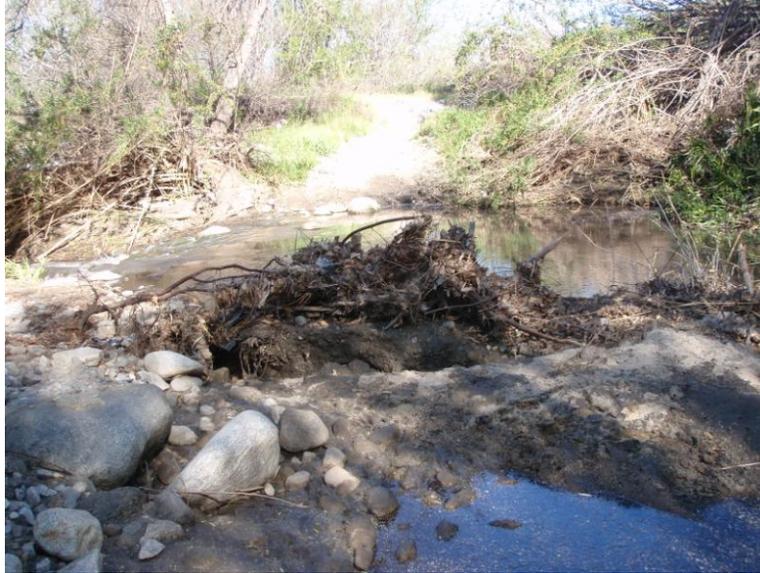
Figure 8. Openings through vegetation along the perimeter of the Tujung Ponds were closed to discourage further use.

Trailblazing was also evident along the perimeter of the Tujunga Ponds. ECORP biologists closed off these newly made paths to discourage their continued use using flagging tape. These new paths were presumably made to access the Tujunga Ponds (Figures 8 and 9).

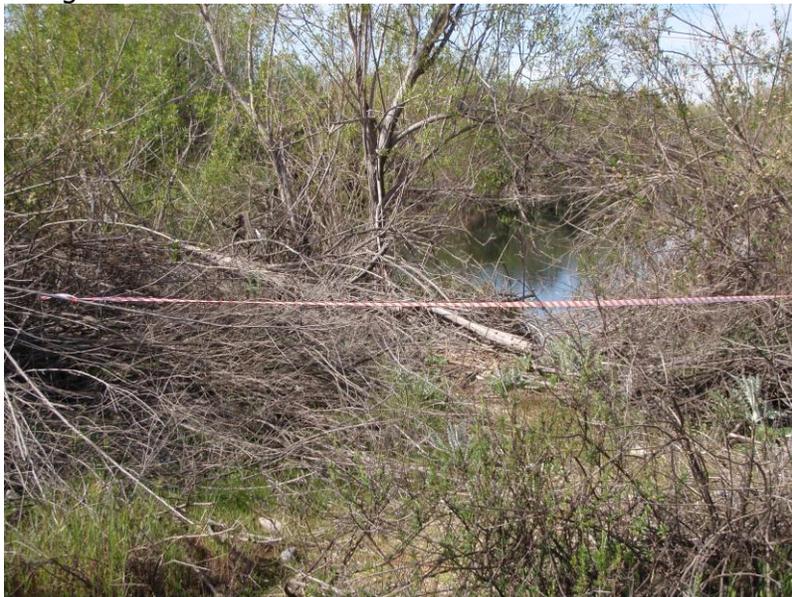
Figure 9. This path leads to an area between the ponds that have been experiencing a greater amount of foot traffic, which necessitated trail closure.

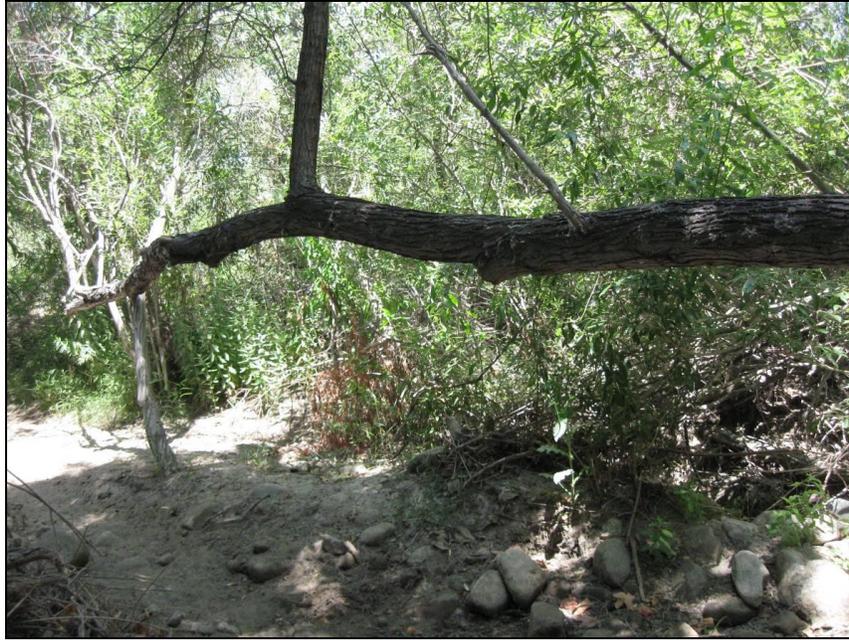
During the outreach effort in June, photographs were taken to document the state of the trails. A short diversion around a dead tree (located 200 meters west of the Upland area) has begun to take a more permanent form (Figure 3). ECORP will schedule the removal of this large tree to prevent further use of the diversion. Of note is the unauthorized use the riparian area by equestrians, specifically at the Wheatland Ave pond (Figure 4). ECORP biologists have in the past observed riders allowing their horses

Figure 3. A diversion trail has begun to form around this large dead tree in the trail.

The aforementioned trails problems are slated to be addressed by Nature's Image in October, with the exception of those issues associated with Haines Canyon Creek. No new trailblazing was observed along the perimeter of the Tujunga Ponds.

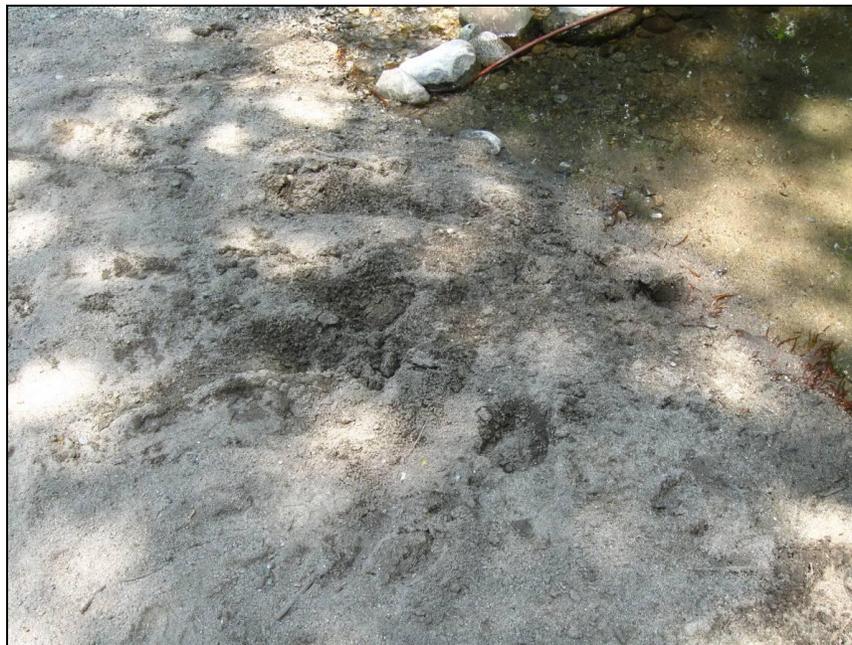
to wade in the Wheatland Ave pond. Figure 4 clearly shows tracks leading into the pond. Directly across the pond (northward) appears to be a newly formed trail leading towards the Big Tujunga Wash (Figure 5). This trail leads into a fairly dense patch of trees, making this trail unattractive, yet increased traffic through and unauthorized live branches clearing of this area will result in a passable trail.

Figure 4. Fresh horse tracks at the Wheatland Ave pond in the Haines Canyon Creek. Equestrians often bring their horses to wade in the Haines Canyon Creek to wade.

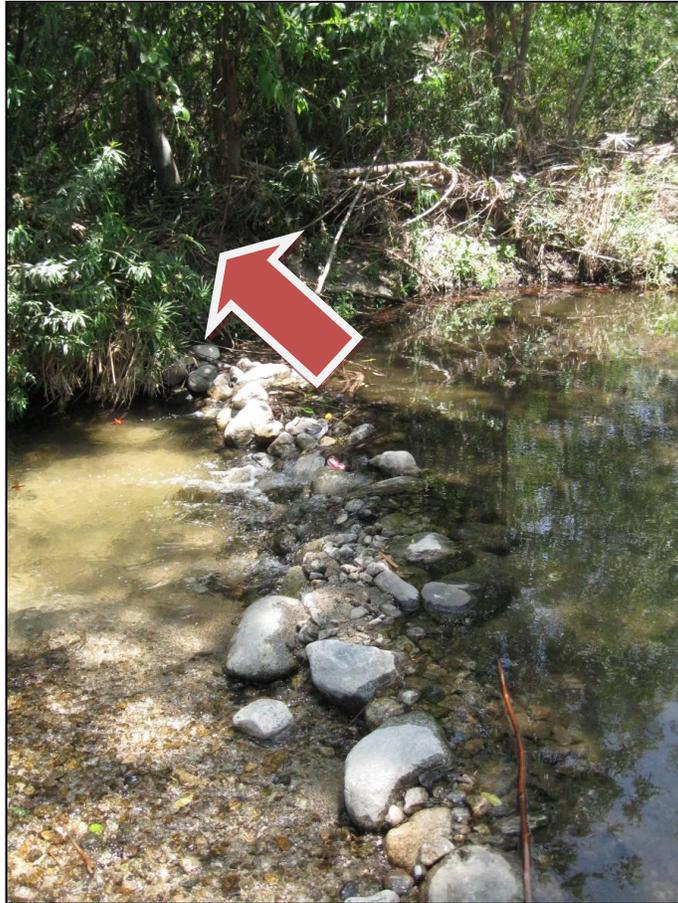
Figure 5. Arrow is pointing at the newly cut trail just at the Wheatland Ave pond. The trail leads towards the Big Tujunga Wash. The rock dam may be serving as a crossing point for visitors.

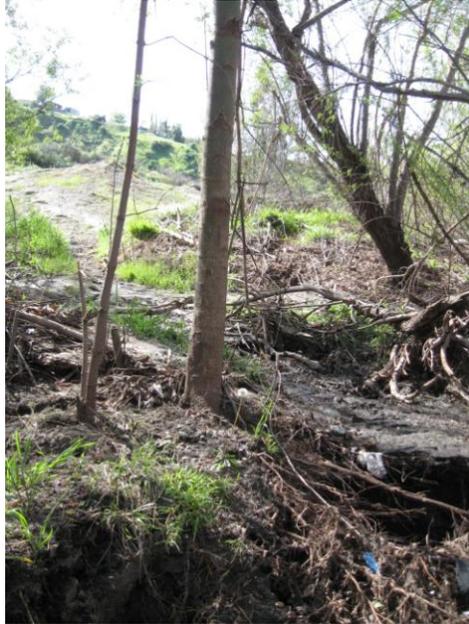
Figure 1. This photo shows the severity of erosion caused by overland runoff from the post Station Fire rains. Note the undermined soil and the exposed roots.

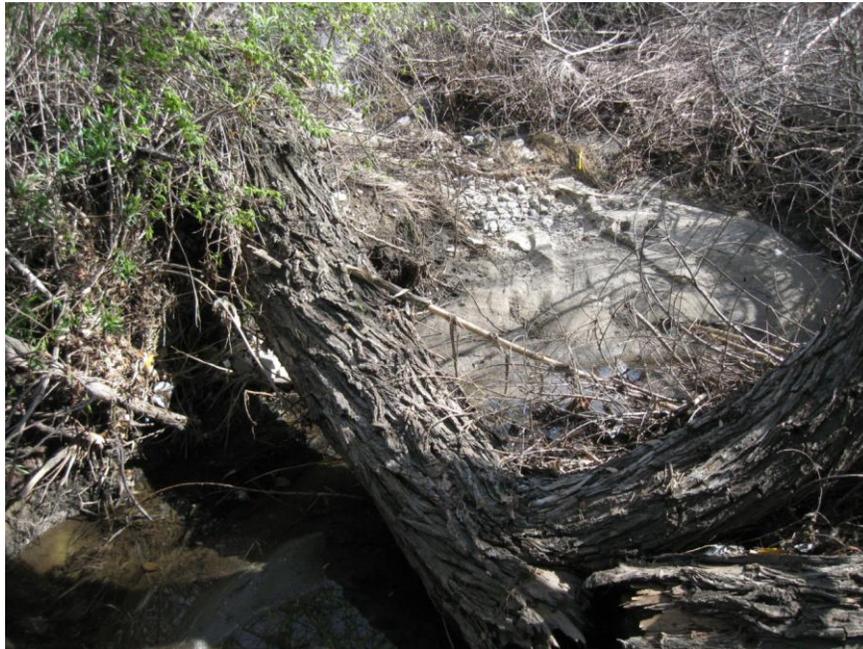
Figure 2. This dead tree was standing before the post Station Fire rains, but erosion caused by overland runoff caused it to fall into the trail.

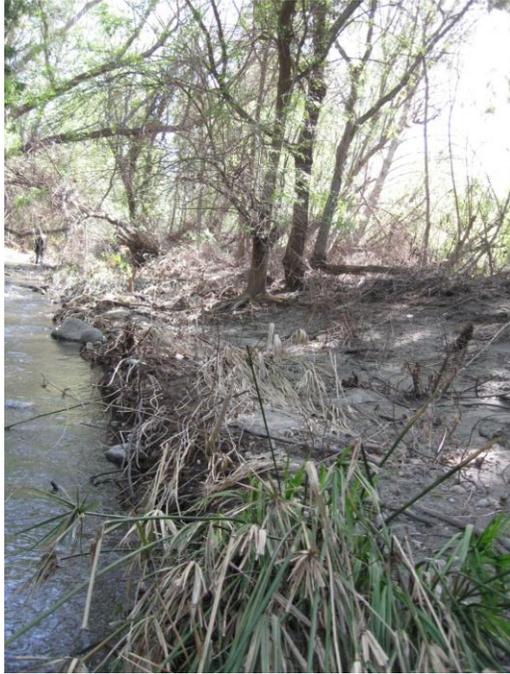
Figure 3a. This photo of Haines Canyon Creek in Restoration Section 3 was taken on March 11, 2010. Note the severe scouring of the bank and the dead vegetation (presumably caused when this part of the creek was inundated). See figure 3b for comparison of this location.

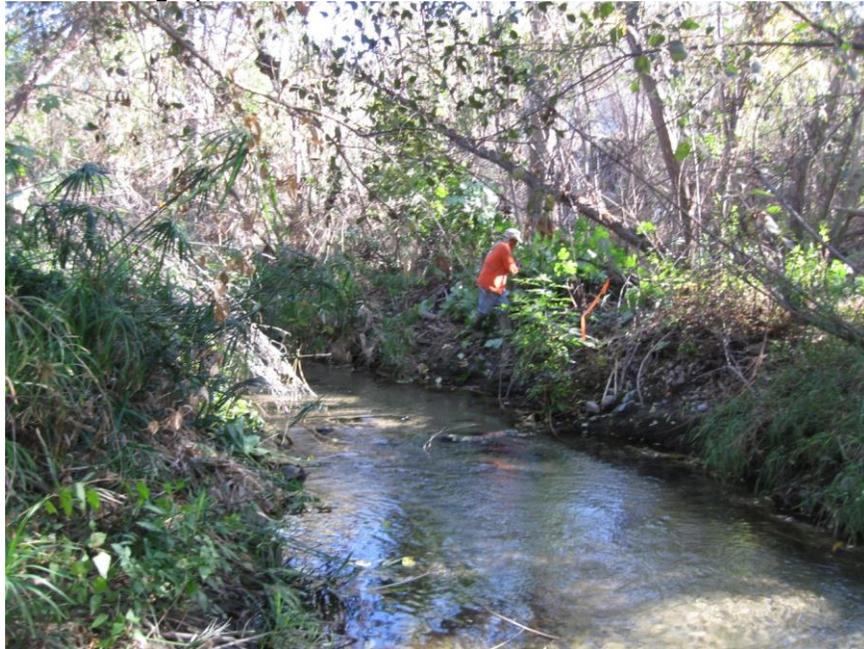
Figure 4. Increased water flow in Haines Canyon Creek undercut bank soil thereby exposing plant roots as pictured here.

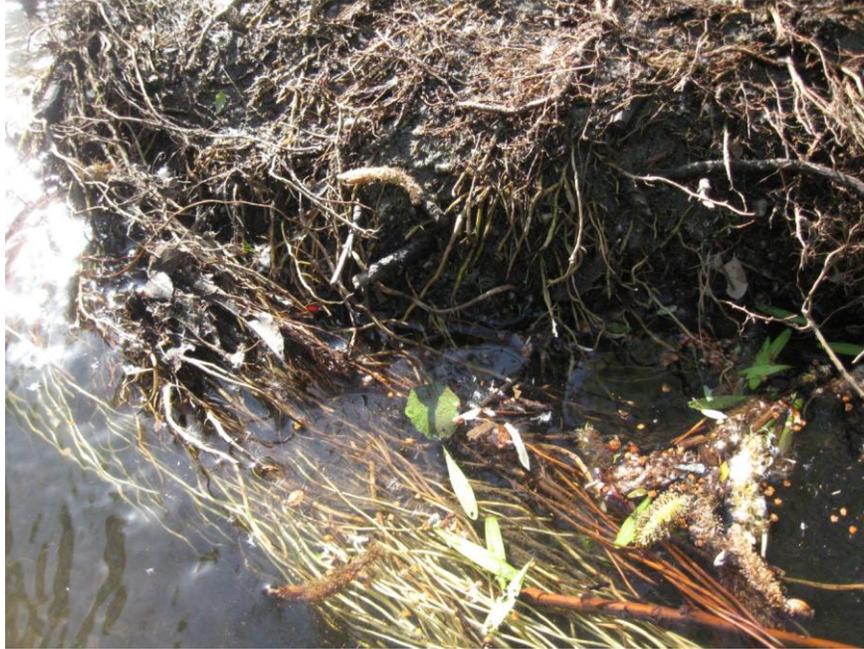
Figure 5. Scouring from high water flow scoured the bank and the terrain adjacent to Haines Canyon Creek. This photo was taken 3 meters away from the creek. Note the dead vegetation and exposed cobble.

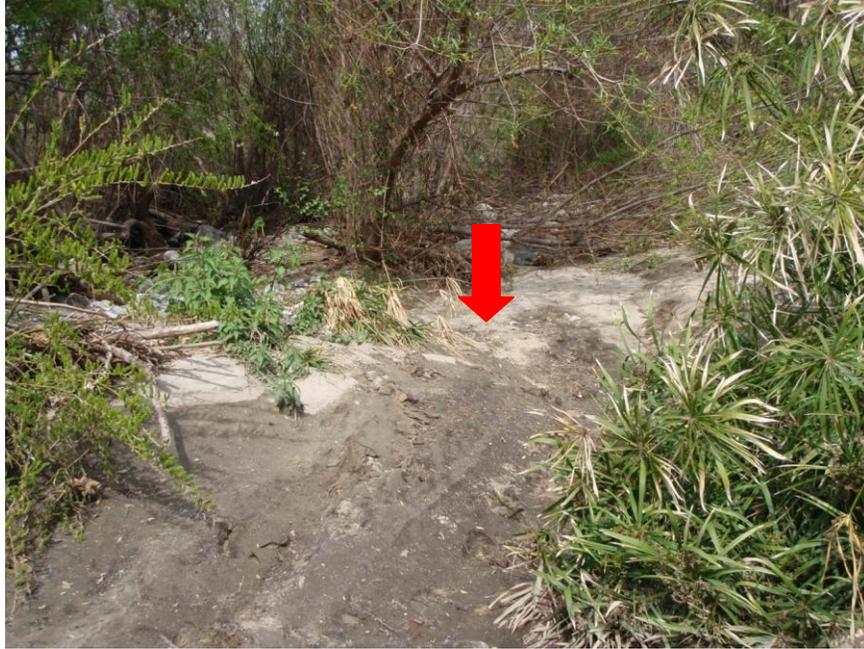
Figure 6. The location marked with the arrow is the portion that was blocked by sediment. The sediment was deposited during the post Station Fire rains caused this channel to become dry.

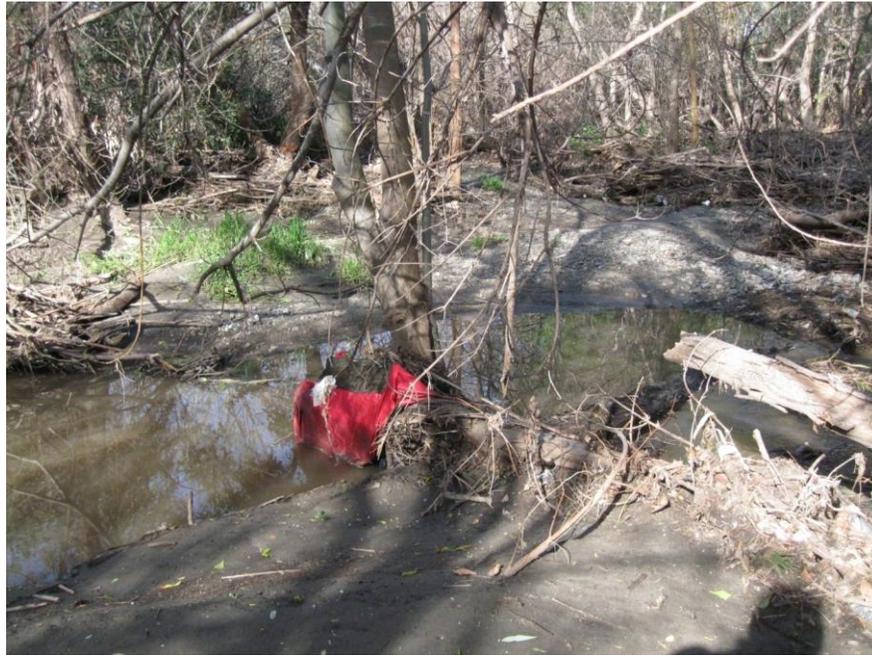
**Figure 1a. Rank: 1. Flooded understory area containing garbage and debris near and on trail (location: 376303/379267).**

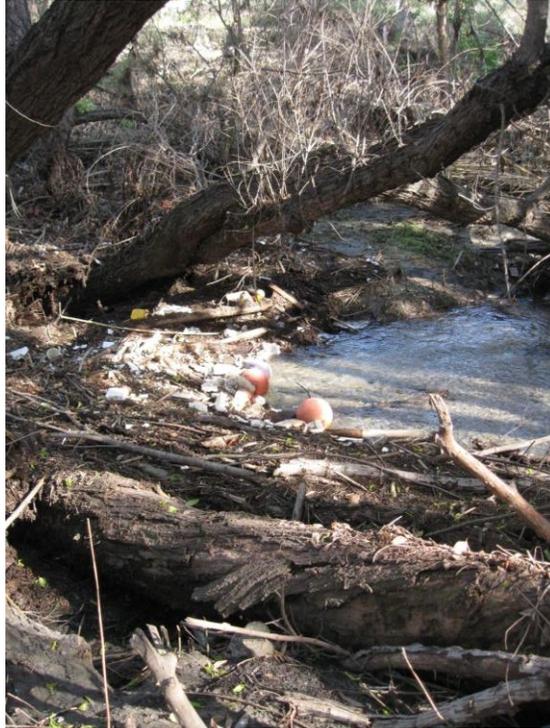
**Figure 1b. Rank: 1. Flooded understory area containing garbage and debris (location: 376303/379267).**

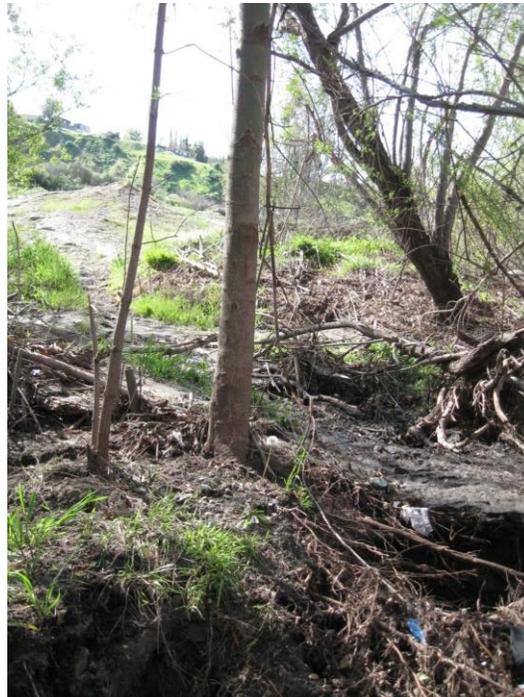
**Figure 2a. Rank: 1. Undermined trail due to erosion and a fallen tree. Water flow that undermined this trailhead and the trees comes from rain water flowing through Haines Canyon (location: 376419/3792488).**

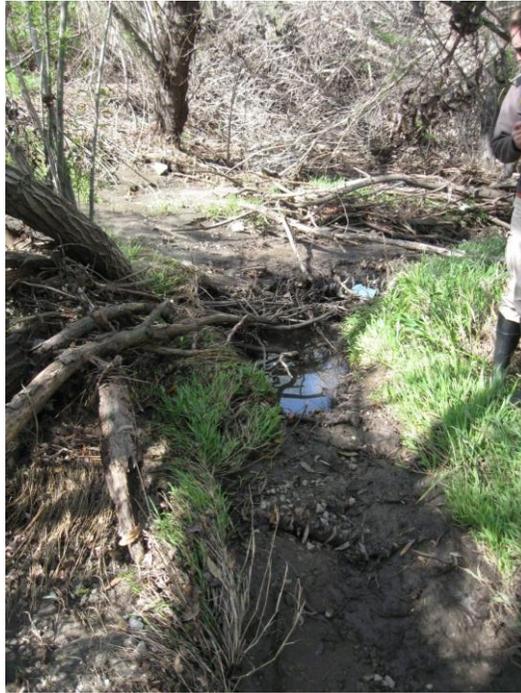
**Figure 2b. Rank: 1. Undermined trail; erosion and fallen tree (location: 376419/3792488).**

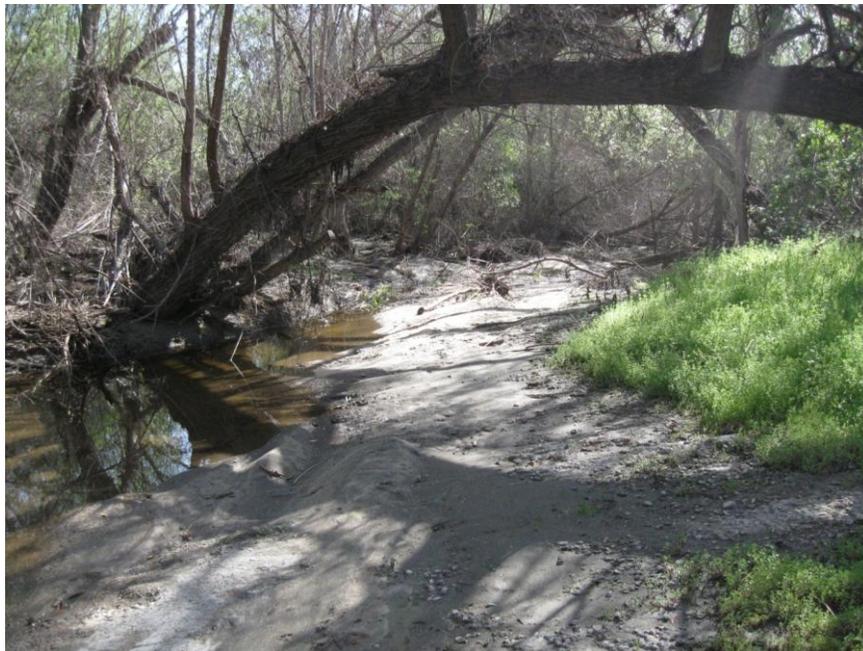
**Figure 3. Rank: 1. Water flow from Haines Canyon Wash has further exposed the roots of this fallen tree. This trail, located near Gibson Ranch, is used daily by equestrians and hikers gaining access to the Tujunga Ponds trails (location: 376433/3792482).**

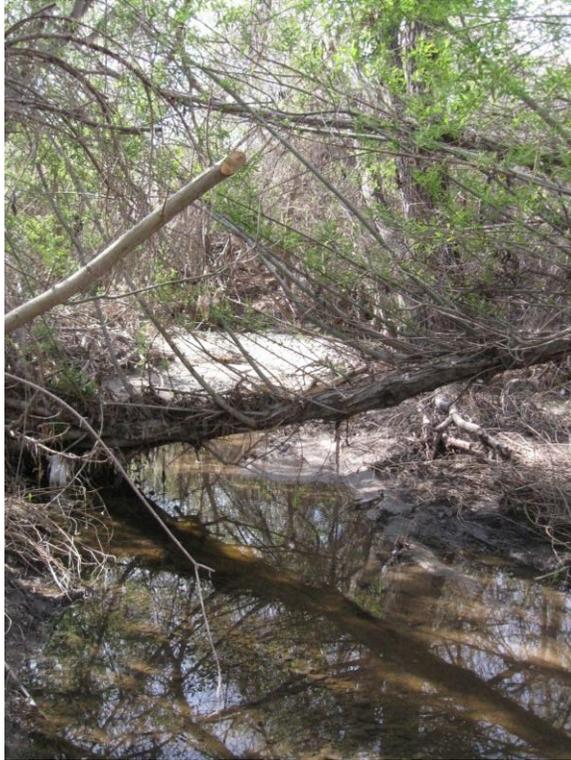
**Figure 4a. Rank: 1. Overflow in Haines Canyon Wash undermined the roots of this live tree, causing it to block normal trail traffic (location: 376451/3792469).**

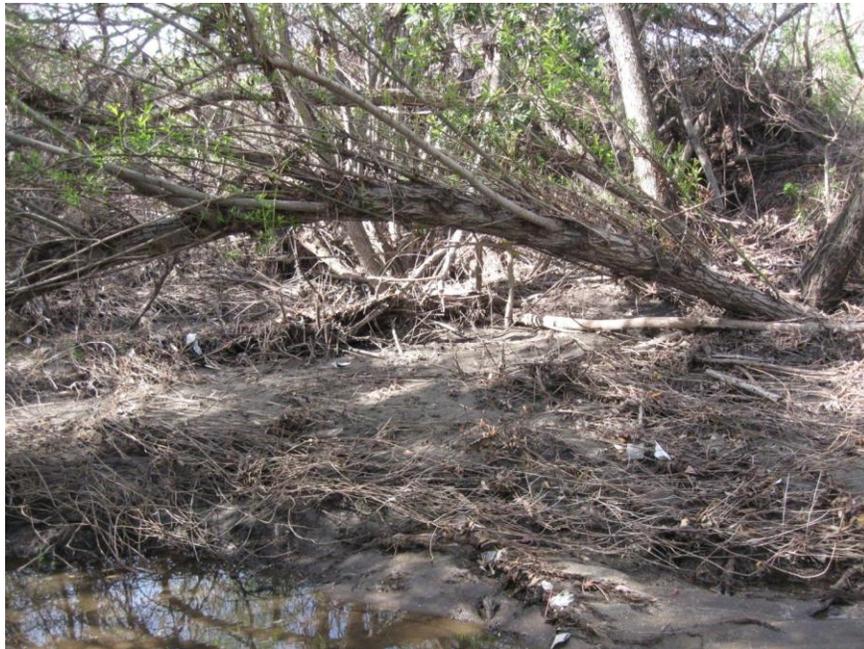
**Figure 4b. Rank: 1. High flows have eroded this trail causing small trees to fall over and block normal traffic flow. At this location, the path width has been narrowed or has been completely submerged by standing water (location: 376520/3792418).**

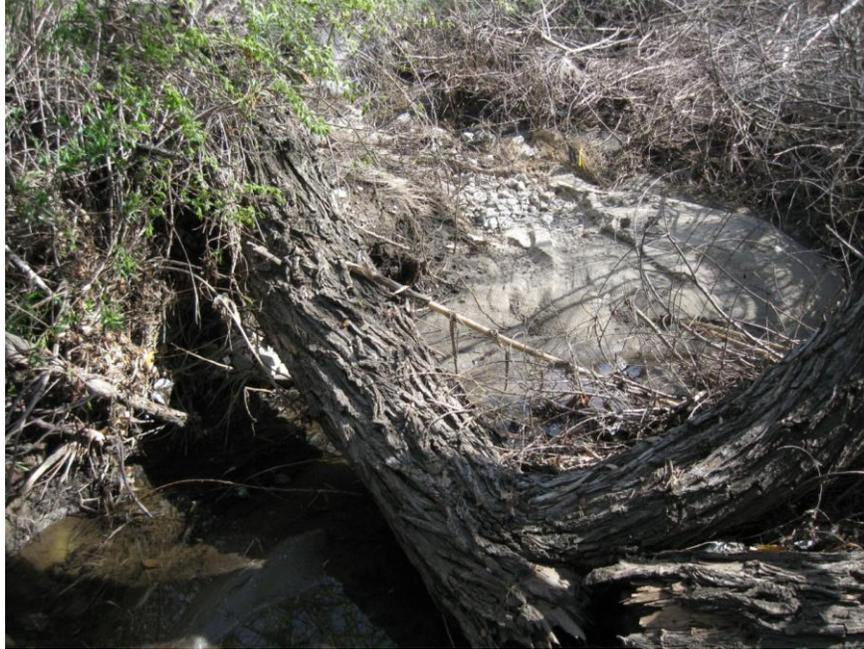
**Figure 5a. Rank: 1. High flows in Haines Canyon Wash caused this dead tree to completely block trail traffic. Notice the large pool of standing water in the lower left hand corner of the photo (location: 376535/3792444).**

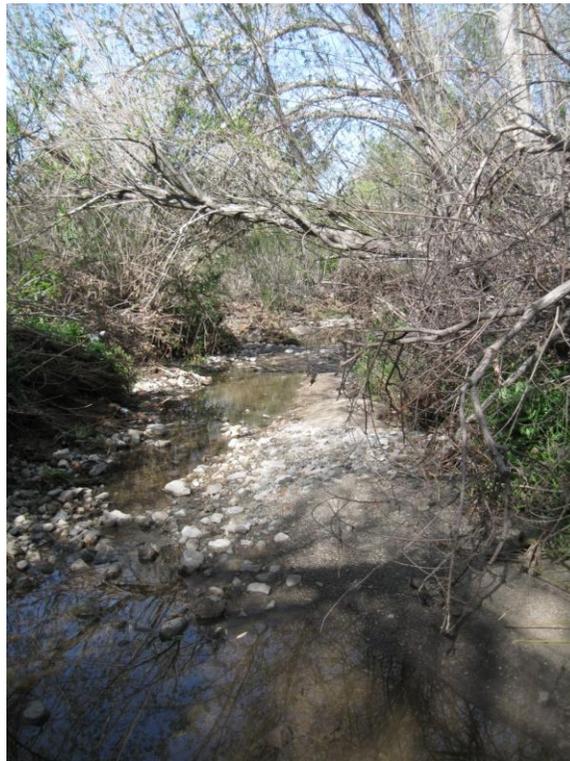
**Figure 5b. Rank: 1. This photo shows the trail leading to the fallen tree (not visible in this photo). Note the fallen-over tree in the background over the partially submerged trail (location: 376300/3792624).**

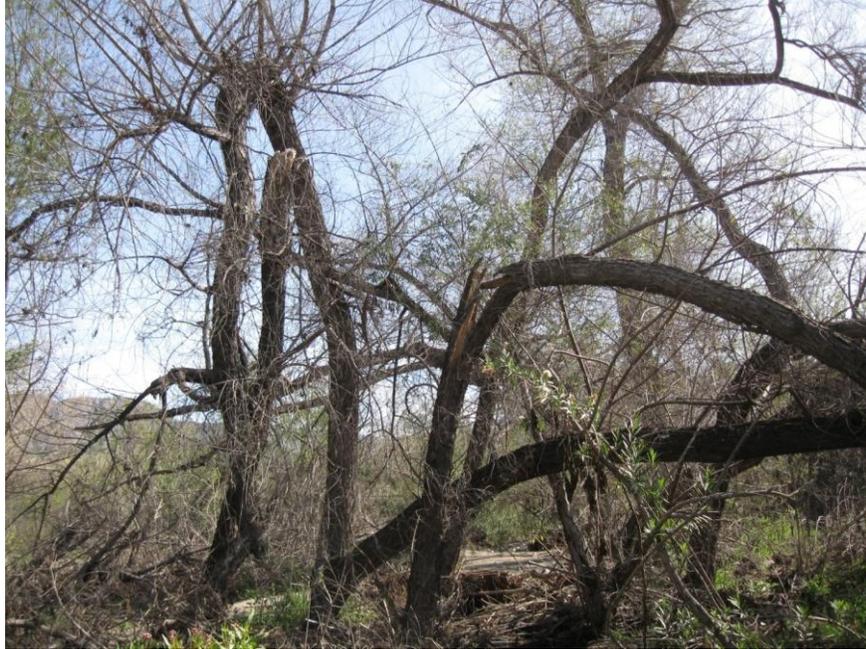
**Figure 6. Rank: 1. A small grove of dead trees that is located near the main trail that has potential of breaking and falling onto trail; needs immediate attention (location: 376508/3792399).**
