# 2010 Annual Report for the Big Tujunga Wash Mitigation Area Los Angeles County, California

**2010 Annual Report for the  
Big Tujunga Wash Mitigation Area,  
Los Angeles County, California**

**Guide to Compliance with the Terms and Conditions in the California  
Department of Fish and Game Streambed Alteration Agreement (SAA) #1600-  
2008-0253-R5 for the Big Tujunga Wash Mitigation Area,  
dated January 29, 2009**

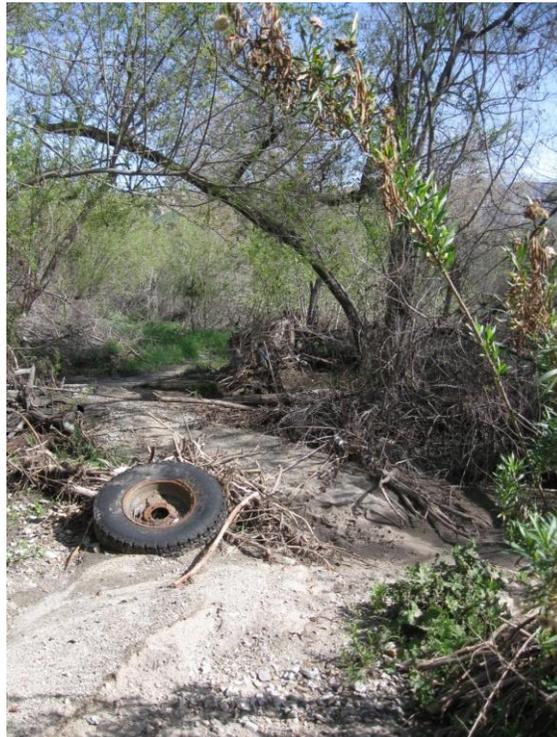
**Figure 7. Rank: 2. Trash and debris washed into the main trail in the restoration area after the post-Station Fire rains (location: 376535/3792436).**

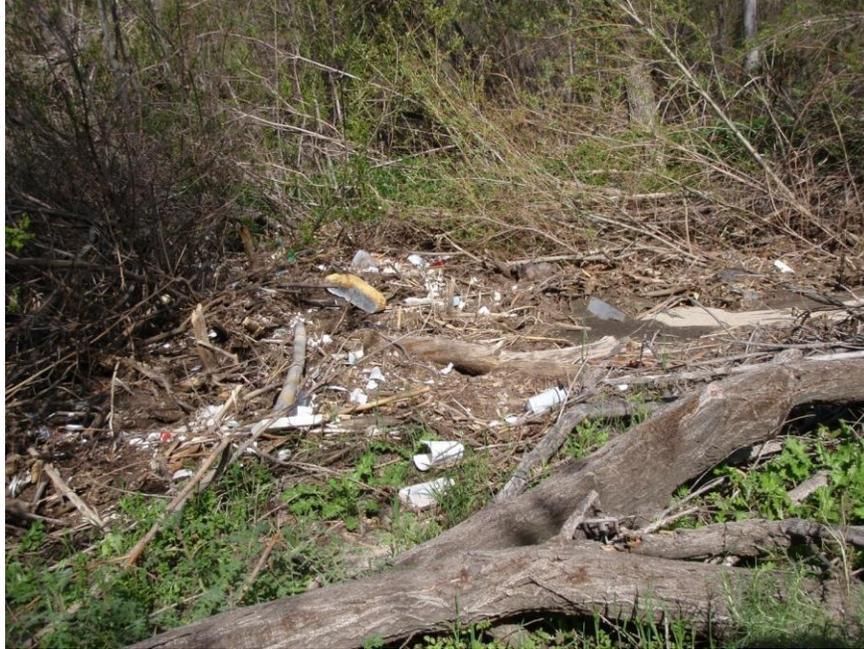
**Figure 8. Rank: 1. Debris and garbage in the trail washed in after rains following the Station Fire need to be cleared to allow normal trail traffic (location: 376528/3792436).**

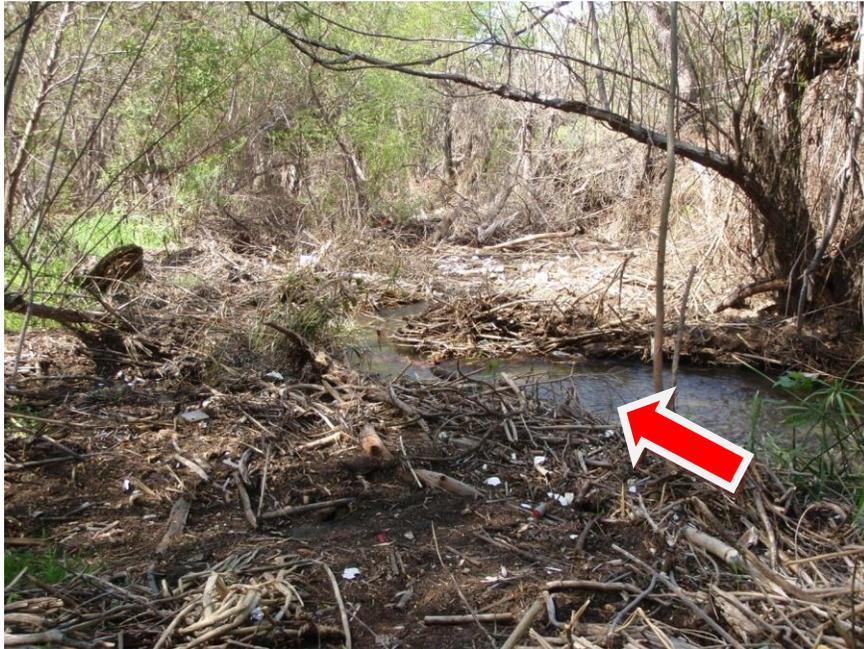
**Figure 9a. Rank: 1. Garbage and debris blocking Haines Canyon Creek that needs to be removed to allow normal creek flow (location: 376373/3792672). Red arrow indicates direction of creek flow.**

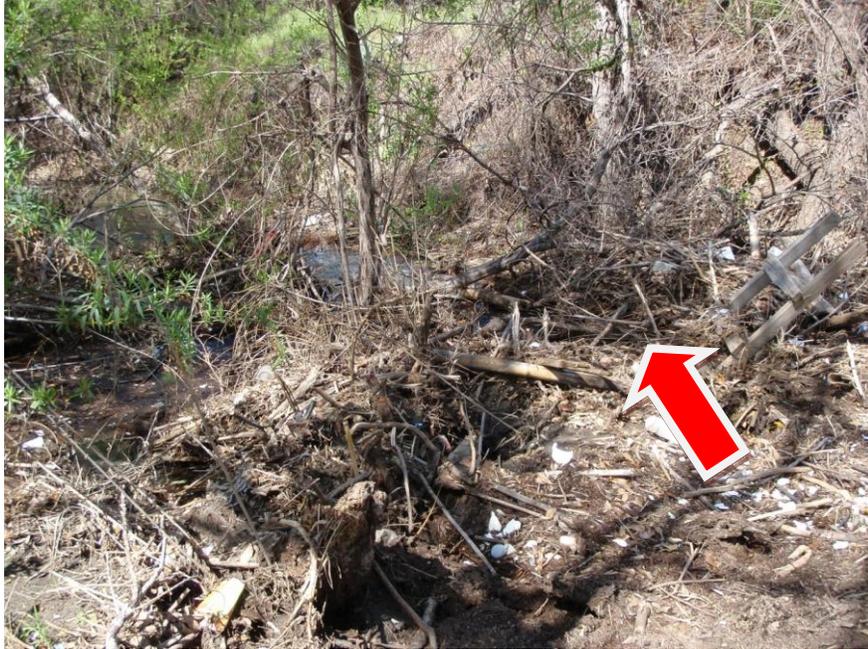
**Figure 9b. Rank: 1. Garbage and debris blocking Haines Canyon Creek that needs to be removed to allow normal creek flow (location: 376373/3792672). Red arrow indicates the direction of creek flow.**

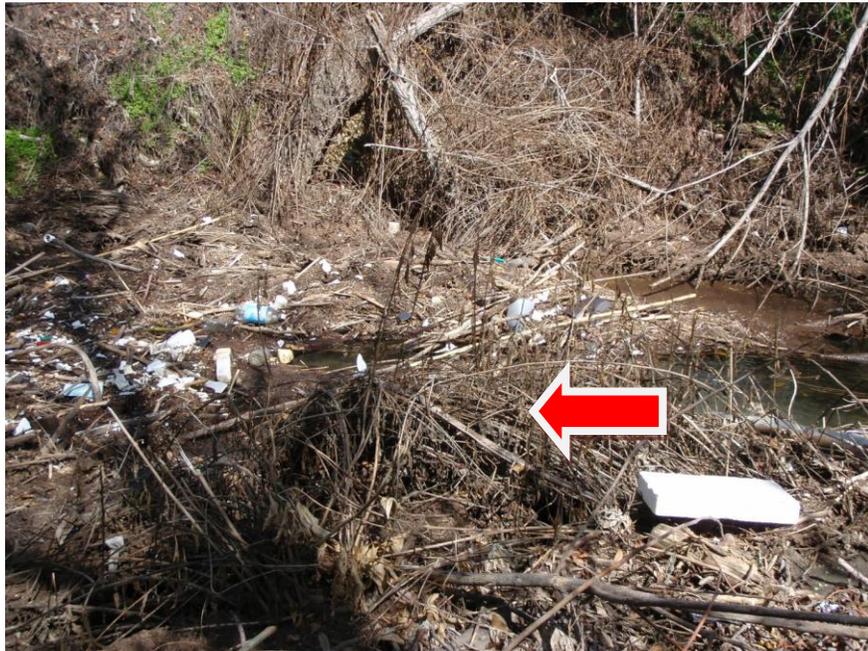
**Figure 9c. Rank: 1. Garbage and debris blocking Haines Canyon Creek that needs to be removed to allow normal creek flow (location: 376373/3792672). Red arrow indicates direction of creek flow.**

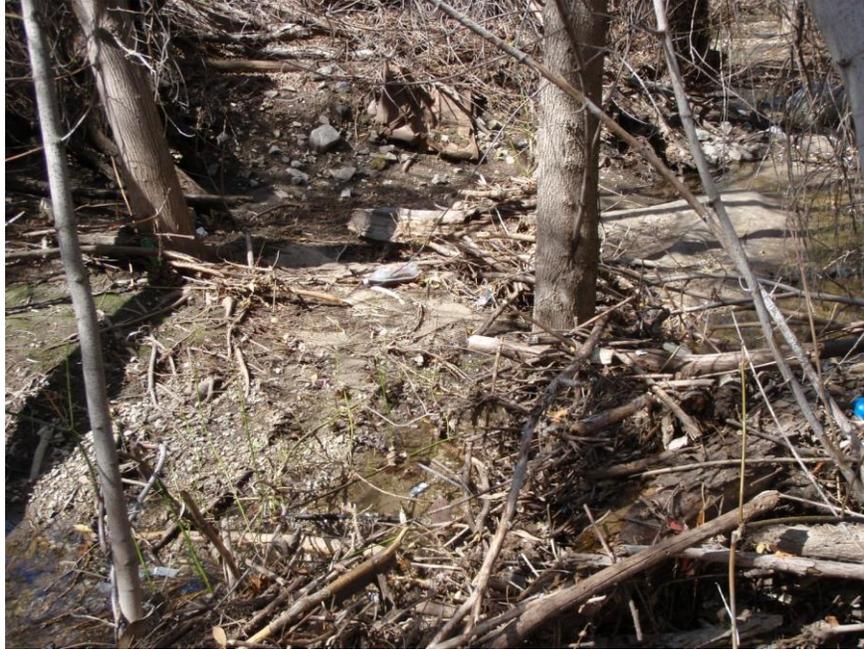
**Figure 10. Rank: 2. Garbage and debris are partially obstructing normal trail traffic and may pose a danger to hikers and equestrians (location 376281/3792658).**

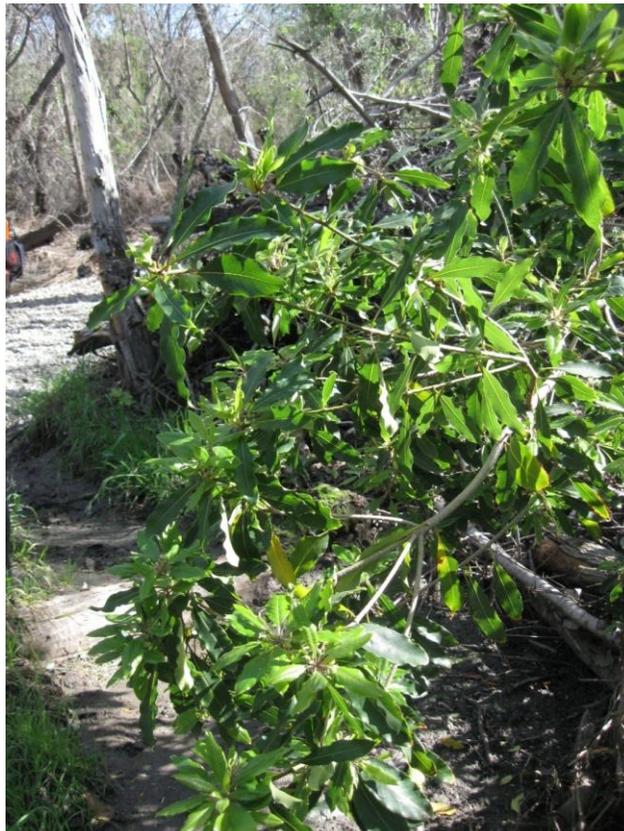
**Figure 11a. Rank: 3. Water flow from the Haines Canyon Wash caused this small tree to fall into the trail as a result of undermined roots. The tree does not appear to pose an immediate danger to park users (location: 376392/3792492).**

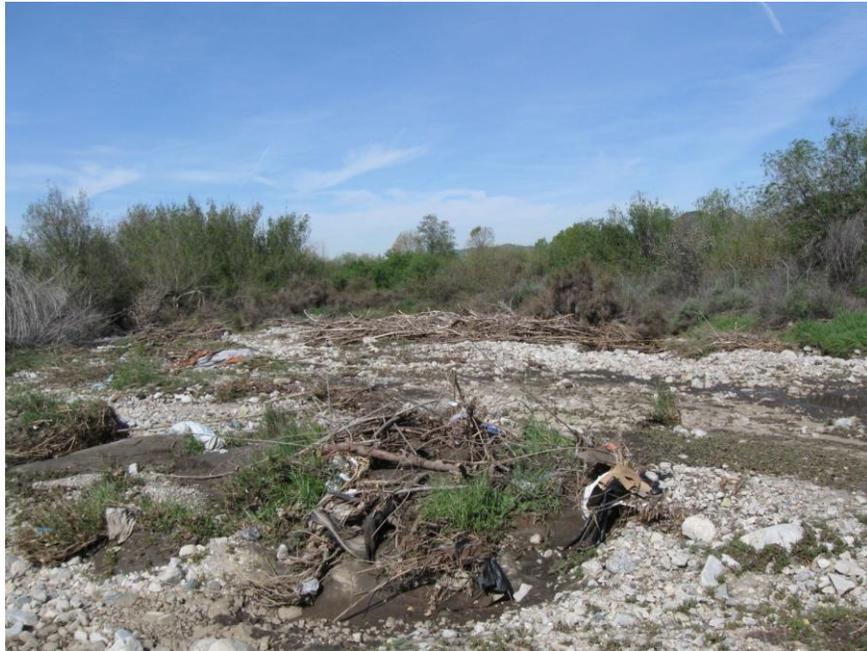
**Figure 12a. Rank: 3. Trash and debris in Haines Canyon Wash (location: 376631/3792616).**

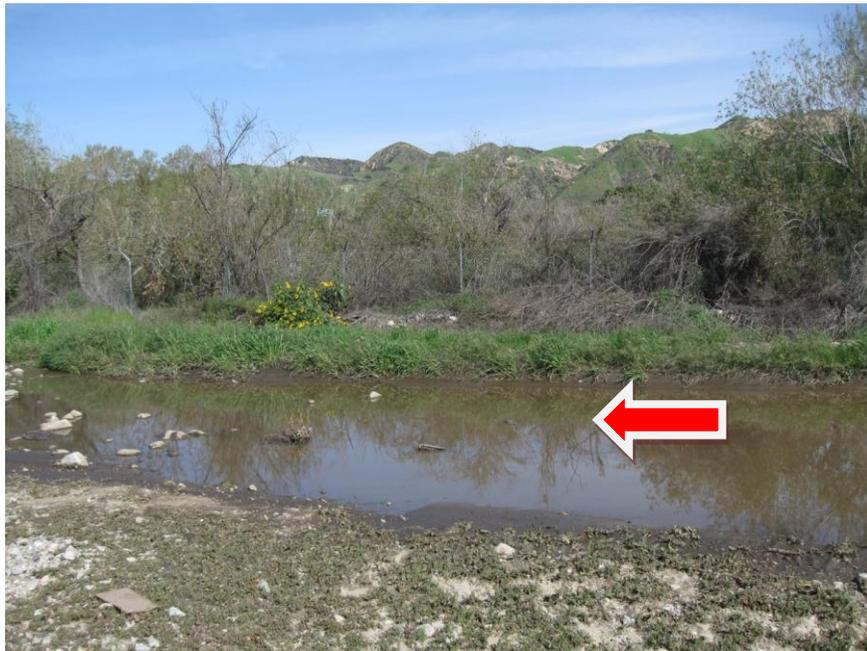
**Figure 12b. Rank: 3. Water from the post-Station Fire rains flows through Haines Canyon Wash and empties into Haines Canyon Creek. Arrow indicates direction of water flow (location: 376631/3792616).**
