Oak Woodland Habitat Revegetation/Mitigation Program

Santa Anita Dam Riser Modification and Reservoir Sediment Removal Project

**Environmental Impact Report Mitigation Measure
Nos. Bio-D and Bio-E**

May 2014

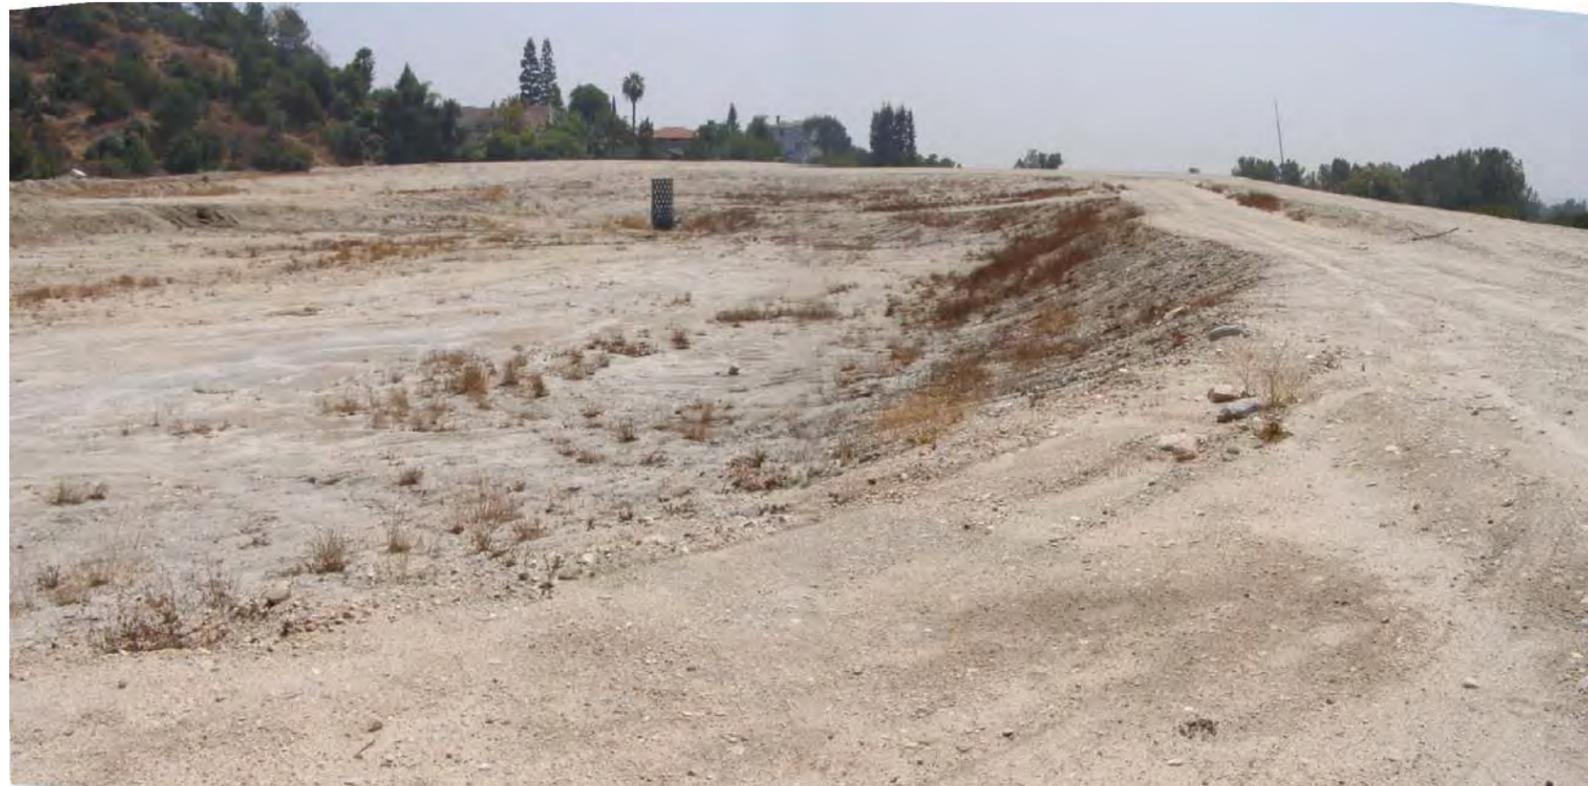
August 2009. Lower Sediment Placement (Mitigation) Site. Interim fill stockpile conditions in the 'plateau' area to be used for oak mitigation (5.5 acres). Off-site drainage inflow from slopes to the east (left in photo) will enhance on-site hydrology for woodland habitat establishment. A total of 30 feet of additional fill will be placed in this area.

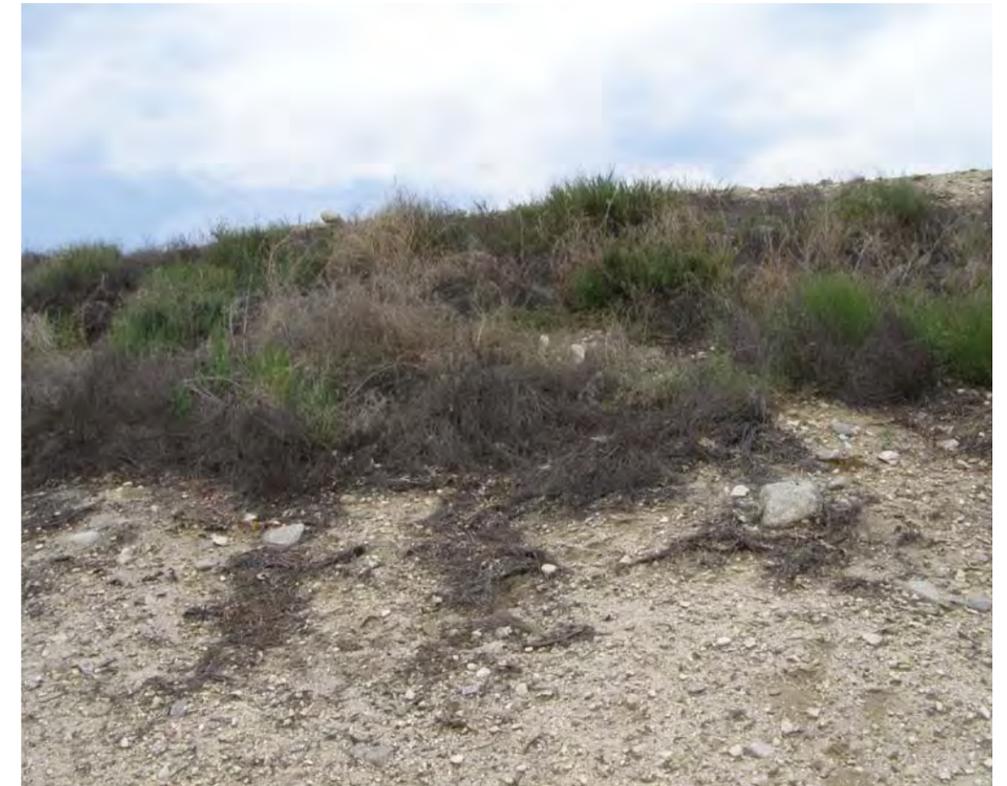
May 2010. Volunteer vegetation growth (including native shrubs) on a slope adjacent to the Middle Sediment Placement (Impact) Site. The slope is composed of transported material from previous sediment removal projects.

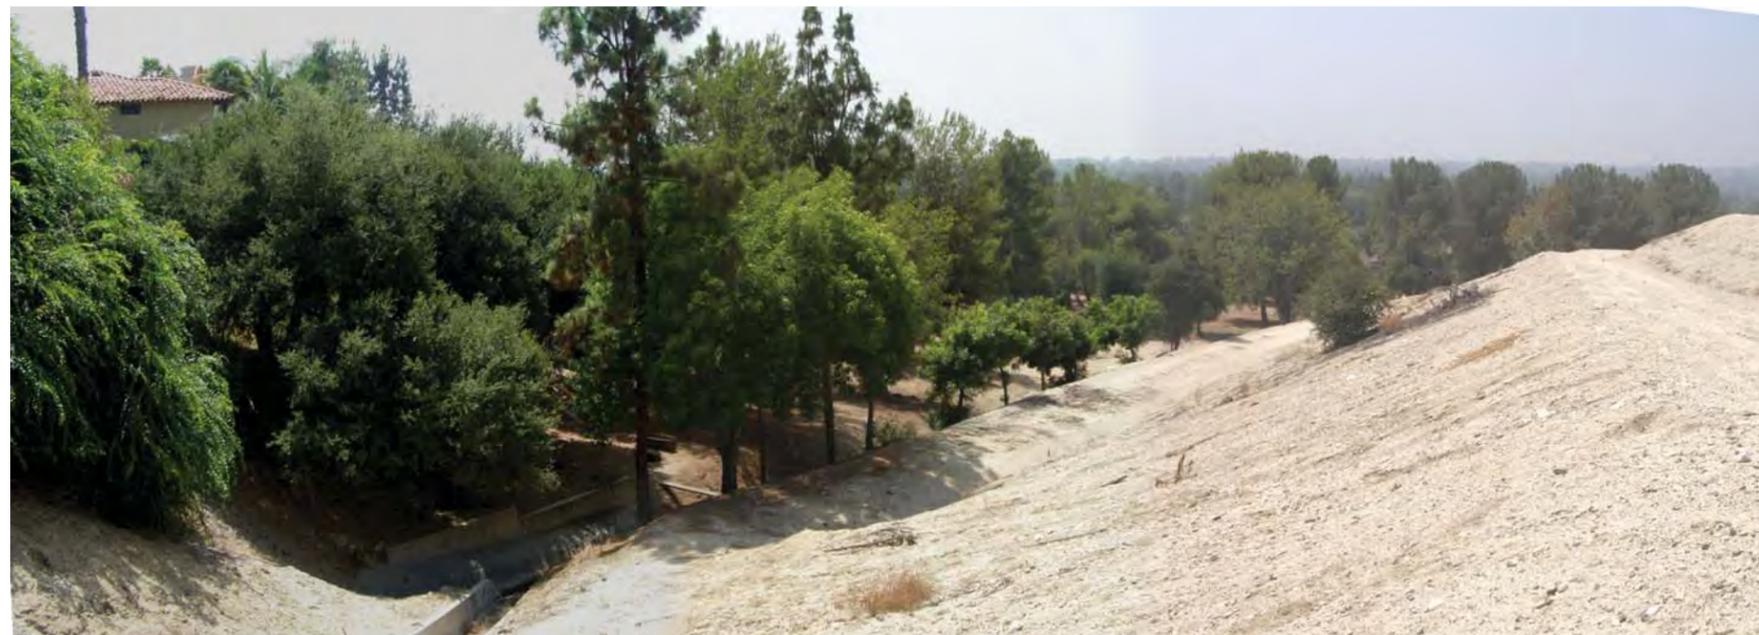
August 2009. Lower Sediment Placement (Mitigation) Site. Side slopes will be revegetated with coastal sage scrub species (2.5 acres). Native scrub plant species will not be installed within 100 feet of adjacent residential structures (left in photo) in compliance with the City of Arcadia's defensible space vegetation requirements.

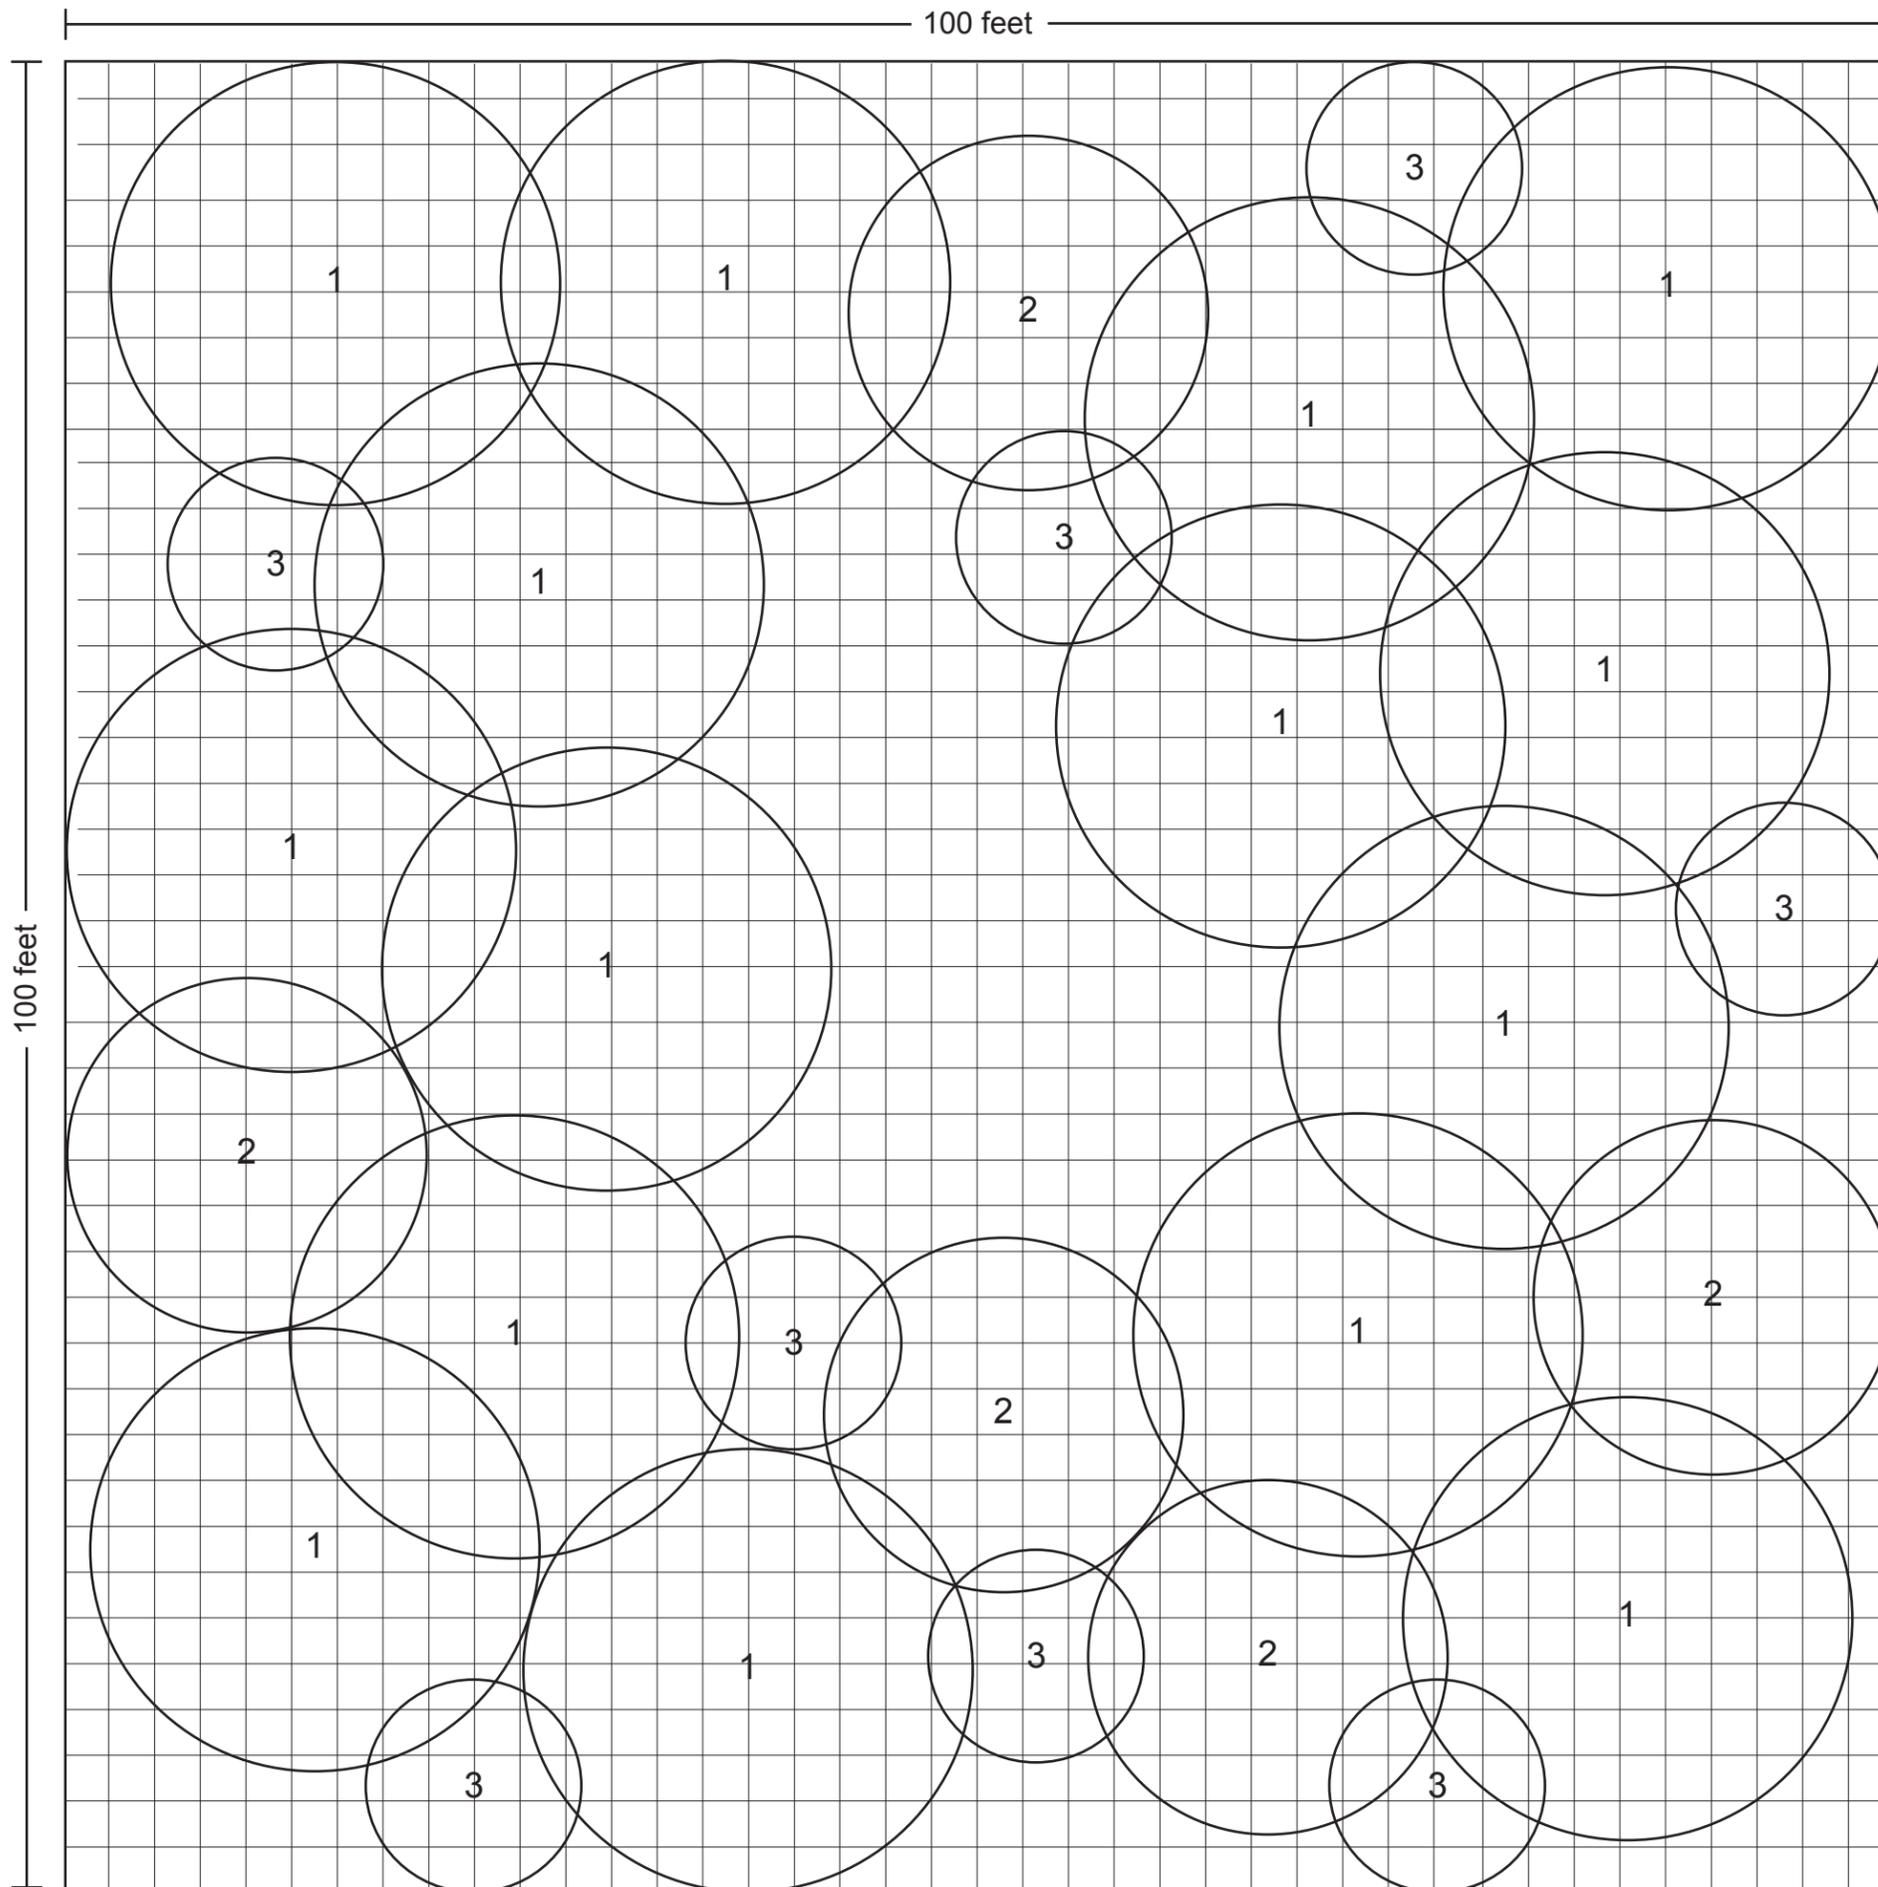
A total of 6 to 8 irregular-shaped planting polygons will be delineated on site with permanent staking to include only oak trees and native herbaceous species (1.0 acre total). These sub-areas of oak trees within native grassland/herbland will be managed throughout the maintenance program to avoid invasion by shrub species, thereby facilitating creation of a naturalistic habitat mosaic and structural 'edge' that is beneficial for a range of wildlife species. The Biological Monitor will create at least two demonstration plots in the oak woodland planting areas, delineated by lath-and-flagging, to indicate the container plant distribution (including the shrub-free sub-areas) that will be reproduced throughout the site. The Biological Monitor shall supply the lath, flagging, and color-coded wire flags for the demonstration plot. The Restoration Specialist shall not install any container plants in an unnatural, linear planting pattern. Container plant species that typically grow in denser shade conditions (including fern species) may be planted in later years of the maintenance program as vegetation cover increases, to enhance plant growth and survival. These plant species are also expected to become established on a volunteer basis from adjacent wildland areas. A list of container plant species is provided in Table 4; the actual container plant species and quantities may be modified based on availability of seed to collect from within the Santa Anita Wash/Rio Hondo Sub-Watershed. A list of the native plant materials installed to-date (between January and March 2014) is provided in Appendix D. A typical planting plan for the oak woodland mitigation area is provided on Exhibit 5. Exhibit 5 shows typical plant quantities, spacing, and plant groupings/configurations to be used in a 0.23-acre area (excluding the shrub-free polygons). Any plant species substitution shall be approved in advance by the CDFW.

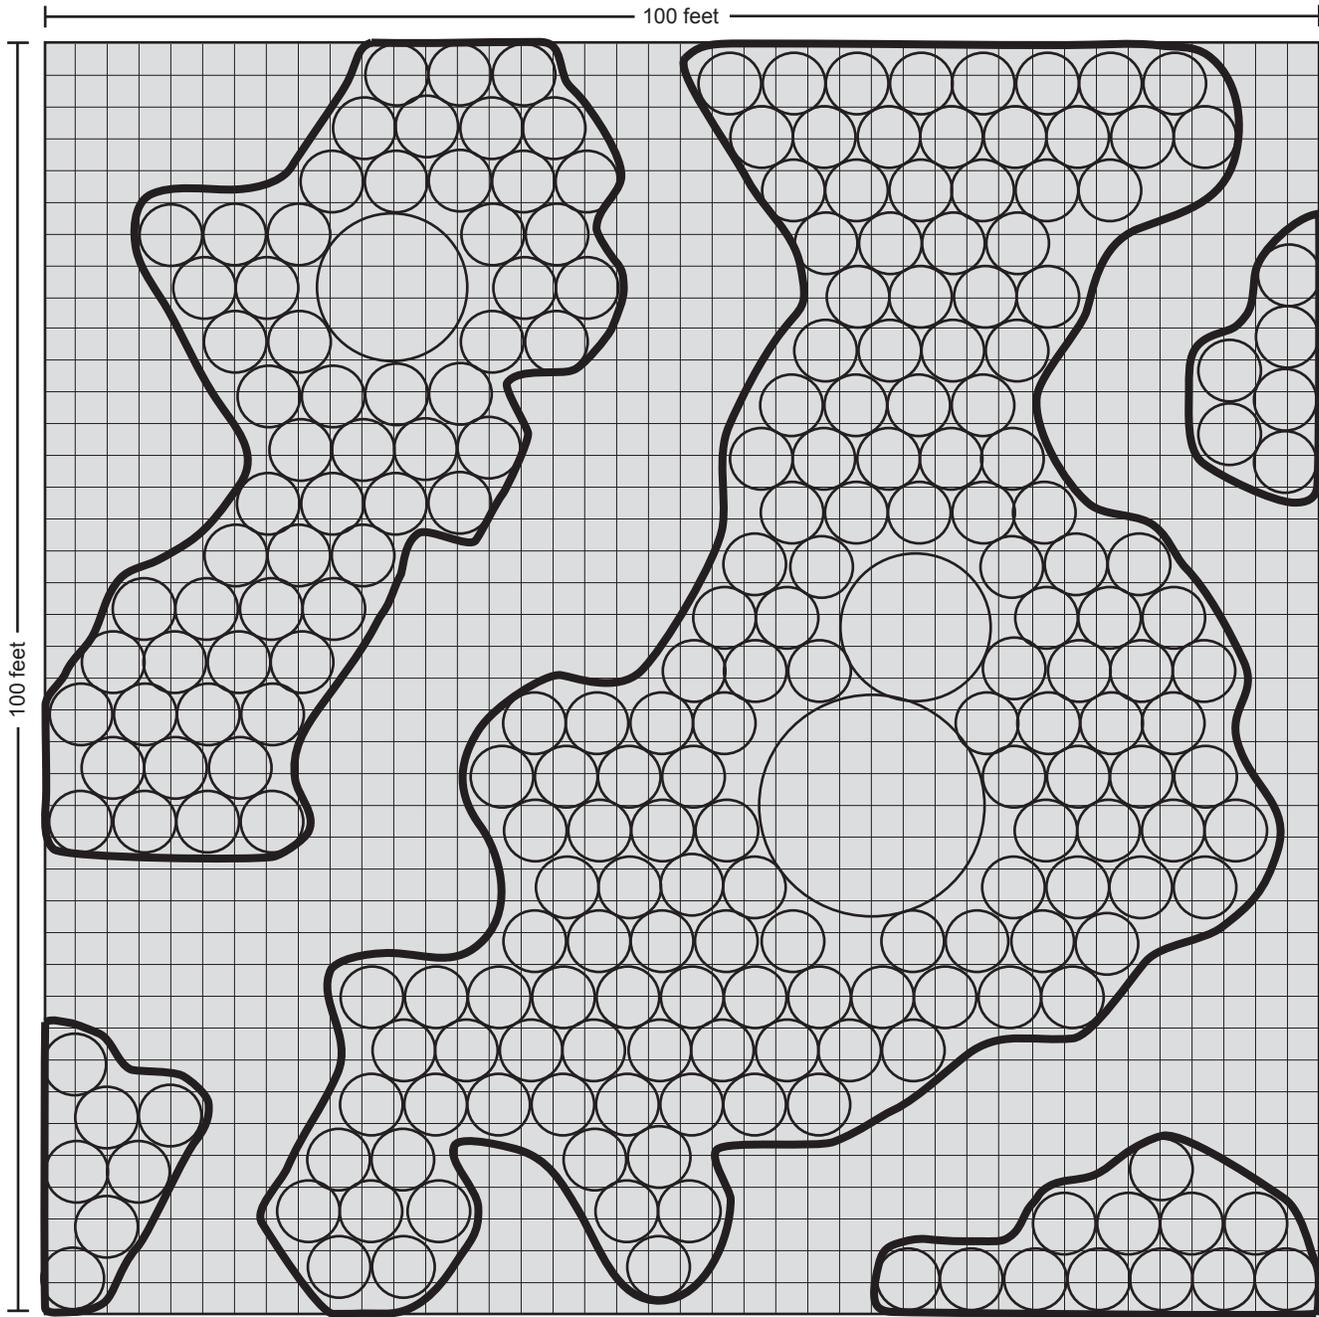
Area shown is 10,000 square feet (0.23 acre)
 Overall container plant density is approximately 1,000 plants/acre
 Actual planting pattern would be random non-linear

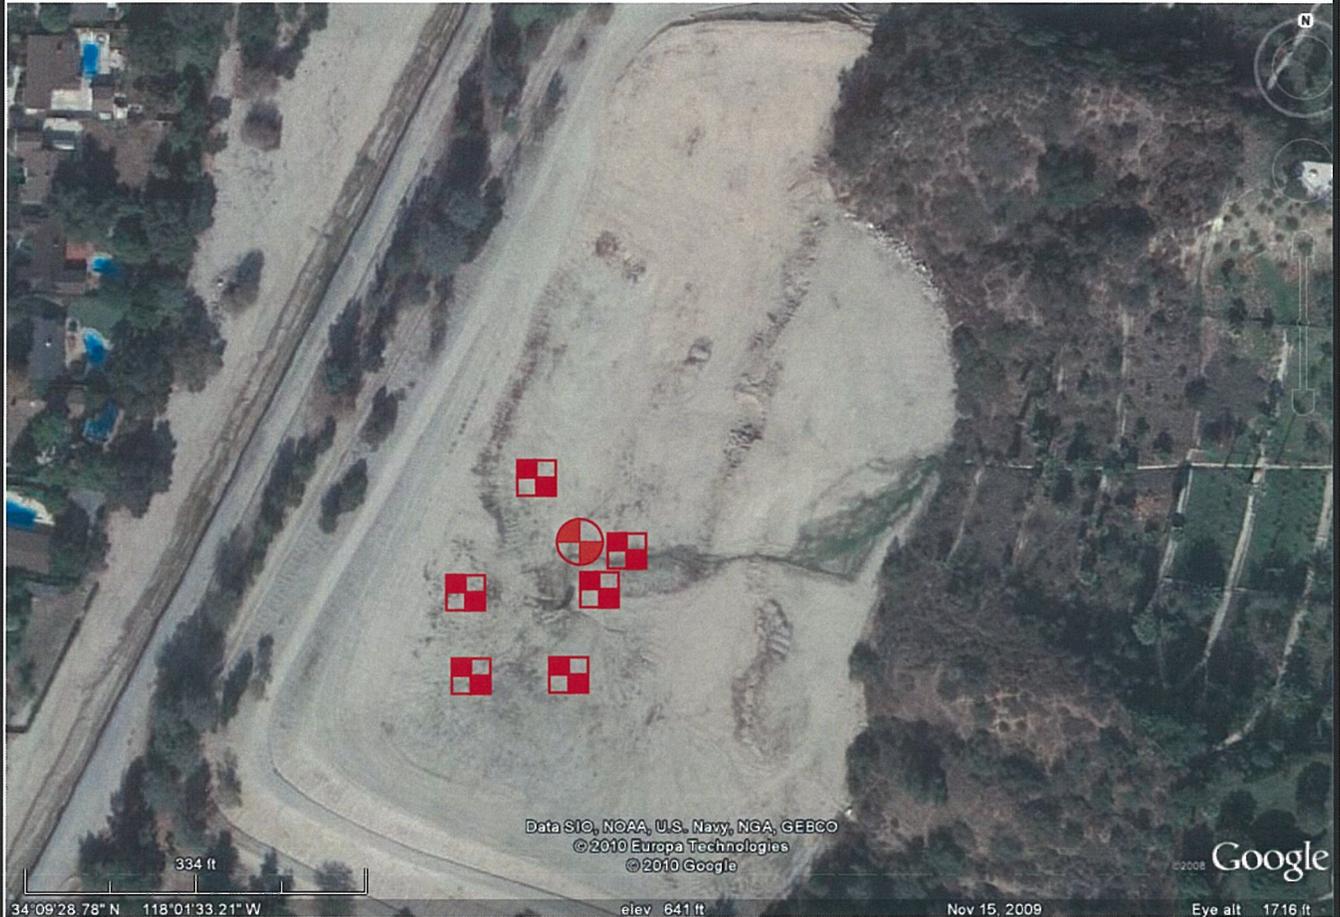
FIGURE 1

Boring location

Nuclear gage test location
