DEPARTMENT OF PUBLIC WORKS

**CONSOLIDATED SEWER MAINTENANCE DISTRICT
CONDITION ASSESSMENT PROGRAM REPORT
PROJECT NO. Y0TV0809C**

**CONDITION ASSESSMENT REPORT
COUNTY OF LOS ANGELES DEPARTMENT OF PUBLIC WORKS
CONSOLIDATED SEWER MAINTENANCE DISTRICT**

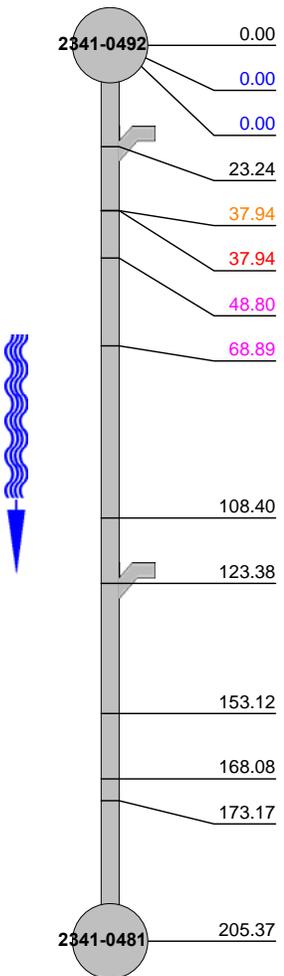
168.08	Roots Fine Joint, from 02 to 03 o'clock, within 8 inch: YES	00:07:53	152, b	
	173.17	Roots Fine Joint, from 02 to 03 o'clock, within 8 inch: YES	00:08:14	154, b

205.37	Downstream Manhole, Survey Ends 2341-0481	00:09:48	156

QSR	QMR	SPR	MPR	OPR	SPRI	MPRI	OPRI
5142	2200	16	4	20	4	2	3.33

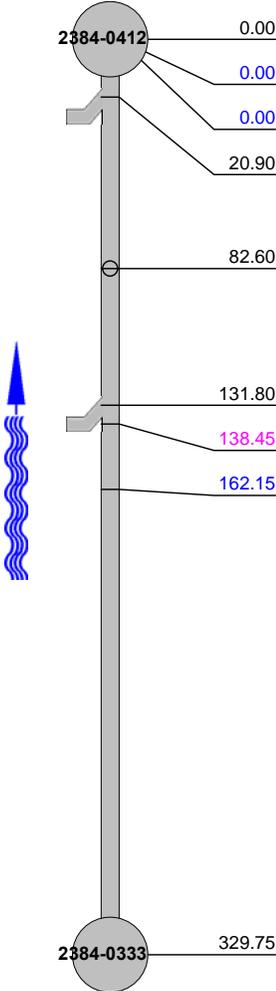
Remark:: **AGAINST THE FLOW**

1:825	position	observation	MPEG	photo	grade
	0.00	Upstream Manhole, Survey Begins 2384-0412		16	
	0.00	Water Level, 5 % of cross sectional area			M 2
	0.00	Water Mark, 5 % of cross sectional area			M 2
	20.90	Tap Factory Made Active, at 03 o'clock, 6", within 8 inch: YES	00:01:06	26	
	82.60	Tap Factory Made Active, at 12 o'clock, 6", within 8 inch: YES	00:03:14	27	
	131.80	Tap Factory Made Active, at 03 o'clock, 6", within 8 inch: YES	00:04:45	28	
	138.45	Fracture Multiple, from 04 to 09 o'clock, within 8 inch: YES	00:05:08	29, b	S 4
	162.15	Fracture Circumferential, from 06 to 11 o'clock, within 8 inch: YES	00:06:28	31, b	S 2
	329.75	Downstream Manhole, Survey Ends 2384-0333	00:12:14	33

QSR	QMR	SPR	MPR	OPR	SPRI	MPRI	OPRI
4121	2200	6	4	10	3	2	2.5

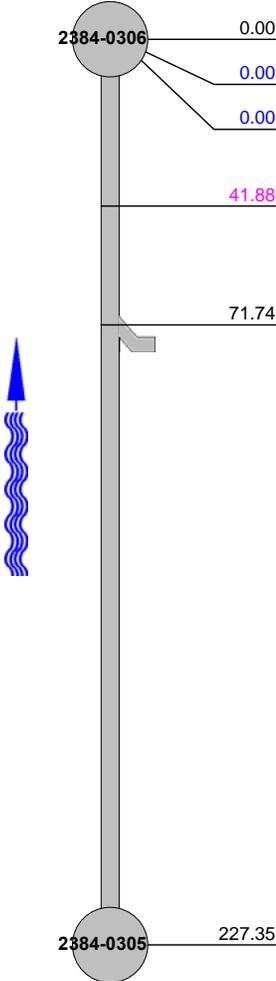
Remark:: **AGAINST THE FLOW**

1:575	position	observation	MPEG	photo	grade
	0.00	Downstream Manhole, Survey Begins 2384-0305		1	
	0.00	Water Level, 5 % of cross sectional area			M 2
	0.00	Water Mark, 5 % of cross sectional area			M 2
	41.88	Fracture Multiple, from 09 to 03 o'clock, within 8 inch: YES	00:03:21	2, b	S 4
	71.74	Tap Factory Made Active, at 10 o'clock, 6", within 8 inch: YES	00:04:27	4	
	227.35	Upstream Manhole, Survey Ends 2384-0306	00:09:22	5

QSR	QMR	SPR	MPR	OPR	SPRI	MPRI	OPRI
4100	2200	4	4	8	4	2	2.67
