**CONSOLIDATED SEWER MAINTENANCE DISTRICT
CONDITION ASSESSMENT PROGRAM REPORT
PROJECT Y0TV0506F**

**CONDITION ASSESSMENT REPORT
COUNTY OF LOS ANGELES DEPARTMENT OF PUBLIC WORKS
CONSOLIDATED SEWER MAINTENANCE DISTRICT**

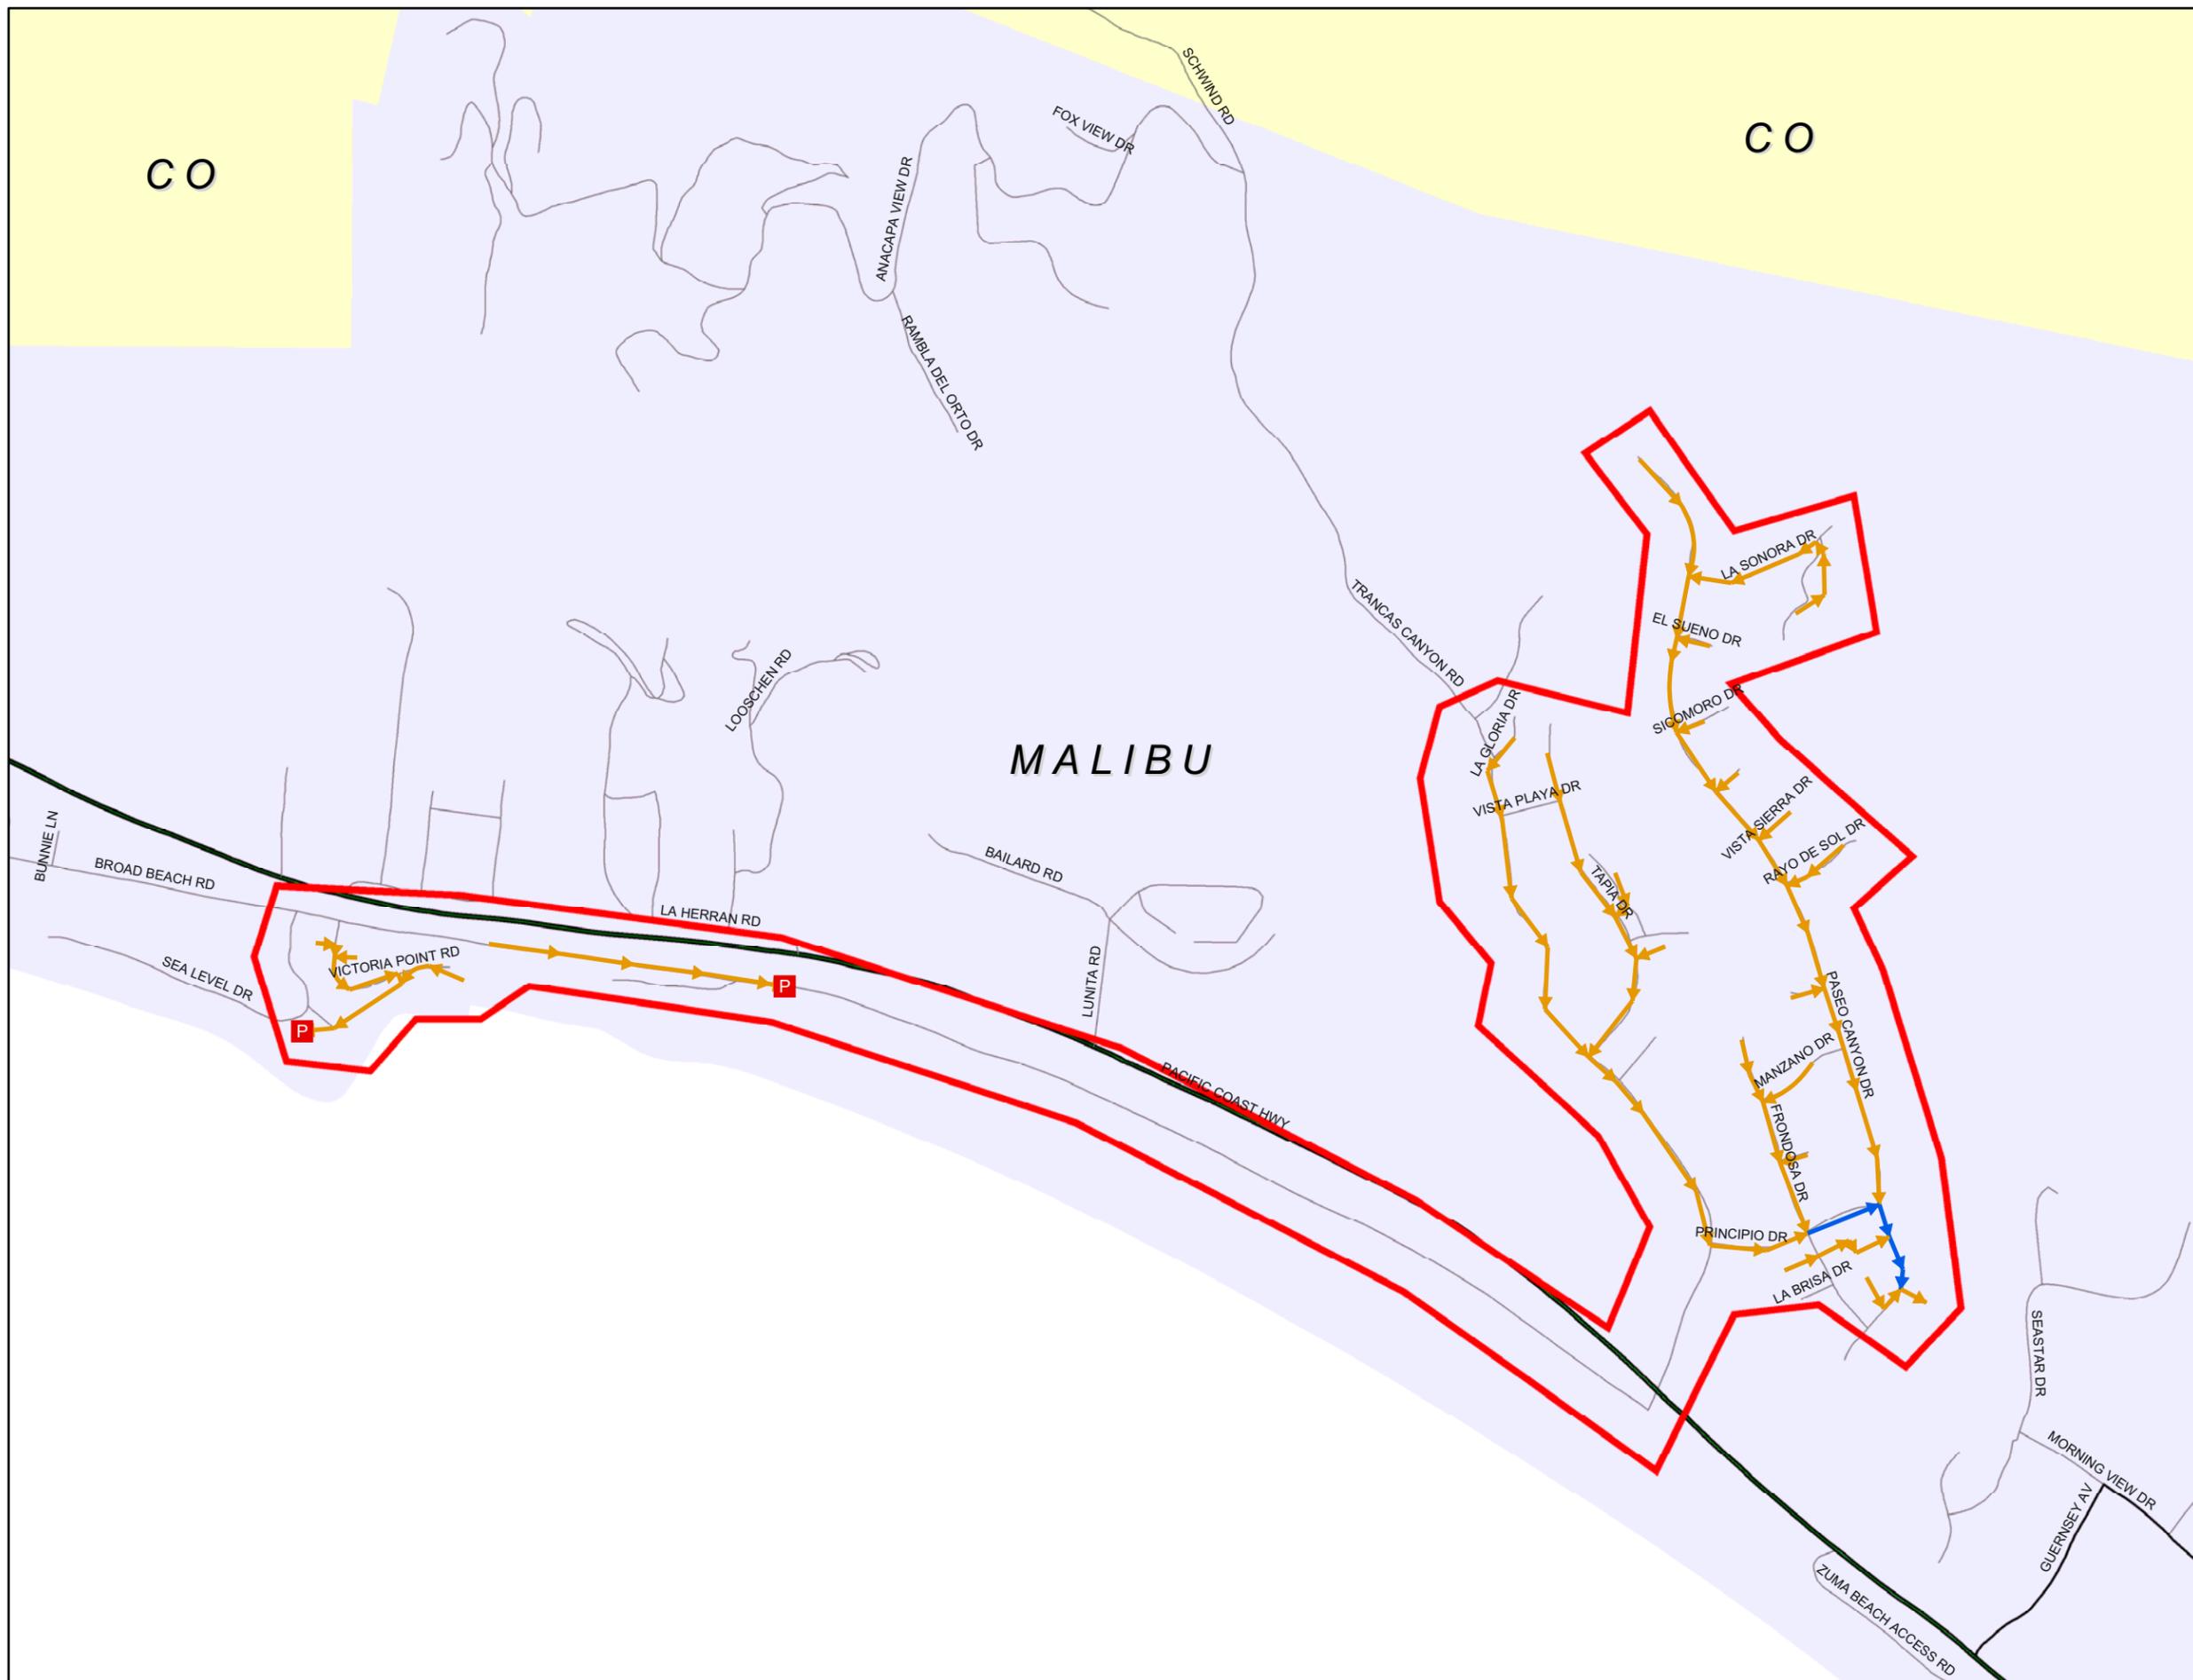
Y0TV0506F_Overview.mdx

- Condition Assessment Report
- Project Overview Map (Enclosure 1)
- Quick Maintenance Rating Report Priority List and Quick Maintenance Rating Map (Enclosure 2)
- Quick Structural Rating Report Priority List and Quick Structural Rating Map (Enclosure 3)
- Infrastructure Inspection Reports for Grades 4 and 5 (Enclosure 4)

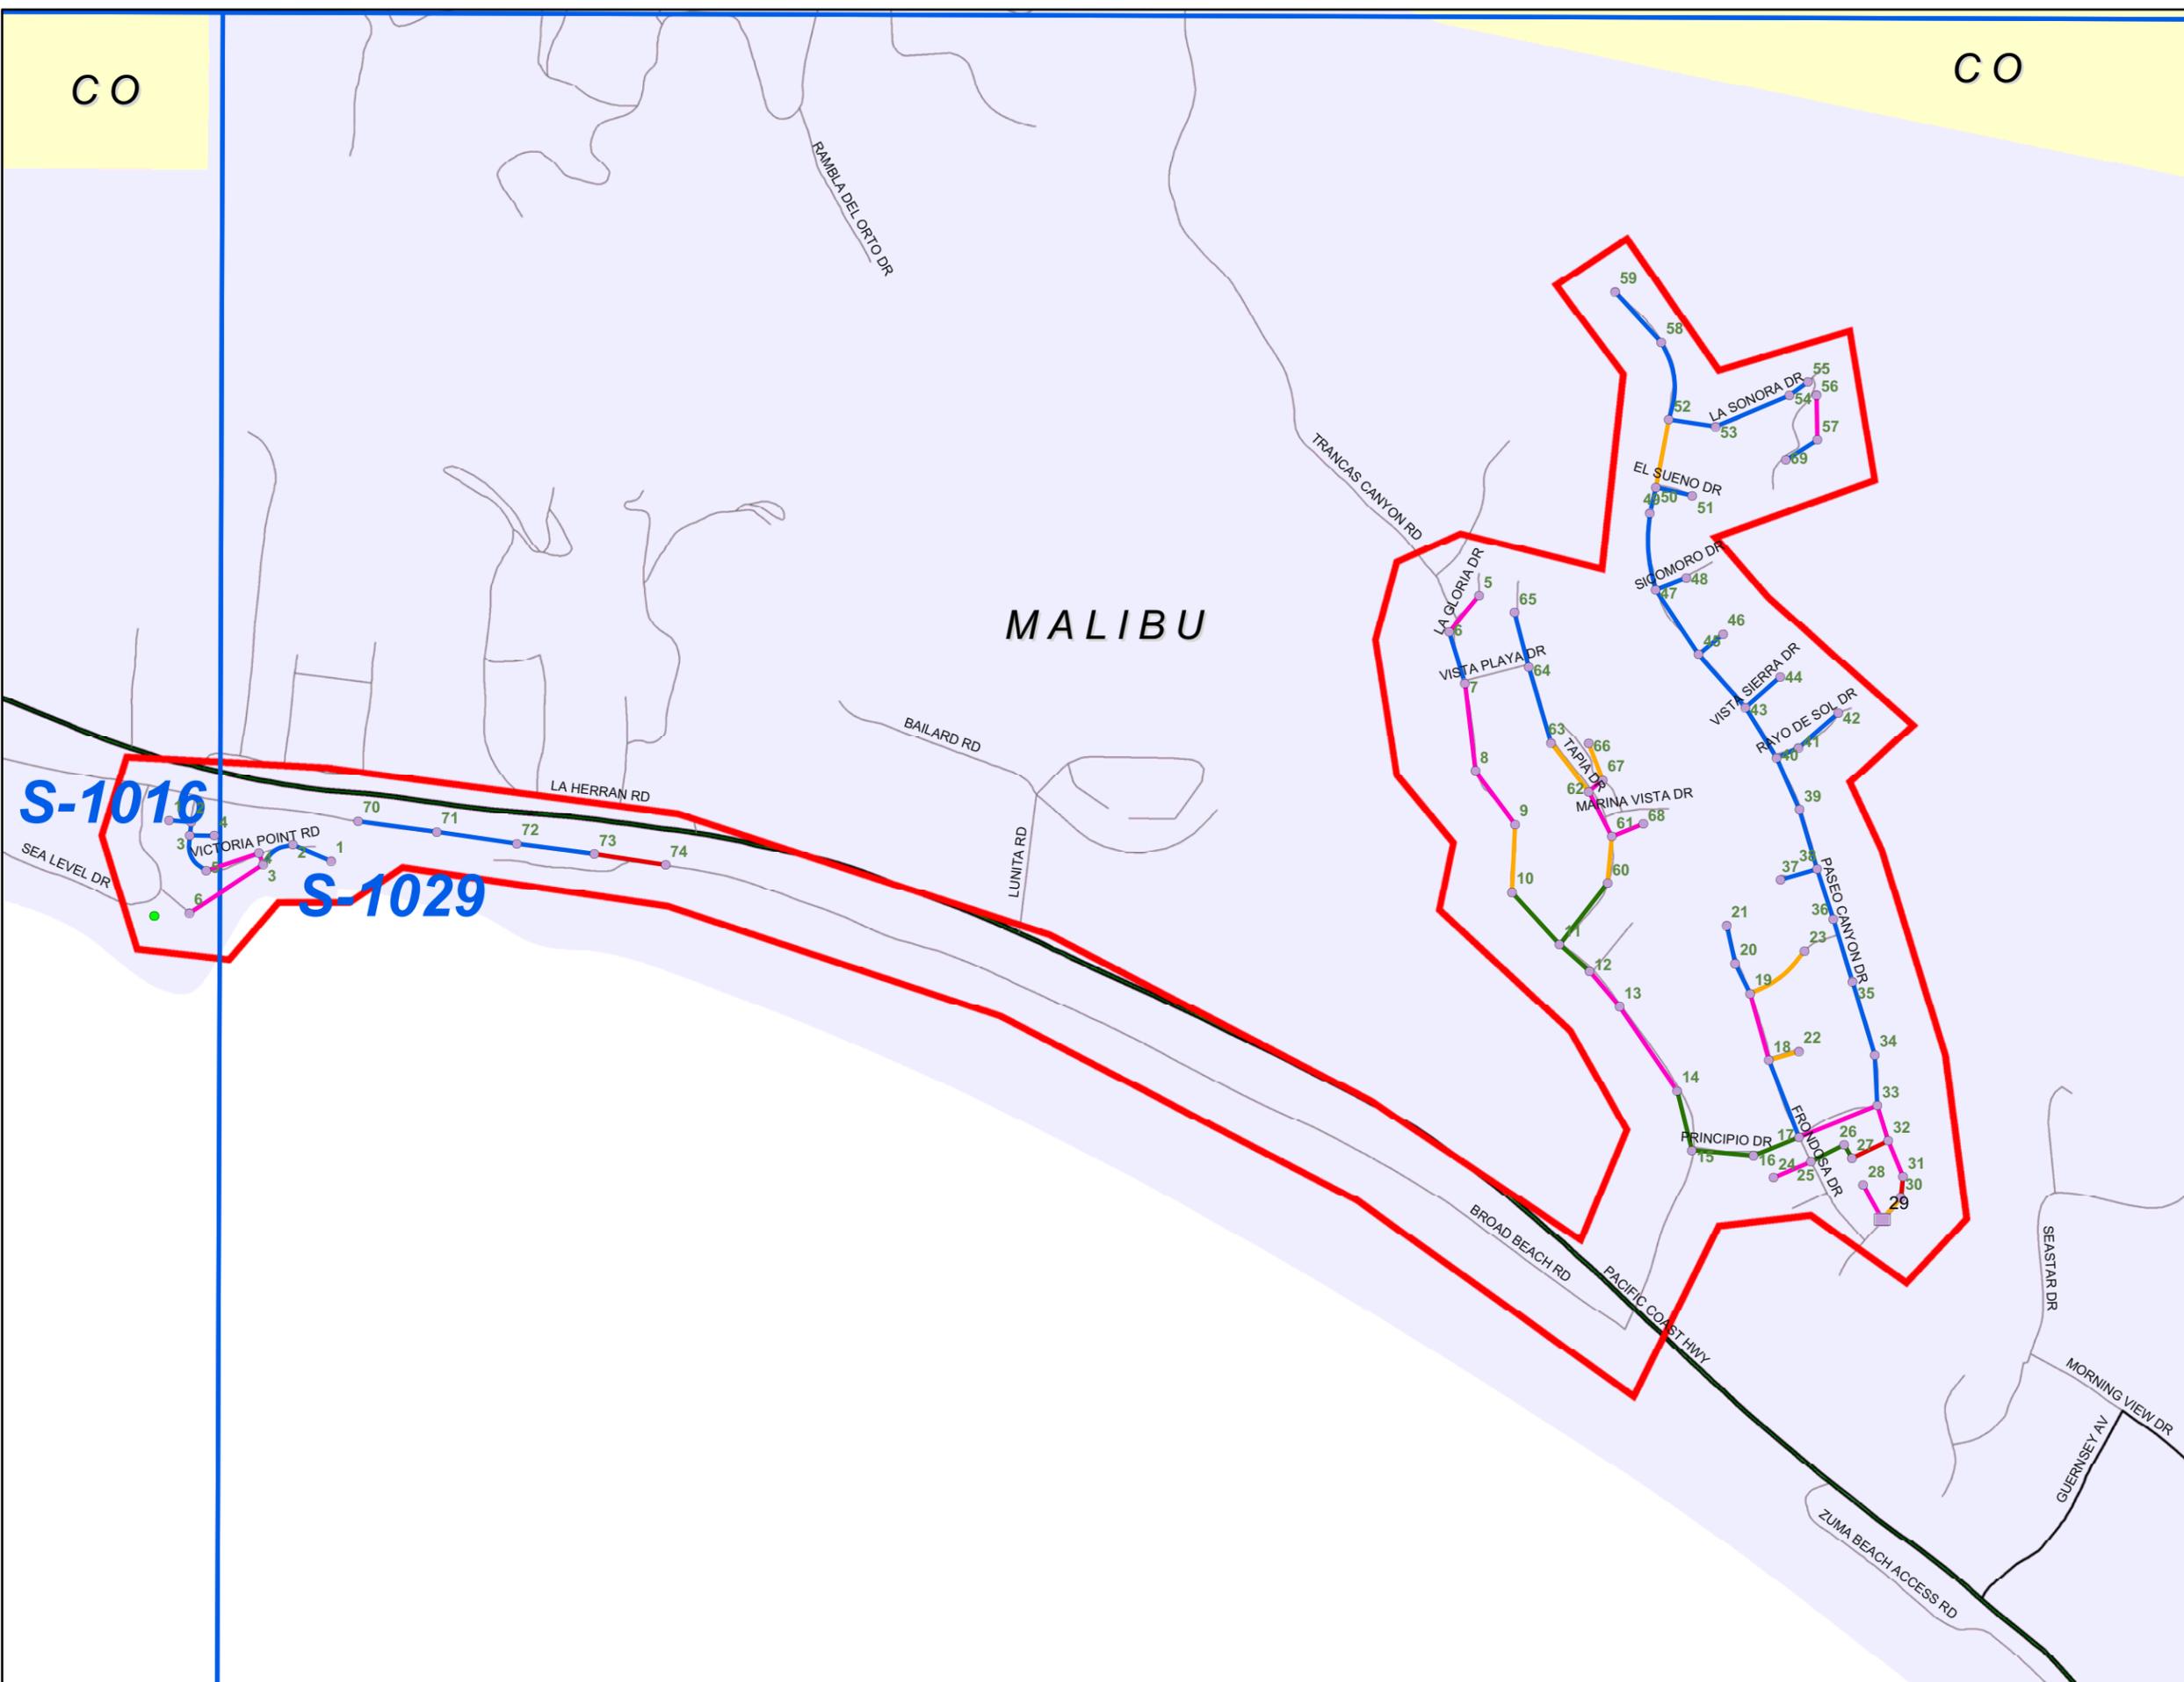
0506F_11x17_QMR_MAL.mdx

ENCLOSURE 2

CCTV PROJECT Y0TV0506F

Our inspection revealed that approximately 77.5 percent of the system televised was free of blockages or restrictions that would impede sewer flows. However, the remaining 22.5 percent of the inspected pipe segments within the Unincorporated County/ Malibu Area had a PACP maintenance grade of 4 or 5 as indicated in the Quick Maintenance Rating Table shown below. These segments have been incorporated into our routine cleaning schedule with corrective action taken as noted on the Quick Maintenance Rating Report Priority List (Enclosure 2). Also included is a color-coded map showing the quick maintenance rating for each pipe segment.

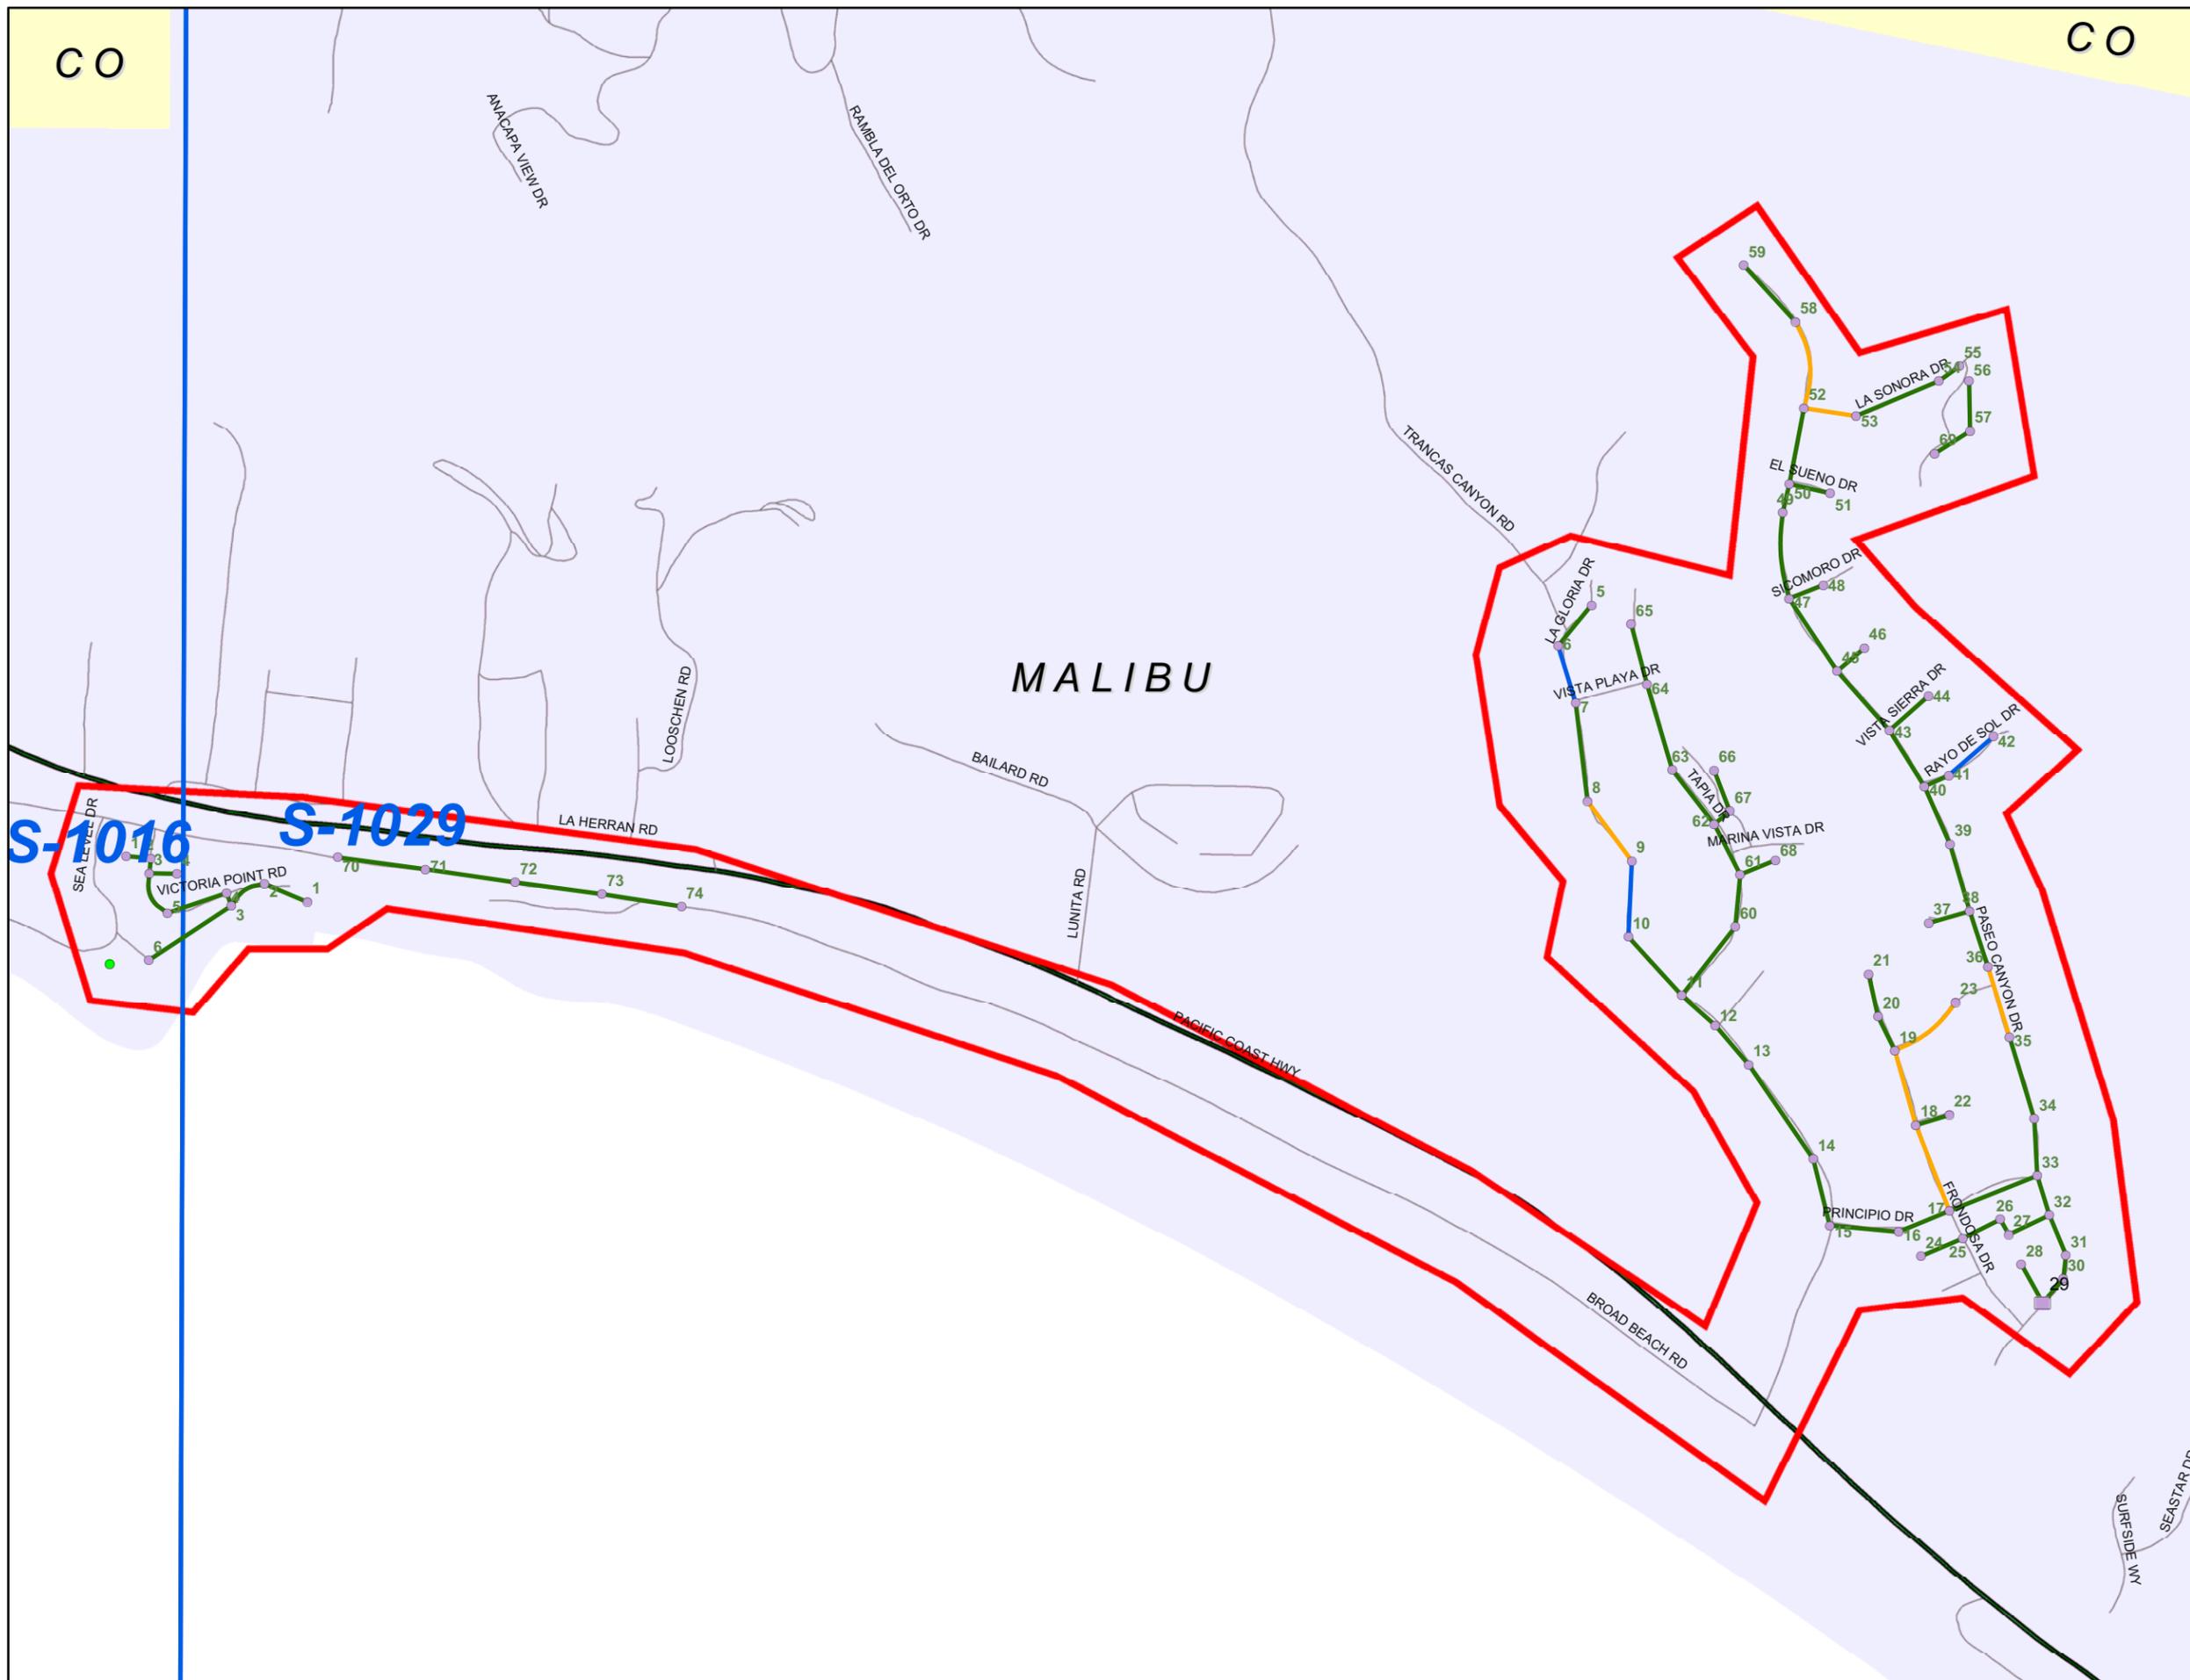
0506F_11x17_QSR_MAL_1.mdx

ENCLOSURE 3

CCTV PROJECT YOTV0506F
